PROBLEM STATEMENT

This specific problem is related to one of the 33 kV lines namely RF - 9 of WPS - 1, which feeds power from Ratmalana GSS to Moratuwa 2×5 MVA PSS and Angulana 3×5 MVA PSS. It is very important to provide a reliable power supply to those areas as they are highly industrialized, commercialized and densely populated. Furthermore those commercial, industrial and residential consumers contribute to a substantial portion of revenue at higher tariff rate to the CEB and they are more concerned about the reliability of electricity supply.

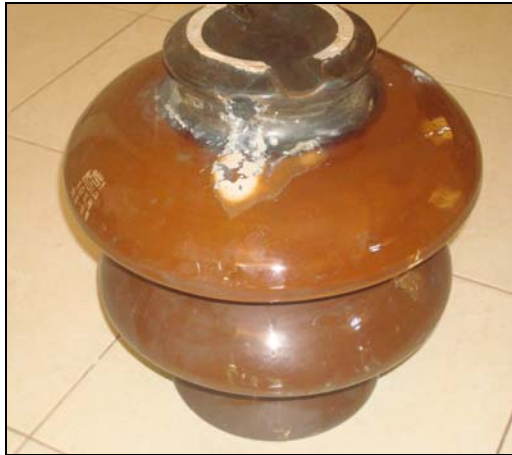
When analyzing the outage details of RF - 9, it has been noted that in most instances of tripping in the feeder were caused by the insulator flashover due to lightning and saline pollution. During the monsoon period, the tripping rate is very high. Most of the flashovers on the insulators have been reported on the 33 kV line running closer to the sea. The outage details except load shedding of RF - 9 are given in Table 2.1.

Some photographs of insulators which are flashed over and replaced from the RF - 9 are shown in Figure 2.4 and 2.5.

Figure 2.4 The Flashover 33kV Pin Insulator

Presently under the routine maintenance, this feeder is washed once a year. During the preventive maintenance programmes all the insulators are visually inspected and those with poor glazed surface are replaced

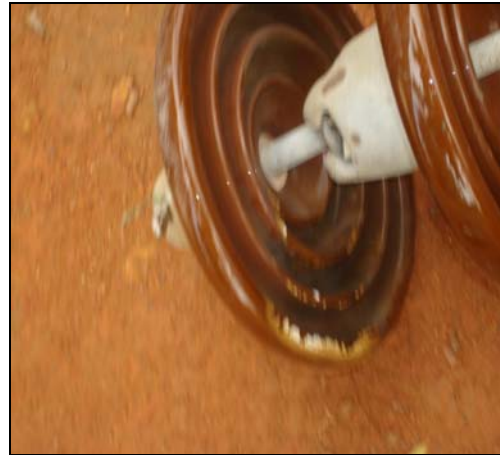
Figure 2.5 The Flashover 33kV Shackle Insulators
