Mine Safety Issues in Quarry Industry: Case Studies of Recent Fatal Accidents in Sri Lanka

***Jagath KV and Siriwardena HP**

¹Geological Survey and Mines Bureau, Pitakotte, Sri Lanka

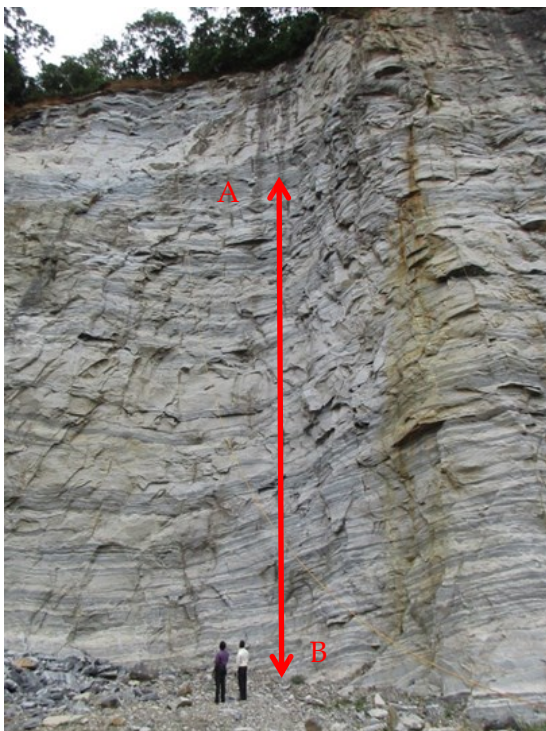
Figure 1: Place of the Incident

- A- The place where the Deceased people were engaging in drilling
- B- The place where the Deceased people have fallen
- AB-70m-80m

Two fatalities were reported in a quarry on 09-07-2021, where the license-IML/C/COL/N/025/R/01 was issued. One of the victims was 42 years old resident of Kaduwela, while the other one was 51 years old resident of Yatiyanthota. Two victims were casual labourers of the quarry and had been working in the quarry for more than ten years. The

licensee has been operating the quarry for more than twelve years. It has only one face with a bench height of more than 200 feet. Workers normally reach the top of the face by the ropes since there is no any other access path to reach the blasting location. The place where the incident occurred is shown in Figure 1.
