# Damage on Masonry Walls due to Blast Vibration

S.A.N.S.Wickramasinghe<sup>1)</sup>, S.R.Masakorala<sup>2)</sup>, E.A.T.P.Jayasinghe<sup>3)</sup>,  
G.H.M.J.Subashi De Silva<sup>4)</sup> and G.S.Y.De Silva<sup>5)</sup>

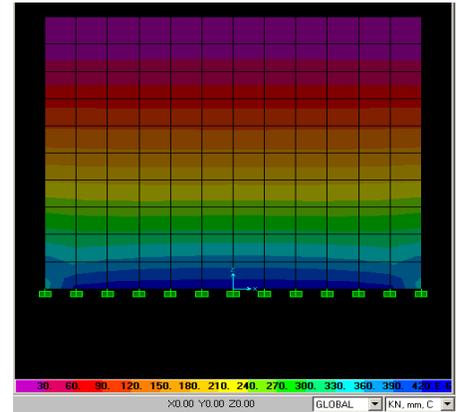
**Figure 3: Stress distribution obtained from analysis for cantilever type wall panel**

Continuation of blasting has resulted in a significant crack between the wall and the foundation of the first model structure which did not have any vertical lateral supports at a vibration level of 30.2 mm/s of ppv at a frequency of 50 Hz. FEM. After the joint was concreted and restored, significant crack (i.e., a structural separation) was

Figure 3 shows the stress distribution along the structure without vertical lateral supports when exposed to the response spectrum of dynamic force. The results of the numerical model using SAP 2000 highlighted an increased S22 stress concentration of about  $420 \times 10^{-3} \text{ N/mm}^2$  at the bottom level of the structure. But according to the results of the model analysis for the structure with vertical lateral supports, the maximum S22 stress level of the model was only about  $112 \times 10^{-3} \text{ N/mm}^2$ .

An increased S22 stress concentration of about 0.42 N/mm<sup>2</sup> observed at the bottom level of the plaster was closer to the splitting tensile strength of 0.402 N/mm<sup>2</sup>. This implies that crack formed at the bottom of the cantilever type structure was possibly due to the greater tensile stress developed at that level.
