CONSIDERATION OF DAMAGES OF A FLOATING ROOF-TYPE OIL STORAGE TANK DUE TO THERMAL STRESS

Abstract

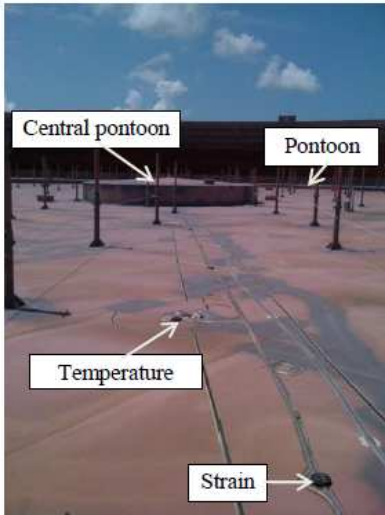
Figure 1 Actual floating roof equipped with pontoon and center pontoon.

The floating roof on which several cracks were found is the single-deck type floating roof with an additional center pontoon. The tank has a diameter of 80m and height of 22m with a 100,000 kL capacity. The thickness of the deck plate is 4.8mm. The tank was built in 1980.

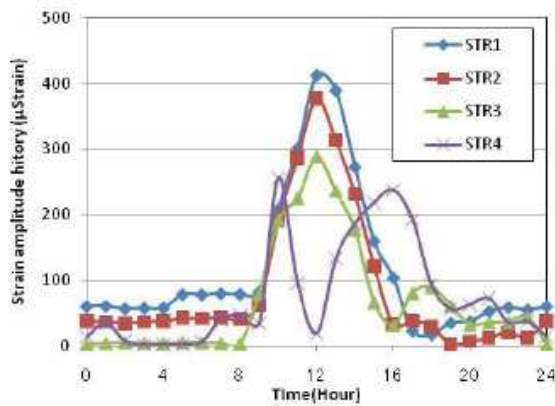
Figure 3 Strain amplitude history in 0° direction.

Figure 3 and Figure 4 show strain and temperature amplitude history in 0° direction during the day respectively. The origin of the time in both figures means 12A.M. Figure 3 shows that 412μStrain amplitude occurred in 12 hours around at STR 1 when temperature amplitude was 56 degree Celsius. If Young’s modulus is 206GPa, 83MPa stress amplitude will occur. This value is less than that of yield stress of general structure steel (245MPa) [4]. As for the result of STR4 in Fig. 3, the buckling could occur in 9 hours. This will be discussed in the section 3.3.

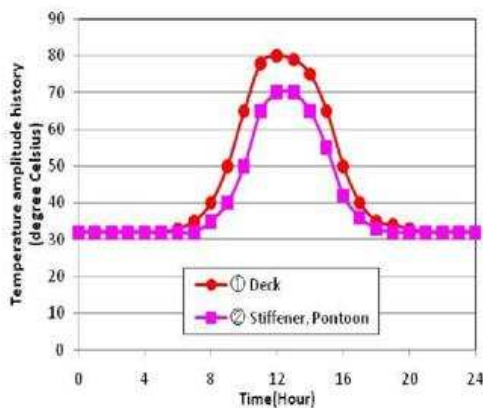
Figure 6 Numerical data of temperature amplitude history.

Figure 6 shows the numerical temperature data based on measurement results and Fig. 7 shows temperature and constrain conditions. Temperature of the deck surface around the stiffener ring was around 10 degree Celsius smaller than that of other area because stiffener rings worked as a heat release fin. Even in the pontoon, the heat was likely to release from the inside wall of the pontoon. Therefore, temperature amplitude histories were given as two types of curves shown in Fig. 6. The circled numbers 1 and 2 in Fig. 7 correspond to the numbers in Fig. 6. This means that the temperature data of the circle number 1 in Fig. 6 was given to the deck surface excluding the surface above the stiffener rings. Also, the temperature data of the circle number 2 in Fig.6 was given to the pontoon surface and the surface above the stiffener rings. As for the inside wall of the pontoon shown as the line of the circle number 3 in Fig. 7, the initial temperature amplitude which was 32 degree Celsius was given. Regarding the constrain conditions, the horizontal translation was fixed on the center line and the vertical on the outer pontoon as shown in Fig. 7.

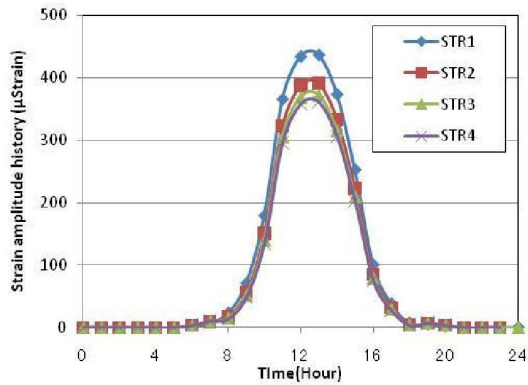
Figure 8 Strain amplitude history of the numerical simulation.

Figure 8 shows the strain amplitude history obtained by the numerical simulation. According to Fig. 8, the strain amplitude history was subject to the temperature history and that the maximum strain amplitude occurred at around maximum temperature amplitude. Compared with Fig. 3, corresponding curves in Fig. 8 show almost the same amplitude except for STR 4. Regarding STR 4, the measurement result could show Snap-back. It is considered that imperfections in the actual floating

roof affected the deformation. The numerical model is the ideal model without imperfections, while the actual floating deck involves welded parts and additional pieces attached to the deck surface, which could be considered the origin of the buckling [5].

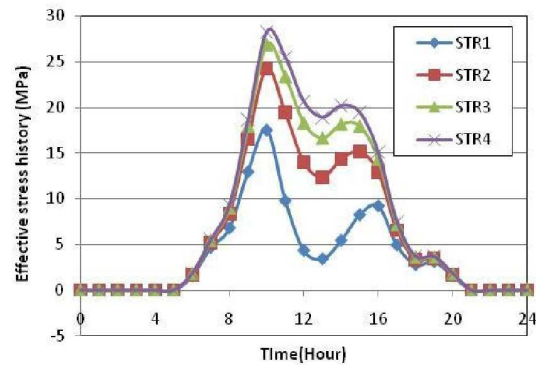
Figure 9 Effective stress amplitude history of the numerical simulation.

Figure 9 shows the effective stress history. Curves fluctuated within 8 to 18 hours. The maximum stress occurred at STR 4 in 10 hours. The maximum stress was at most 27.4MPa. In comparison with tensile strength of the general structure steel (400MPa) [4], the value of the maximum stress was fairly small. Furthermore, the maximum stress was less than the fatigue limit that is around 100MPa in the case of the general structure steel [6]. From these results, thermal stress on the floating roof was unlikely to lead to the fracture on the actual floating roof.

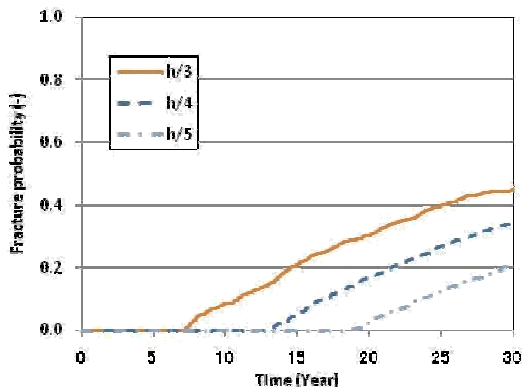
Figure 13 Fracture probability (average crack length: $h/3$, $h/4$, $h/5$ without any of inspections).

Figure 13 shows the fracture probability in case that average crack lengths are $h/3$, $h/4$, and $h/5$ without any of the initial inspection or the periodic. According to Fig. 13, the larger the average crack length is, the earlier the fracture begins to occur. In the case of $h/3$, the fracture begins to cause in 7.2 years and the fracture probability could attain to 0.45 in 30 years. Similarly, in the case of $h/4$, fracture would begin to occur in 12.8 years and the fracture probability could attain to 0.39 in 30 years. In the case of $h/5$, the fracture probability could attain to 0.21 within 18.8 years to 30 years.

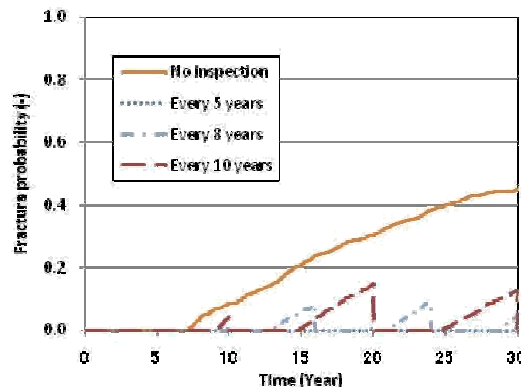
Figure 14 Fracture probability considering the periodic inspection (average crack length: $h/3$).

Next, Figure 14 shows the fracture probability considering the periodic inspection (every 5, 8 and 10 years) in case of $h/3$. Figure 14 illustrates that the fracture probability can be approximately zero right after the periodic inspection. This result does not depend on the period of the inspection. The shorter the interval of the inspection is, the lower the maximum value of the fracture probability becomes.

The actual tank shall be inspected every 8 years. Based on the period of service (about 30 years), the fracture probability was supposed to be $4.3e-2$ when the cracks on the floating roof were detected.
