# **Performance of Timber, Masonry and Earth Houses in the Christchurch Earthquakes New Zealand September 2010 and February 2011**

Hugh W Morris,  
Department of Civil & Environmental Engineering  
The University of Auckland  
(hw.morris@auckland.ac.nz)  
Andrew H Buchanan,  
David Carradine  
The University of Canterbury  
Richard Walker  
Consulting Engineer

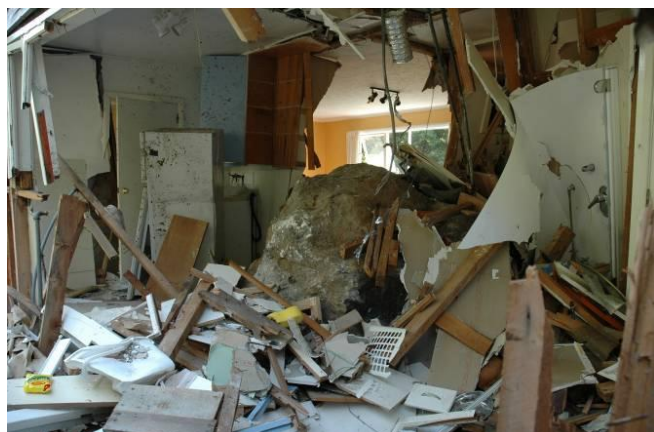
In areas to the southeast of the city centre houses were damaged due to landslides and boulders that broke free from hillsides during the earthquake. In some cases this type of damage was severe and resulted in large portions of houses being destroyed and rendered uninhabitable, as shown in Figures 4 and 5.

Figure 4. House damage in Heathcote due to rock fall (Carradine)

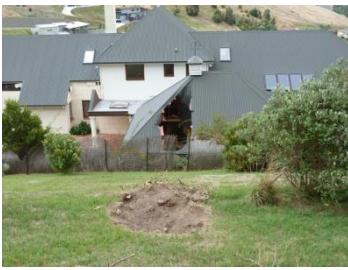
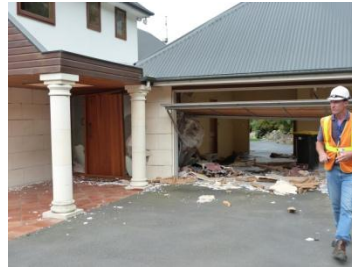
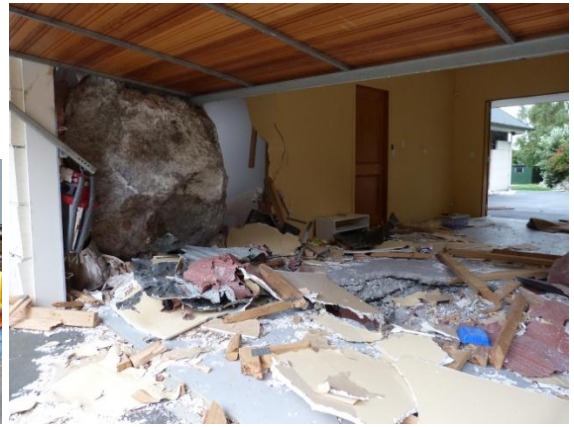
Figure 5a Fallen rock entry point 5b House and garage

5c Close up of fallen rock inside house and garage

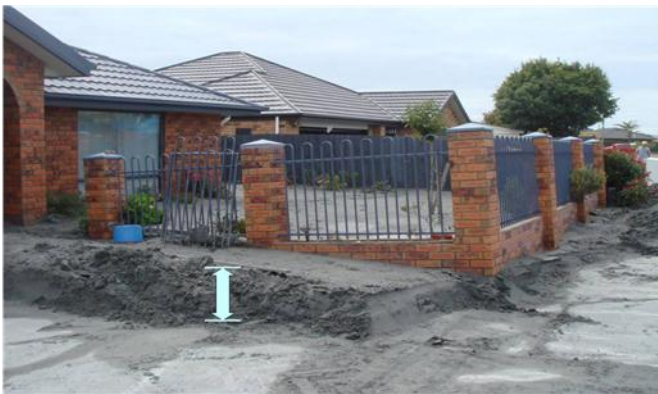
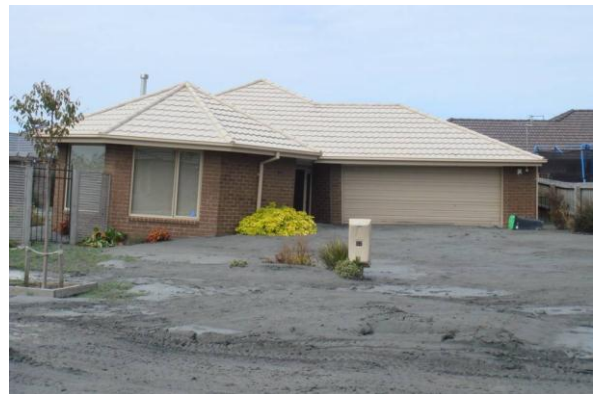
Figure 6 Houses that settled and have been inundated by ejected material in a major liquefaction zone

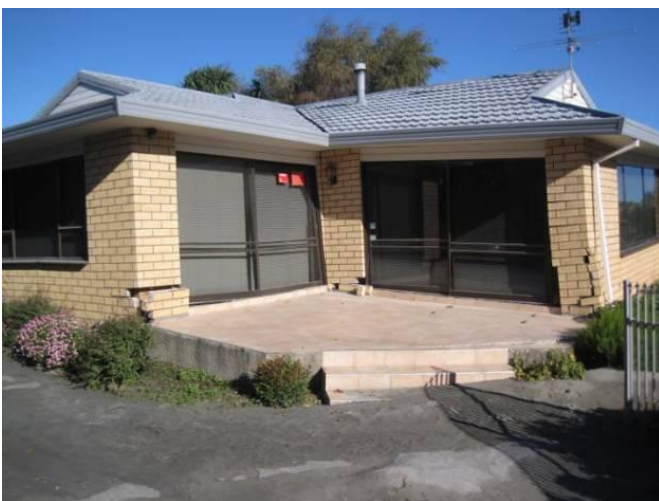
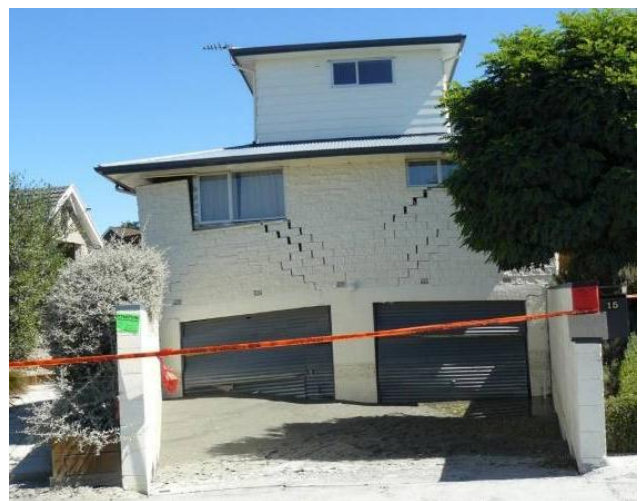
Figure 7 Masonry veneer damage due to lateral spreading and differential settlement (Buchanan) and due to differential settlement

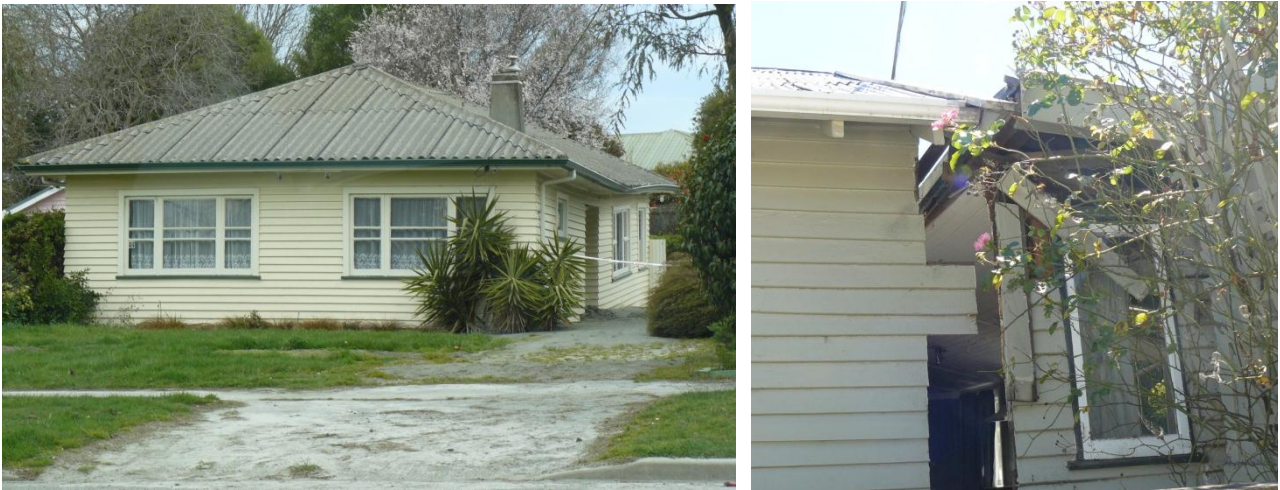
Liquefaction occurs when silty or sandy soils of a relatively constant grain size and moderate to low density are below the water table when an earthquake occurs. The shaking causes the particles to settle towards a more compact configuration and causes a major increase in pore pressure effectively turning the soil into a liquid for a short time. This caused house foundations to sink and pipes and manholes to float (Fig 6,7). When liquefaction occurs near rivers, estuaries or other unconstrained slopes the liquefied soil moves downhill and causes house foundations to spread laterally (Fig 8).

**Figure 8 Houses near rivers that have been subject to differential settlement and lateral spreading**

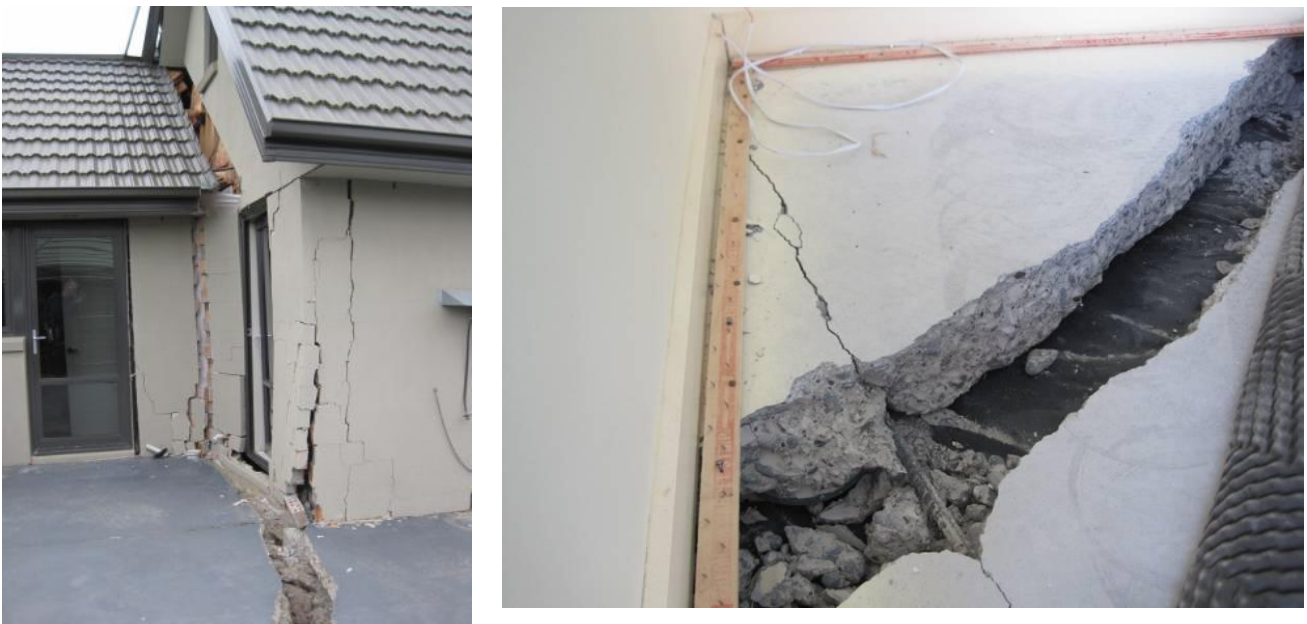
Floor slabs are either unreinforced or reinforced with a welded wire steel mesh but in many cases the lateral spreading caused slab fractures and resulting structural house damage (Figure 9).

**Figure 9 House and reinforced slab damage as a result of ground movement (Buchanan)**

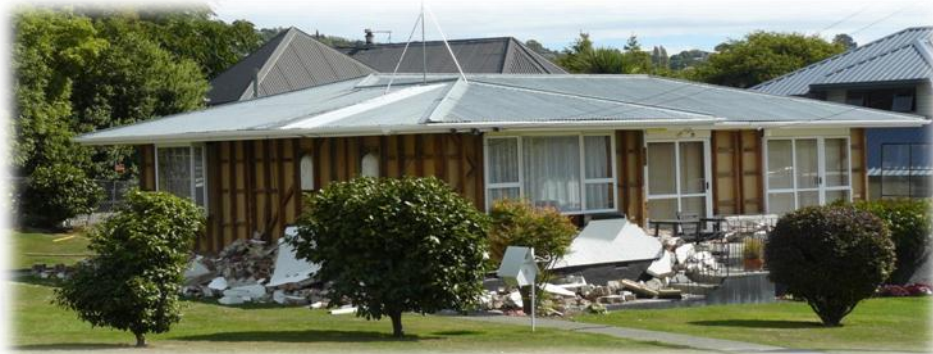
Lightweight timber cladding systems such as weatherboards suffered less damage than heavier facades such as brick and masonry. The most commonly observed failure was where the masonry veneer separated from the frame due to inadequate tie systems and in particular the bond with the mortar. This damage was worst in the hill suburbs. Figures 11 and 12 show masonry veneer failures. Some failures were due to differential movement between systems having different structural stiffness.

Figure 11 A house that totally lost its masonry and stucco facade

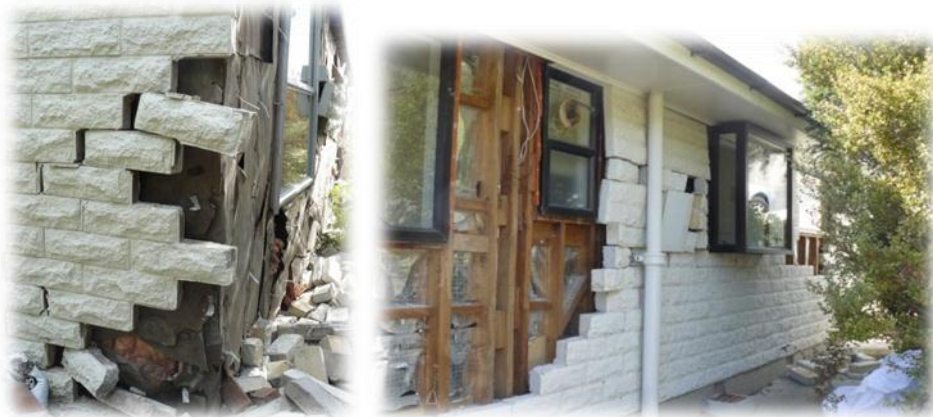
Figure 12 Two examples of masonry veneers detached from the wall framing. The first example with such poor mortar that the veneer has separated into individual bricks

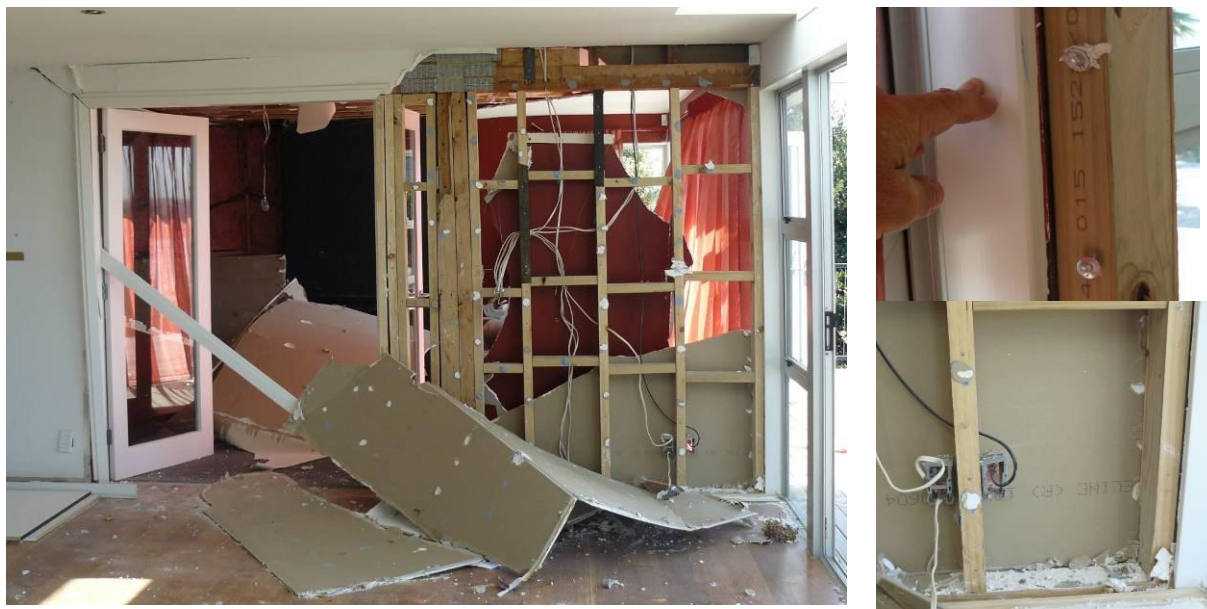
**Figure 13. Severe failure of GIB Braceline internal linings (Morris)**

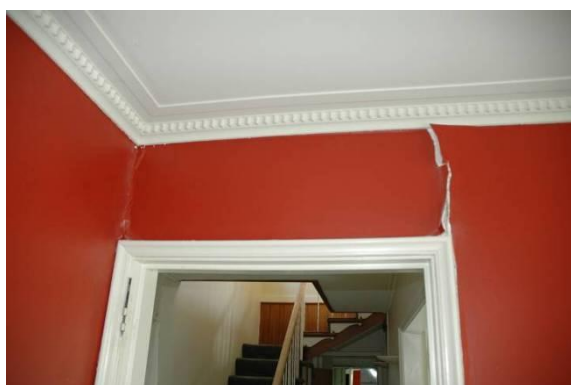
In most cases internal plaster damage was limited to cracks, but in some cases there was enough movement to cause the plaster to buckle, as in Figure 14.

**Figure 14 Buckled plasterboard in house in Heathcote Valley (Carradine)**

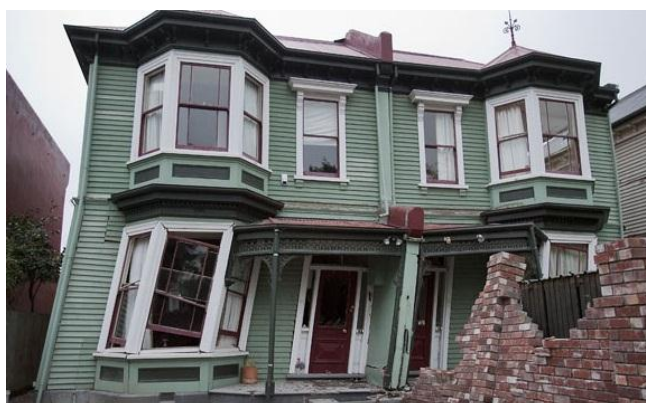
**Figure 15. A soft storey failure of a timber framed house not resulting in collapse**

Several examples of soft storey failures were observed where there was inadequate bracing capacity in the lower level as illustrated in figure 15.

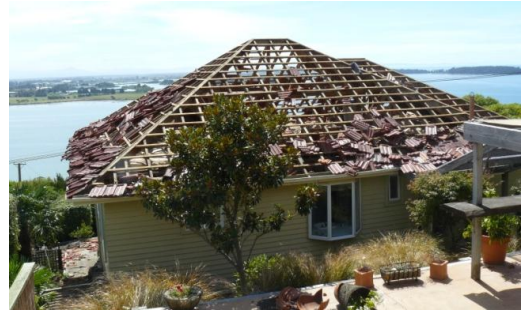
Vertical accelerations are likely to have had a significant effect on masonry performance. The effects were most evident with heavy clay and concrete tiled roofs. These had little or no tie downs and in many cases tiles were dislodged, in the worst cases the roofs shed most tiles as shown in figure 16.

Figure 16 House with all roof tiles dislodged

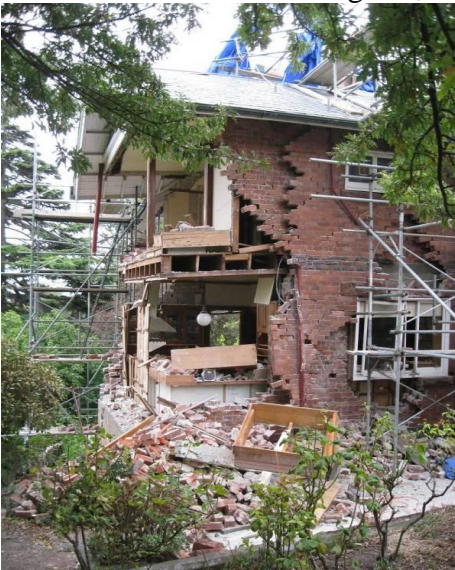
As discussed earlier masonry facades caused significant problems however the timber frame stayed intact. Double brick houses performed much worse and many were observed to have partially collapsed as shown in Figure 17. Generally, fully reinforced and grouted concrete block masonry houses performed very well although walls constructed with partially filled cells, with only the reinforced cells filled with grout, did not perform as well. (Figure 18).

Figure 17 Examples of partial collapse of double brick houses (Carradine)

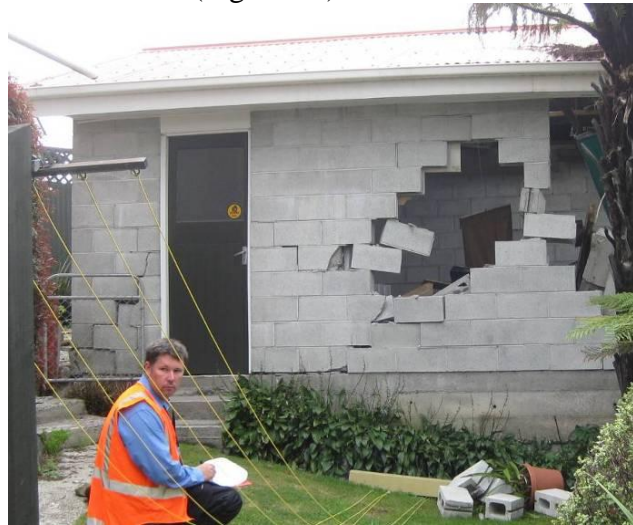
Figure 18 UngROUTED cells with reinforcing steel in place (Beattie)

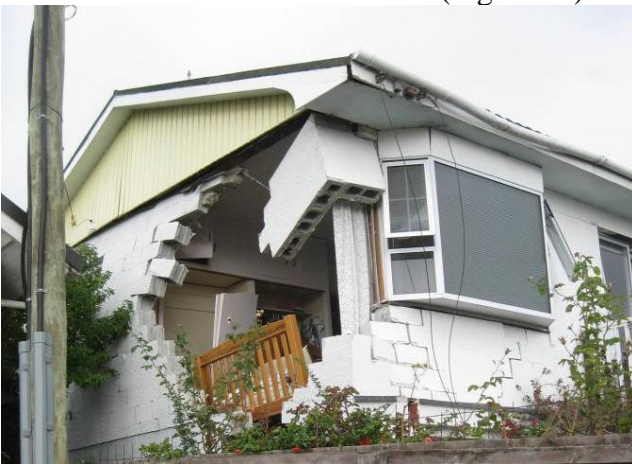
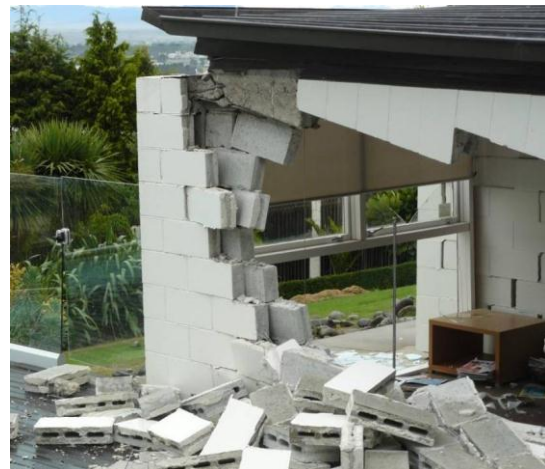
Unreinforced masonry houses performed badly during the earthquake and there were many examples of exterior structural wall failures (Figure 19).

Figure 19 Left: Collapse of unreinforced masonry exterior wall (Carradine), and Right: Collapse of unreinforced masonry exterior wall (Morris)

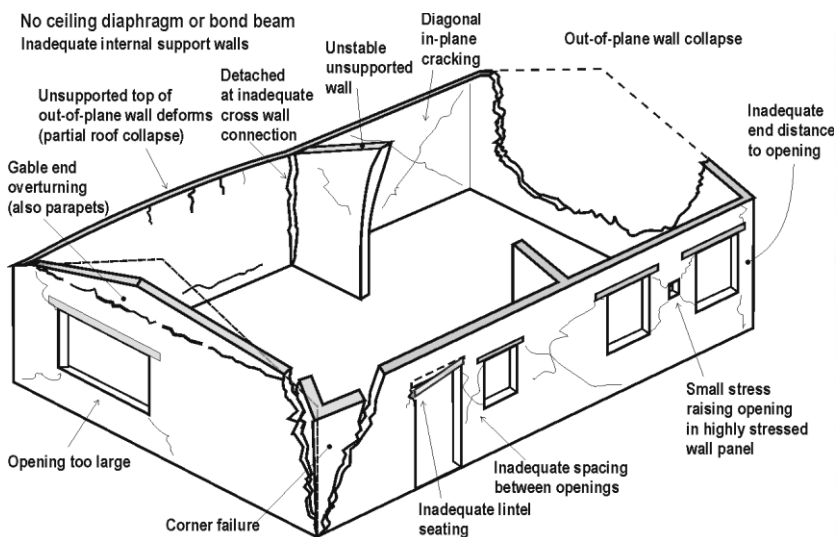
Earth buildings that are unreinforced have a number of typical failure modes as illustrated in Figure . These modes of failure were observed in two reconstructed historic cottages. Serious damage to Cotons Cottage in Hororata is shown in Figure , the horizontal peak ground acceleration (PGA) during the September earthquake was measured 0.5g just 350m away. (Gledhill et al. 2010, Cousins and McVerry 2010).

**Figure 20 Typical failures of unreinforced earth construction**  
(C) Morris

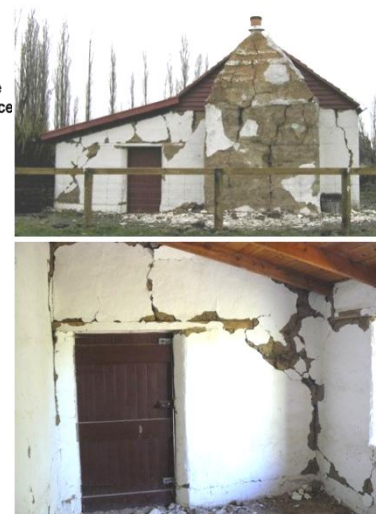
**Figure 21 Cotons cob cottage extensively damaged**

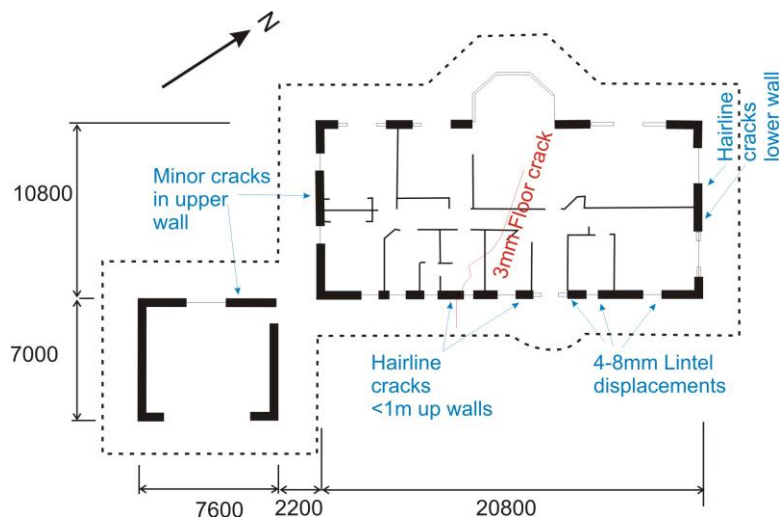
**Figure 22 Charing Cross adobe house plan showing adobe walls and minor damage locations**

continuous to the top plate which is additionally anchored to both the wall and the ceiling diaphragm. The most significant damage was a cracked floor slab evident from a 2-3mm crack in the floor tiles. This crack continued as a 1mm crack through the concrete foundation beam reinforced with a D16 top and bottom (two top and bottom are recommended in NZS4299). There were also hairline cracks at foundation level as shown in Figure 22. It appears that there was some differential movement at the west corner where settlement and movement of the verandah posts embedded in the concrete path caused cracking in the upper south wall (Figure 1). Lateral movement had caused movement or minor pounding of the lintels leaving gaps of 4-6mm at ends of the lintels (Figure ).

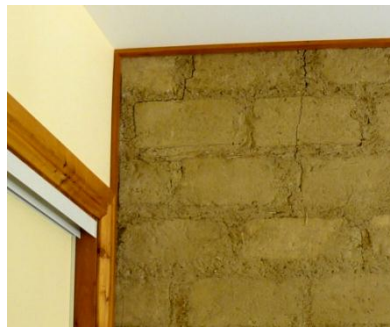
**Figure 14** Crack in wall near the west corner

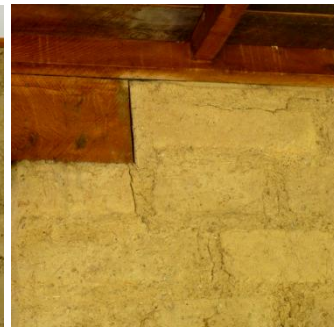
**Figure 25** Opening at edge of lintel beam

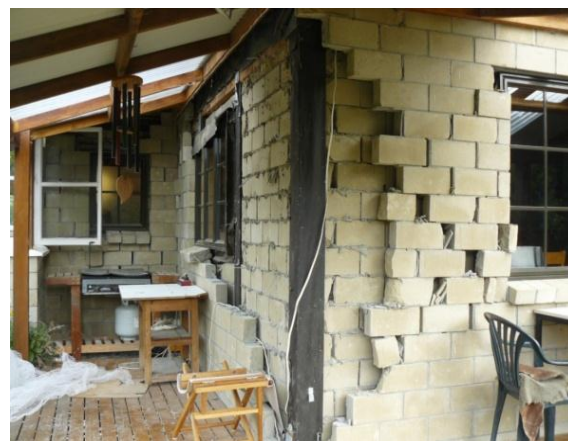
The most significant damage to earth buildings occurred with pressed earth brick masonry cavity walls and veneers. Pressed earth bricks are made of soil-cement in a compacting press. The performance of buildings using this technology was very much the worst of the modern earth wall technologies and while not specifically covered by the NZ Earth Building Standards will need to be specifically excluded.

**Figure 25** Pressed earth double skin masonry, serious wall failures were avoided because of the post and beam construction supporting the upper storey.
