**IMPORTANCE OF DETAILED CONSIDERATION OF  
CONSTRUCTION SEQUENCE IN INSTALLATION OF  
RETAINING WALLS WITH EXCAVATION:**

**A CASE STUDY**

M.Eng. in Foundation Engineering and Earth Retaining Systems

Department of Civil Engineering

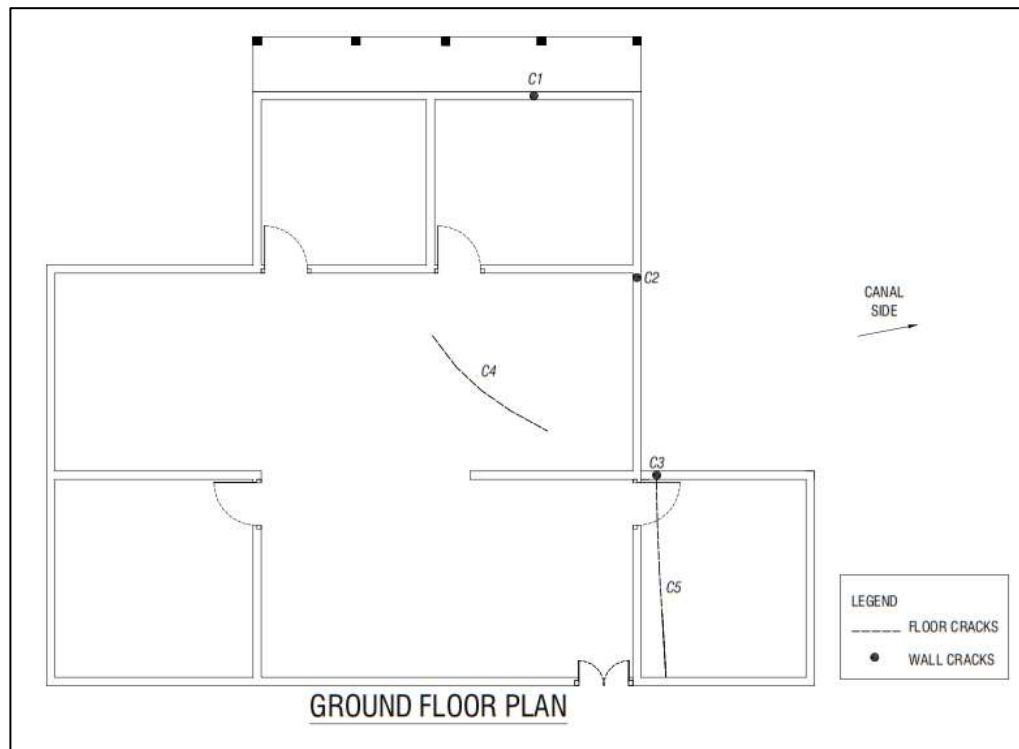
The locations of the cracks appeared in the “House” are shown in Figure 2.7.

*Figure 2.7: Crack locations at "House".*

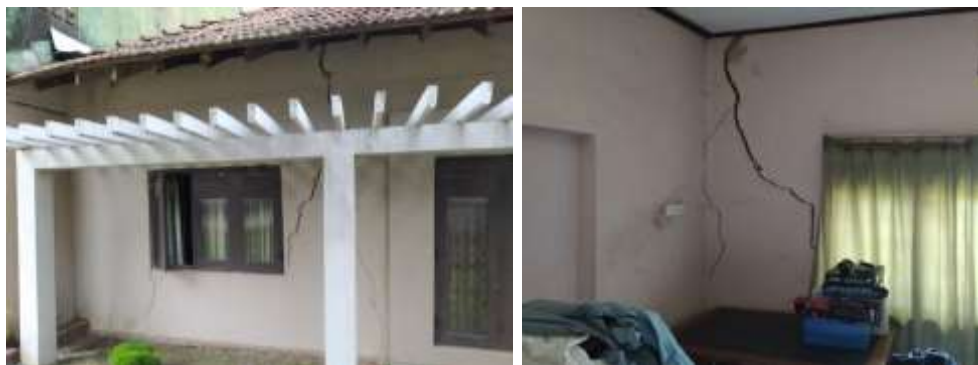
(a) C1 crack outside view

*Figure 2.8: C1 crack.*

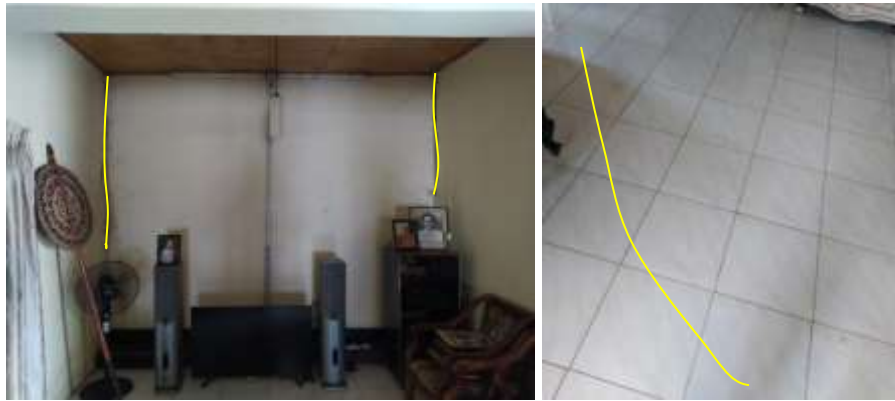
(a) C2 wall crack

(b) C4 floor crack

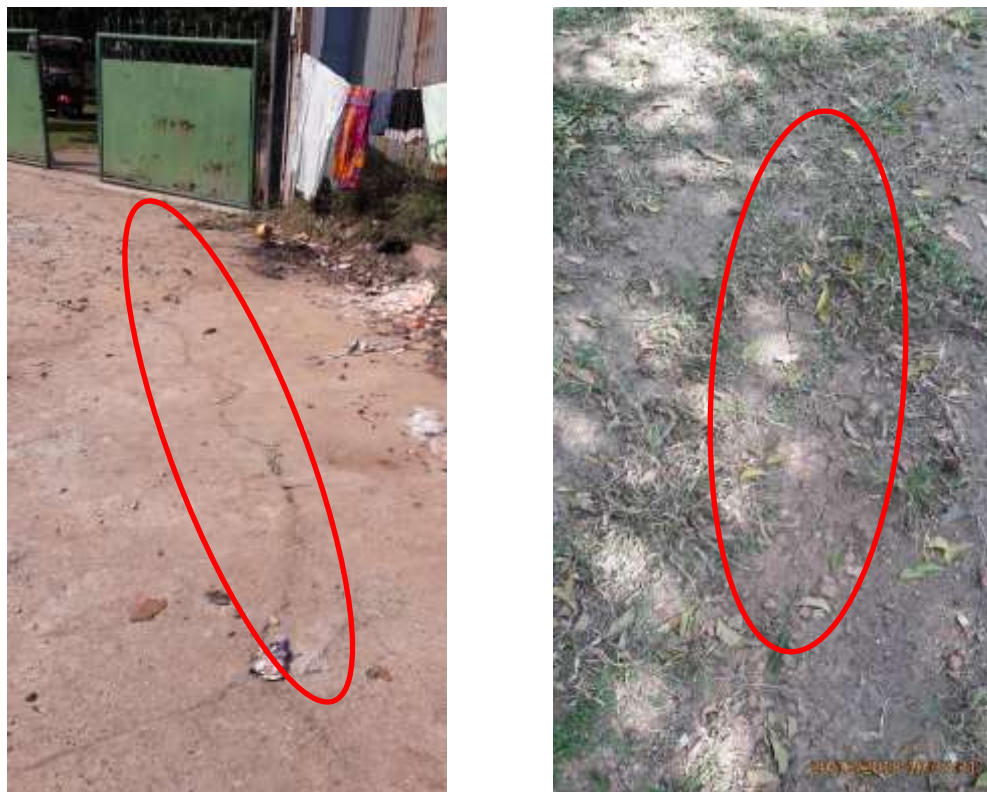
At this point of time, appearance of ground cracks was visible (Figure 2.18) and subsequently separation of the boundary walls (Figure 2.19) had been visible and at the same time, cracks were started to appear within multiple areas of the damaged house making the structure almost unserviceable.

Figure 2.18: Ground Cracks at front side of T13 House.

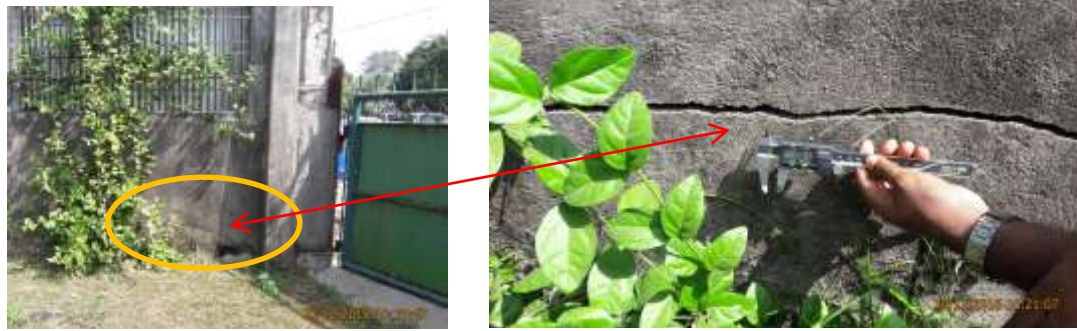
*Figure 2.19: Separation of boundary wall of T13 House.*

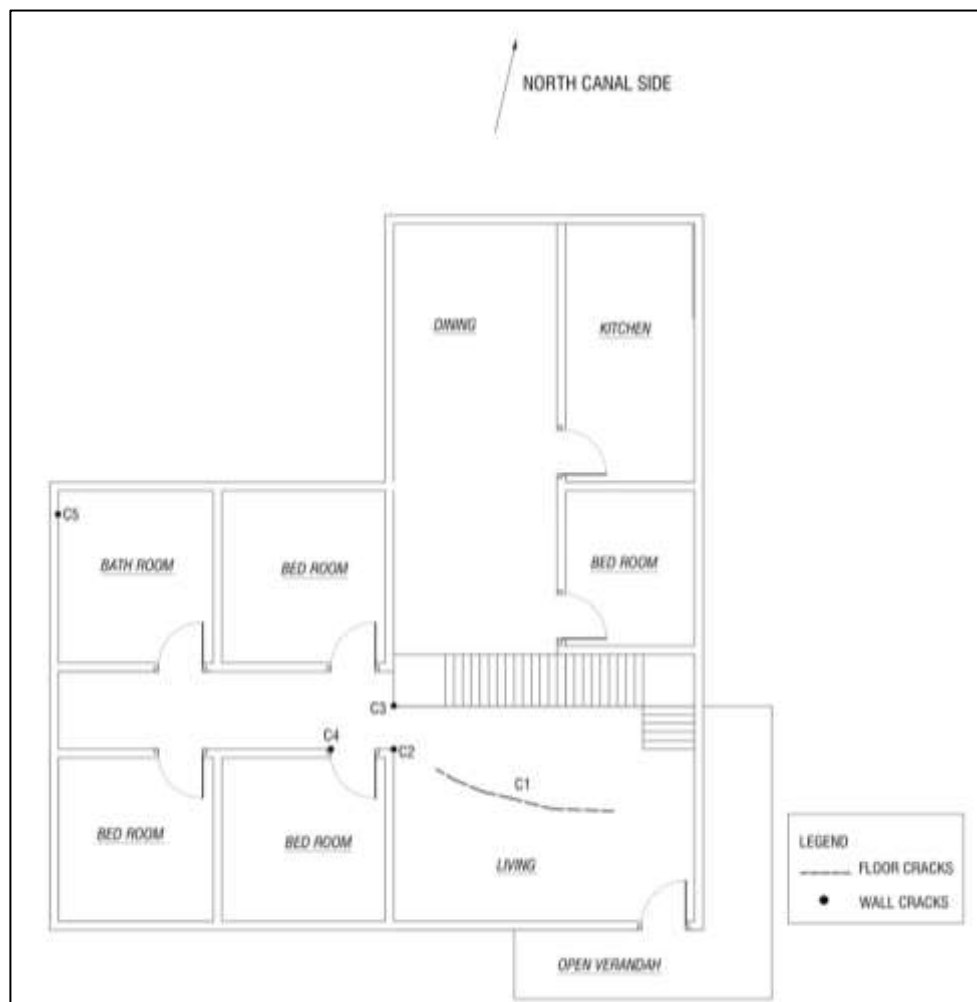
Thereafter, the construction works had temporarily been suspended and crack widths, crack propagations were monitored carefully. The preliminary inspection yielded that some of these cracks were actually widenings of the existed cracks which were identified during pre-construction survey and some were new severe cracks appeared due to unstable ground condition.

*Figure 2.20: Ground Floor Crack Locations of T13 House.*

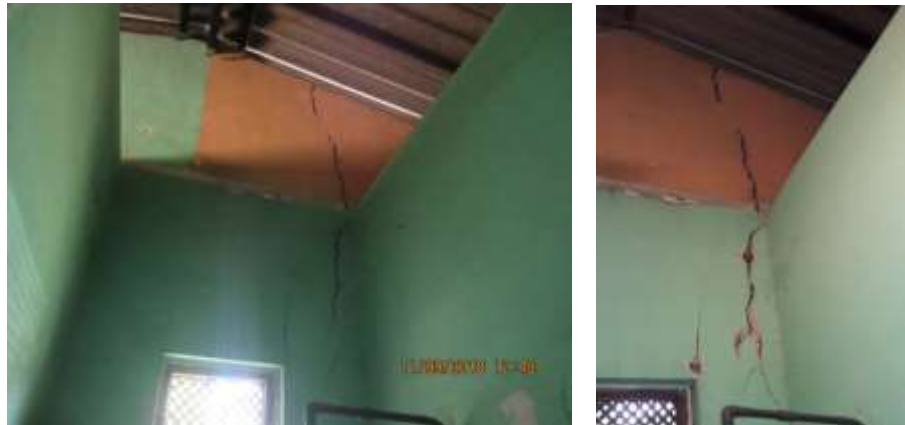
Figure 2.24: C4 crack on 11.09.2018 and 19.12.2018.

The crack C4 was a widening of an existed crack. Crack width was 2mm prior to the construction and it had widen to 13mm during dewatering and further widened to 17.15mm after 03 months of the incident.

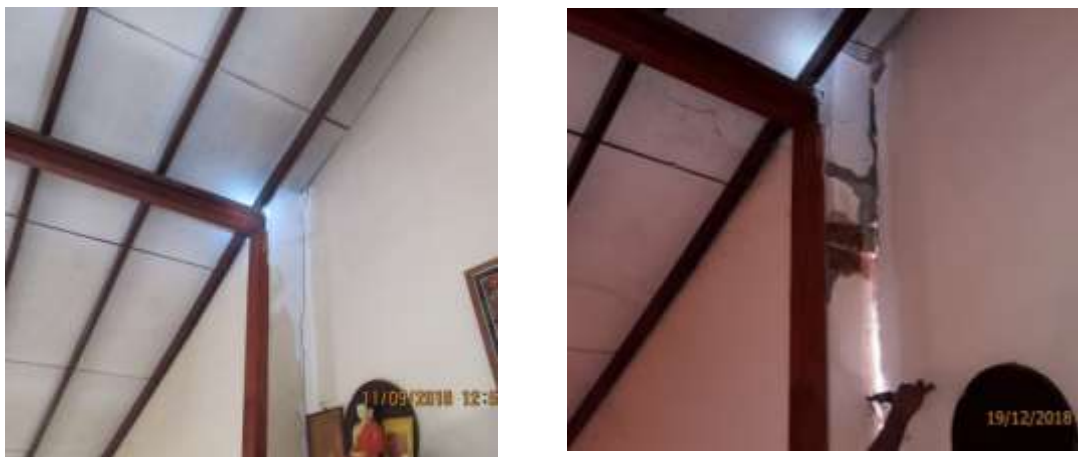
Figure 2.25: C5 crack on 11.09.2018 and 19.12.2018.

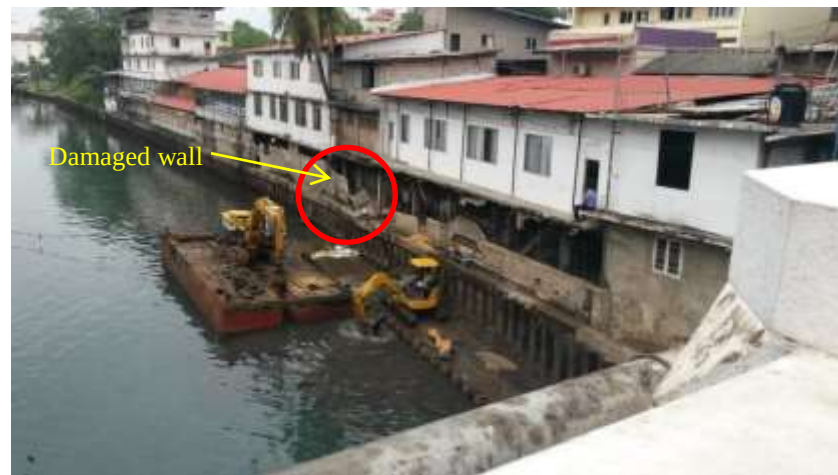
During the implementation, the new proposed set of sheet piles had been set up and tried to cut the berm sheet piles as per the construction methodology. However, once the berm sheet piles were cut off heavy ground settlements were appeared on the lower basements and numerous cracks were visible at multiple points of the structure (Figure 2.31). The lower basement (+2.8m MSL level) had been severely affected where the existing ground columns were tilted towards the canal due to unstable foundation condition (Figure 2.32).

*Figure 2.31: Location of canal bank instability initiated.*

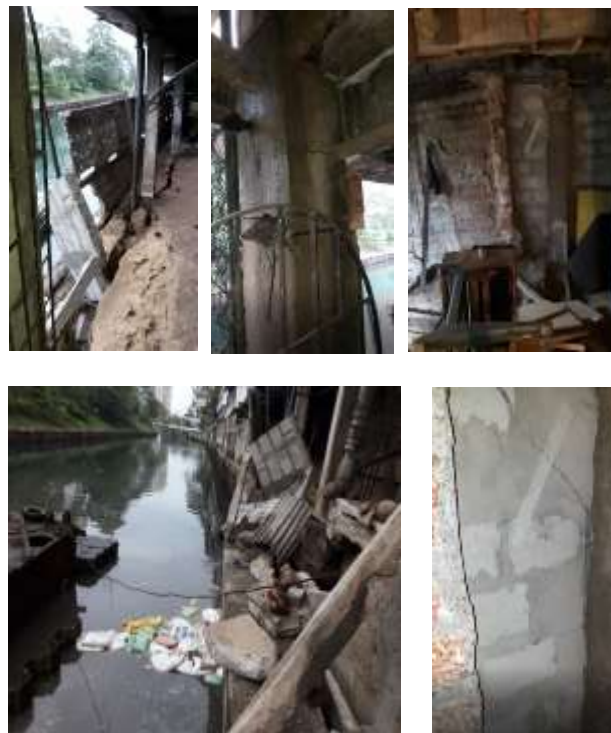
It had been identified that 03 columns in the lower basement were severely damaged. The excessive ground settlements had occurred due to insufficient lateral support from the canal bank level existing sheet piles. Poor construction quality of the lower basement had also worsened the damage.

*Figure 2.32: Photographs of cracks in the lower basement.*

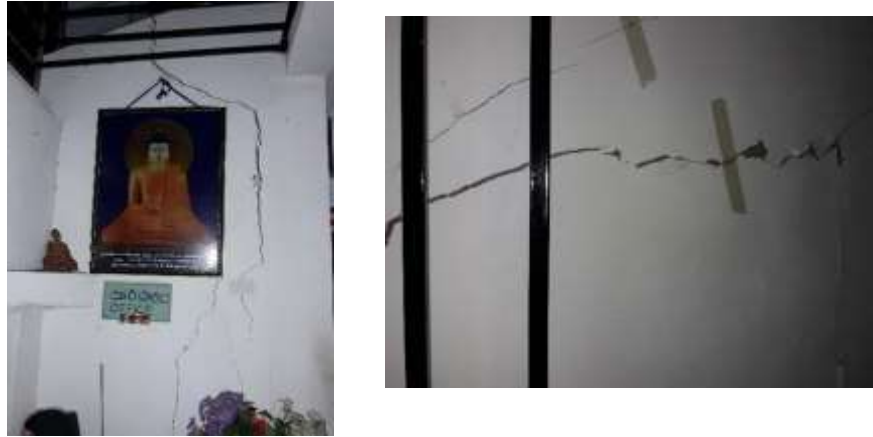
The cracks appeared in the upper basement (at +5.8 m MSL level) were mainly on the walls due to differential settlements of the lower basement columns (Figure 2.33).

*Figure 2.33: Photographs of cracks in the upper basement.*

The major cause of the damage was found as the loss of lateral pressure from the berm and lost the stability. All construction works were temporality suspended after the collapse and widening or propagation of the cracks were monitored. The central engineering consultancy bureau were requested to assess the damage and submit a remediation plan .

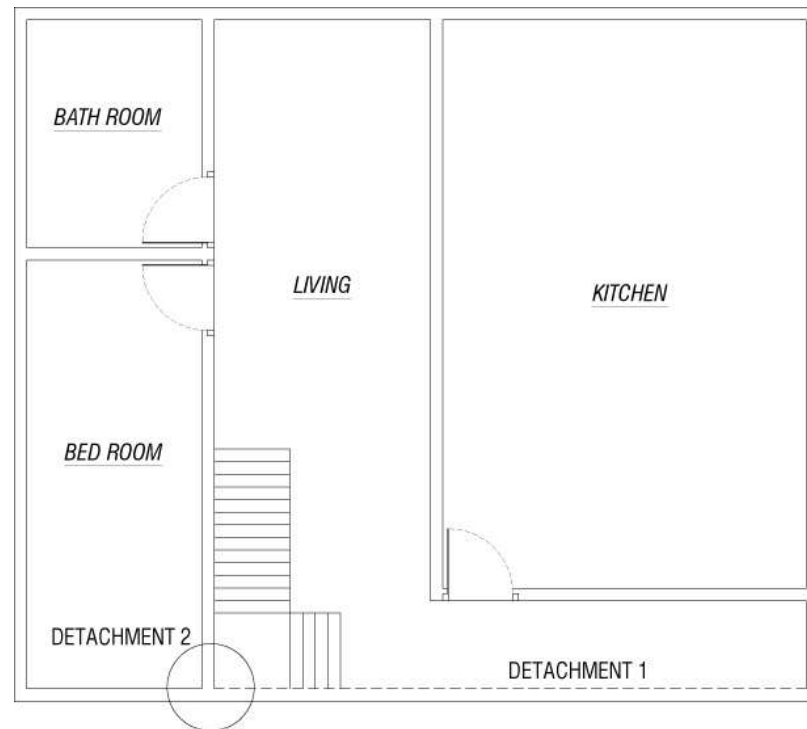
It was to be mentioned that there were no records about those detachments in the structure during the pre condition survey. So that, it was clear that the back part of P62B house has been moved towards the St. Sebastian North Canal.

*Figure 3.7: Ground Floor Plan of the damaged P62B house and detached locations.*

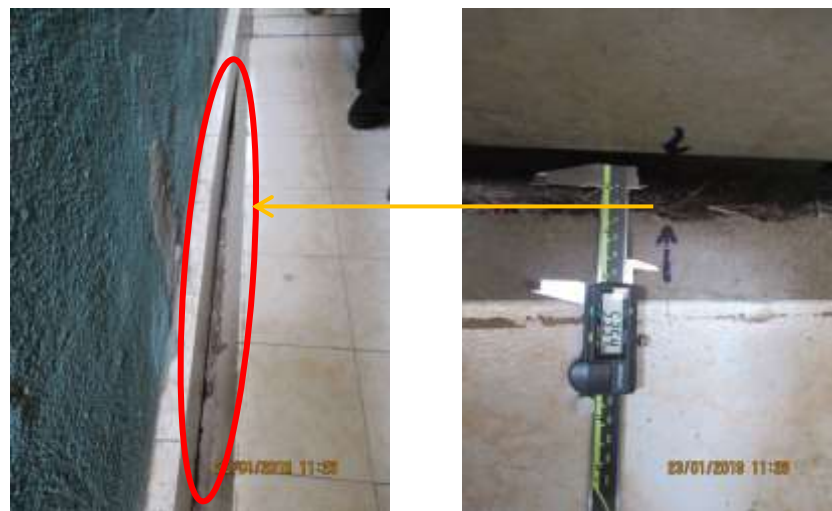
*Figure 3.8: Detachment -1 occurred in the floor.*

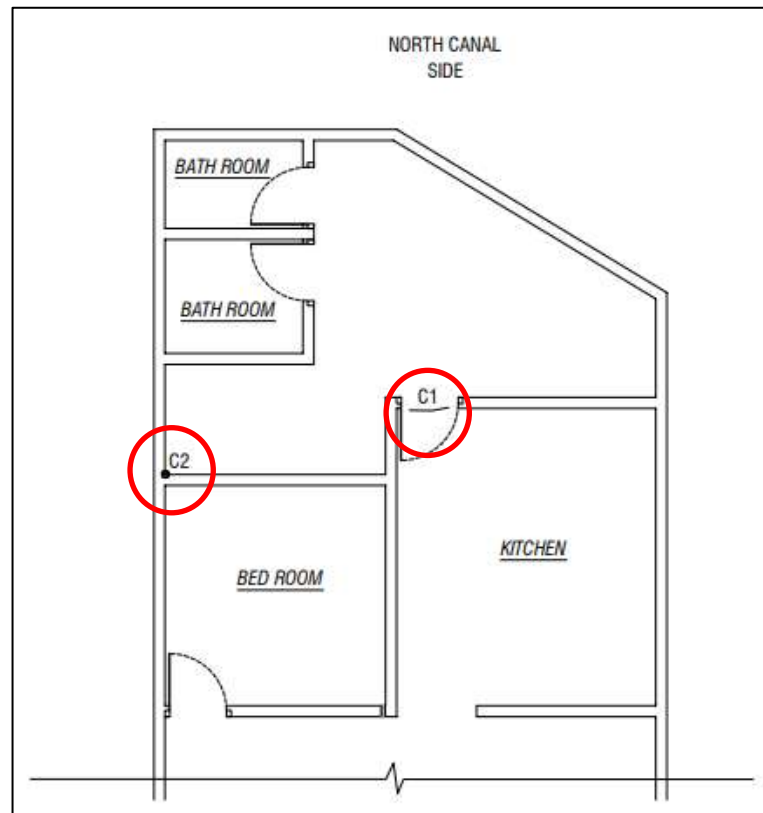
Mainly two cracked locations were observed in back side of P61 house as shown in Figure 3.11. C1 was a floor crack appeared in the kitchen and C2 was a wall detachment appeared in the space in between bedroom and bathroom.

*Figure 3.11: Back view plan of P61 house from Canal side.*

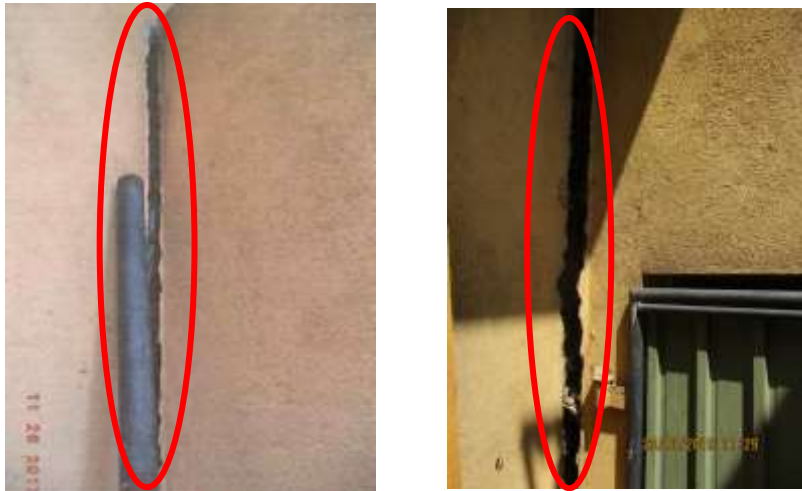
Measured Crack Width on 23.01.2019 was 16.46mm. This crack has been appeared at the rear side of the House Ref. No. P61. The crack which is depicted in above photograph has widened horizontally and displaced vertically. Through the observations, it can be determined that this part of the House Ref. No. P61 which is cracked along the line as depicted in the photograph is moving towards the canal gradually.

Figure 3.13: Comparison of the C2 crack recorded in the Pre-Condition Survey on 26.11.2017 and the Condition Survey on 23.01.2019 of the House Ref No. P61

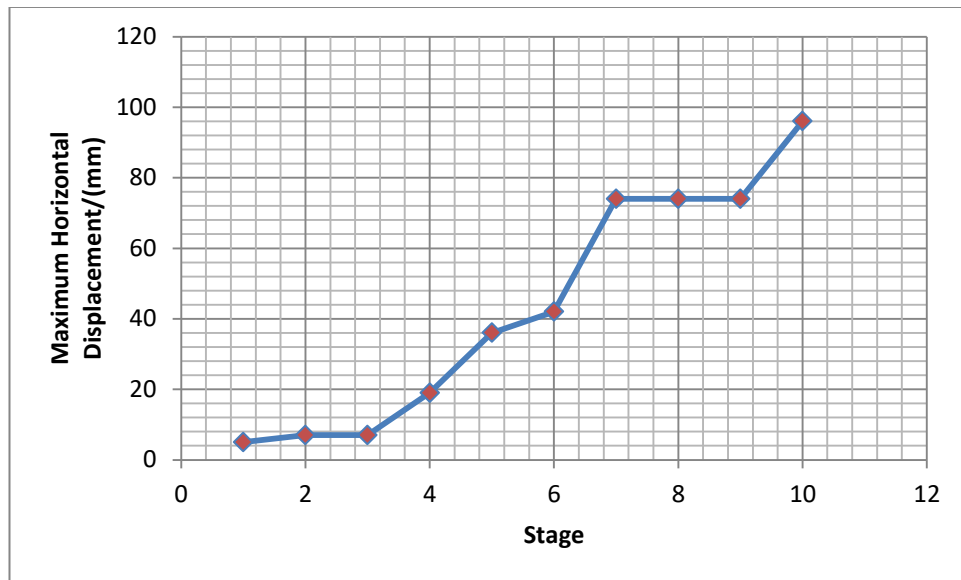
construction works of gabion canal bank protection, the ground settlements have been increased to 110mm since the dewatering is being continued. Finally, before the completion of gabion structure, the sheet piles and the “H” iron prop have been removed increasing the ground settlements to 130mm which is beyond the allowable ground settlement limit.

*Figure 4.11: Maximum Horizontal displacement at damaged building location for each stage for System 01.*

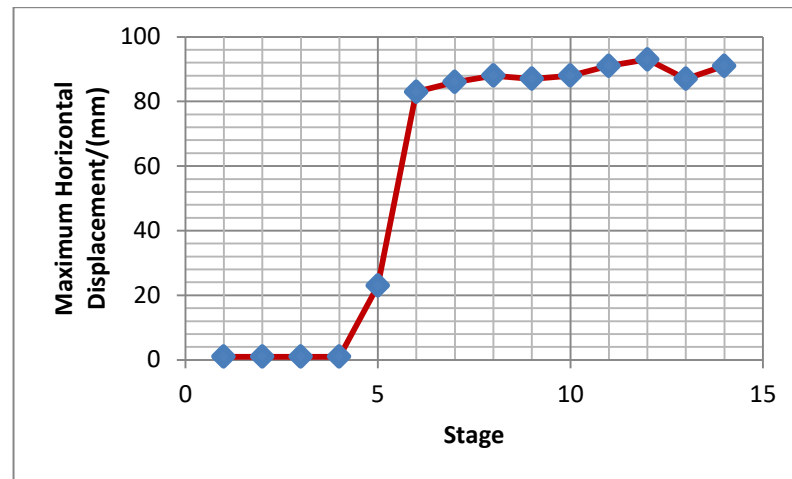
However, the allowable settlement for the safety of the surrounding structures has been set up as 40mm and it is evident that implementation of system 02 exceeds this threshold limit and therefore, implementation of system 02 is not recommended.

*Figure 4.17: Maximum Horizontal displacement at damaged structure location for each stage of System 02.*

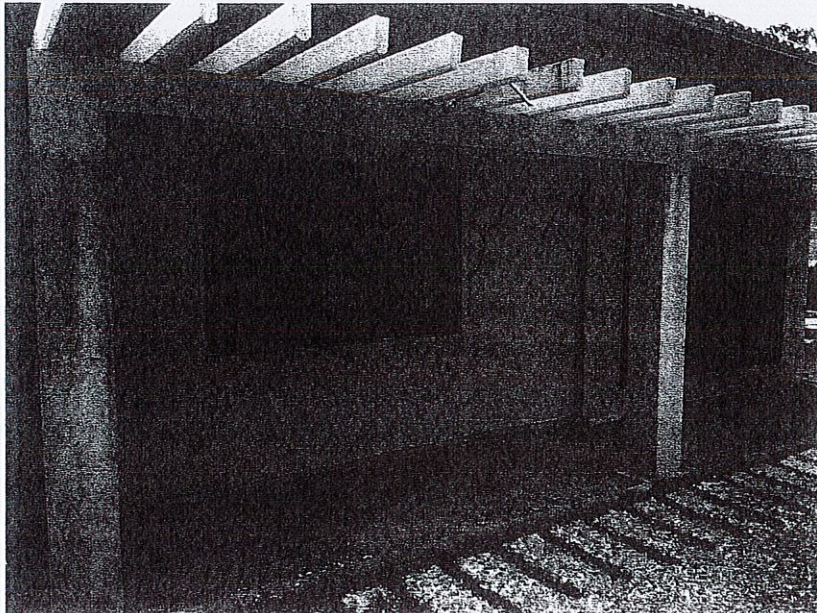
Figure 06 - Cracks at the front side of the building

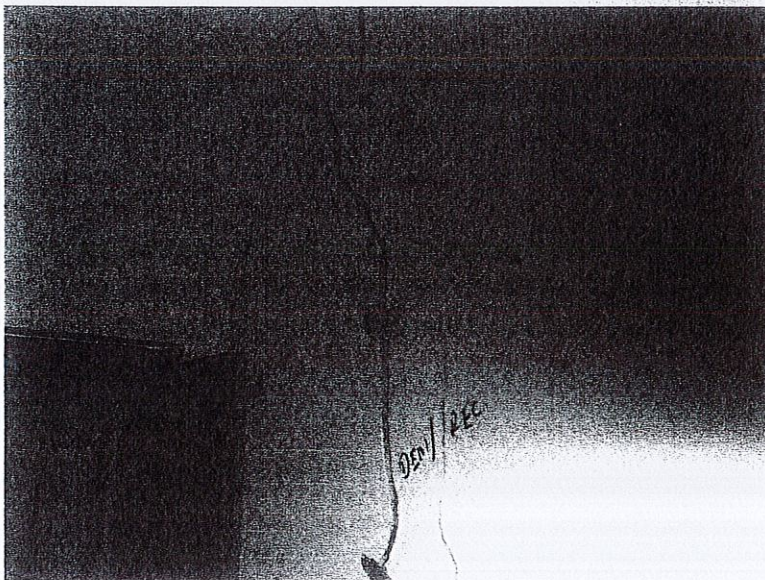
Figure 08 – Vertical cracks of width more than 2mm

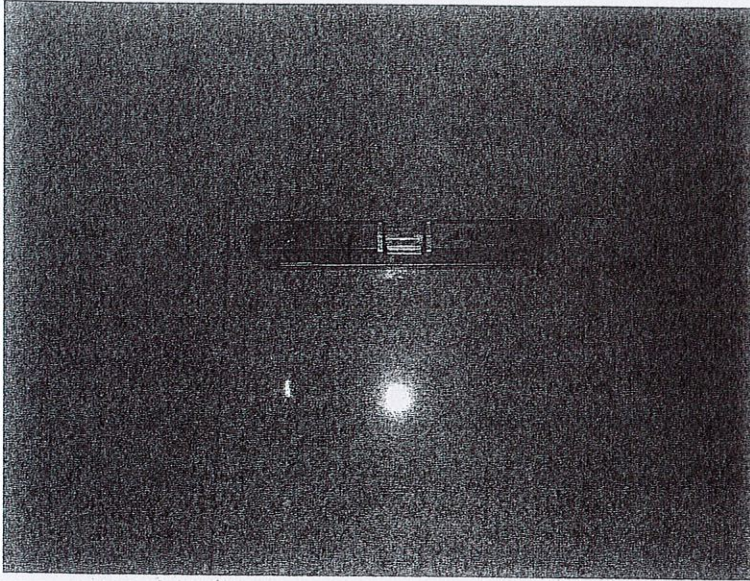
Figure 11 – Tilt observed in the floor of the house

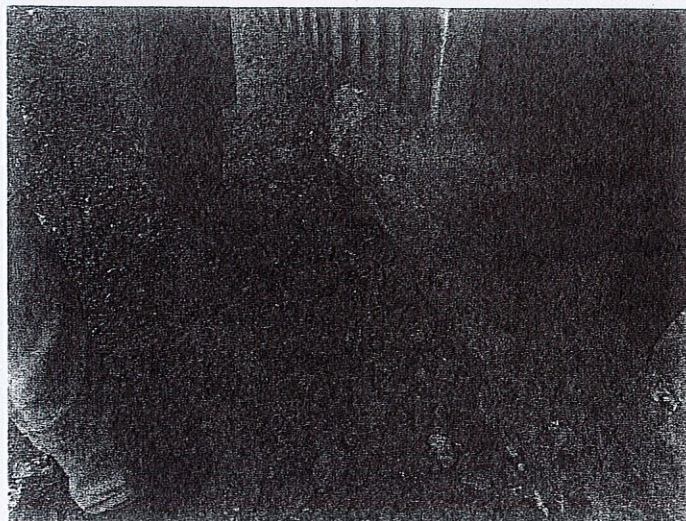
Figure 13 – Vertical cracks at wall corners

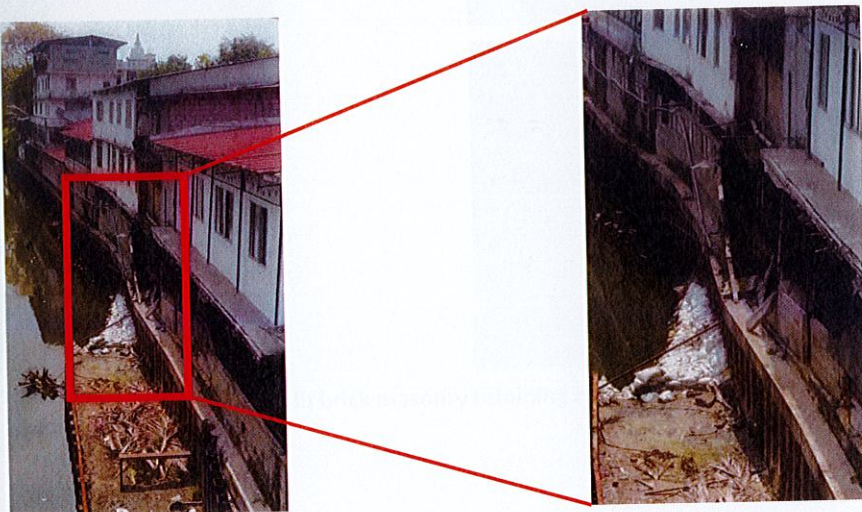
**Figure 4 - Location where the canal bank instability had occurred**

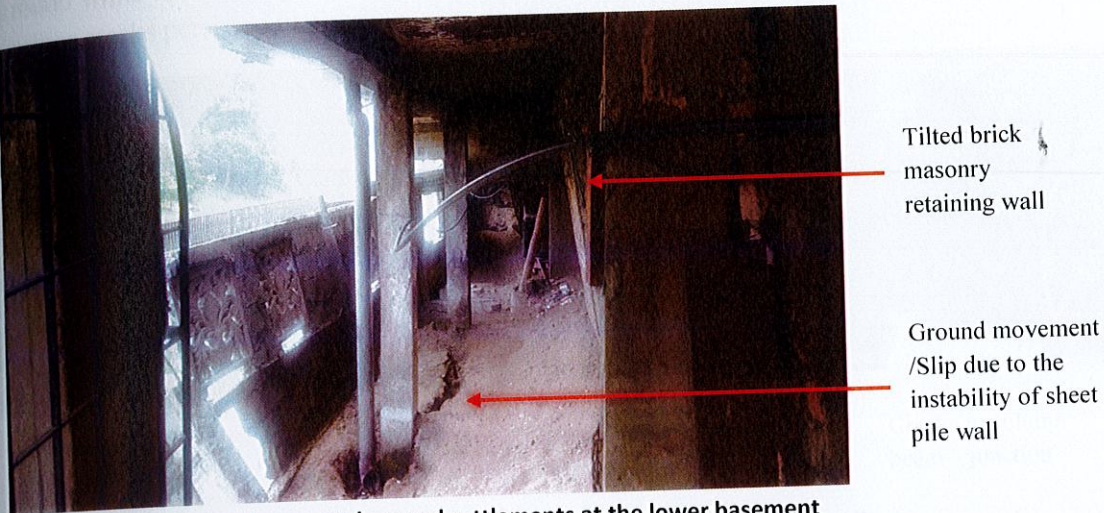
Figure 5 - Obsolete columns and ground settlements at the lower basement

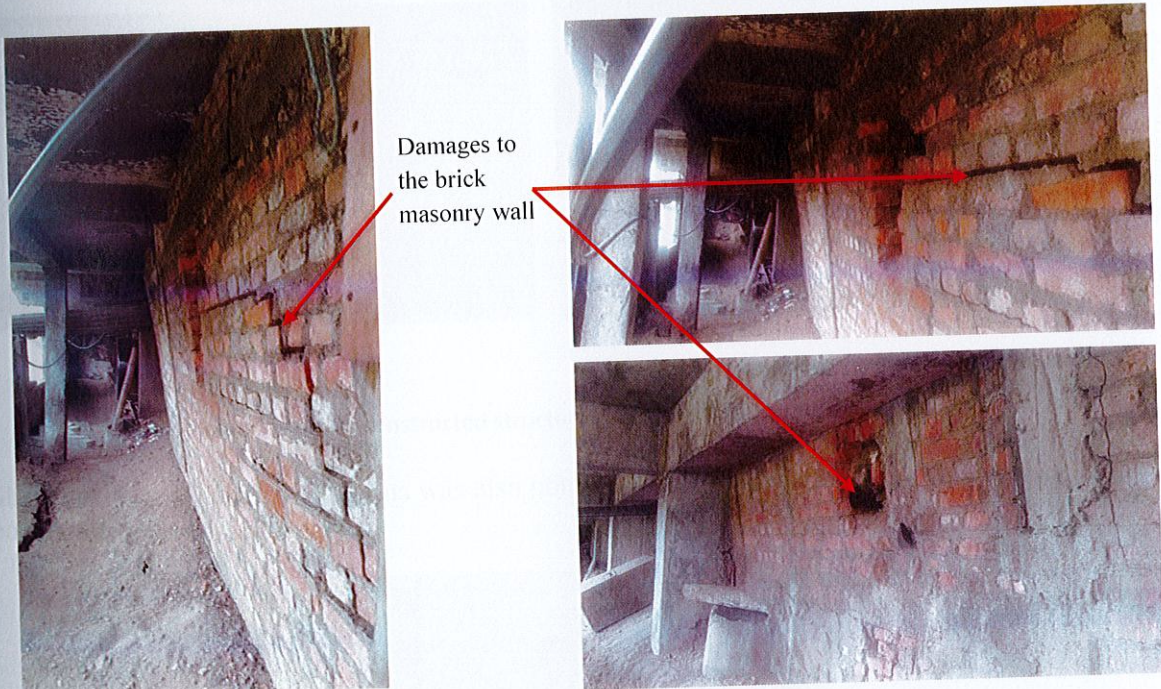
Figure 6 - Damages in brick masonry retaining wall at lower basement

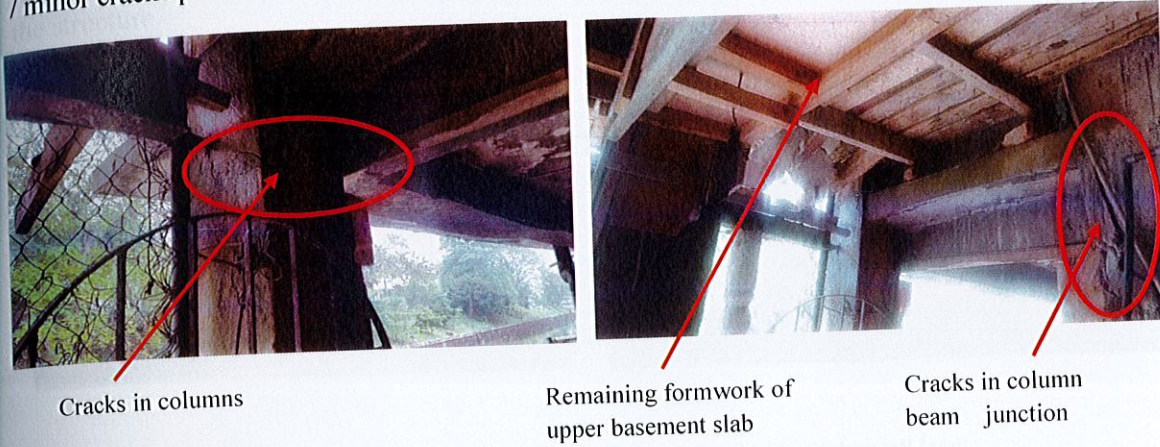
**Figure 7 - Cracked structural elements in the lower basement floor**

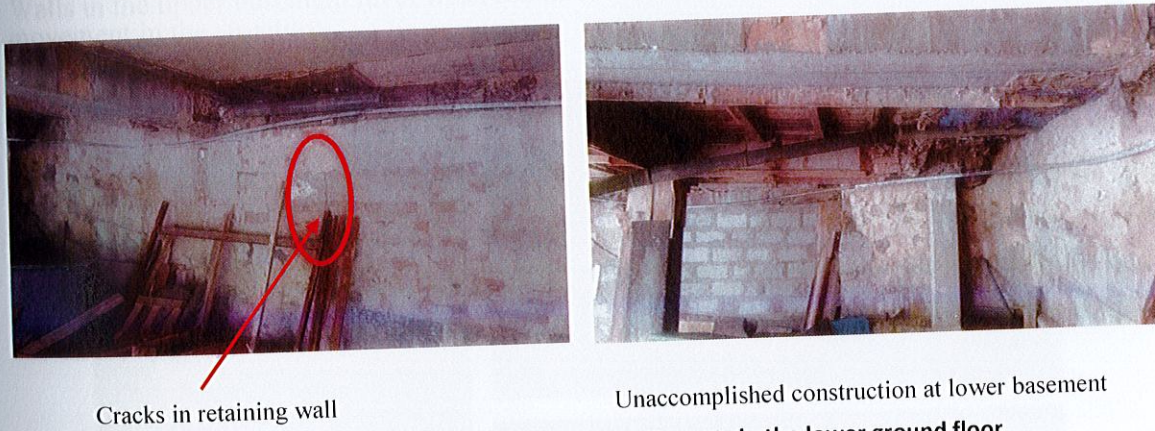
**Figure 8 - Poorly constructed structural elements in the lower ground floor**

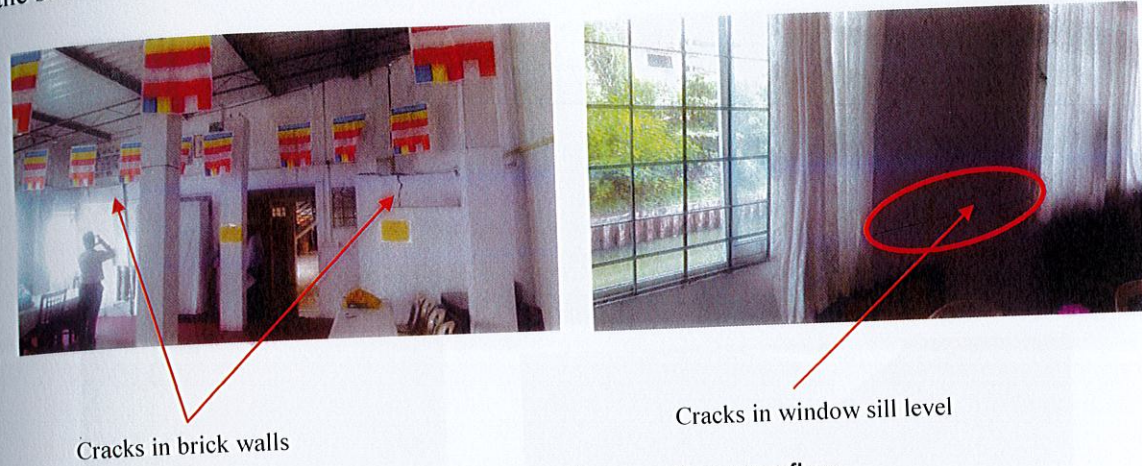
Figure 10 - Cracks observed in upper basement floor

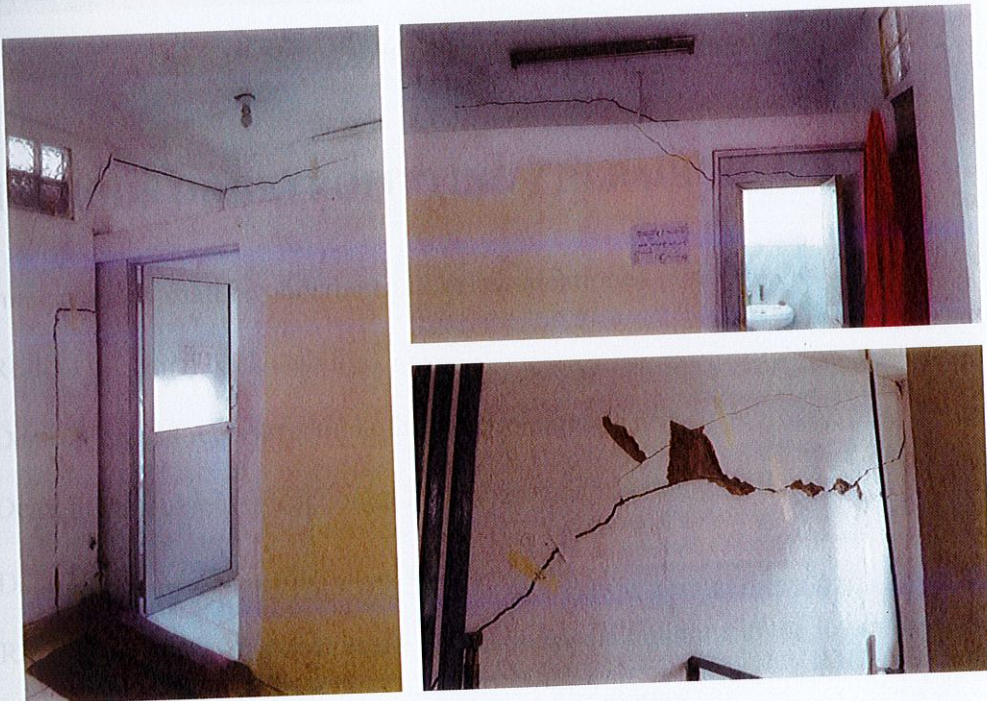
Figure 11 - Cracks observed in upper basement wash room walls

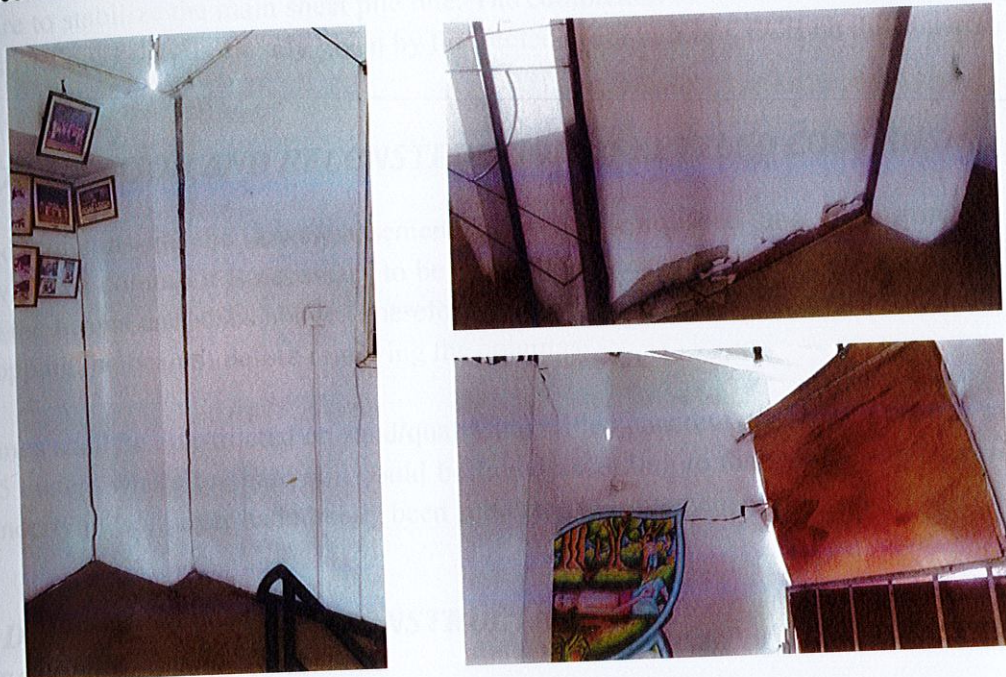
Figure 12 - Shifted walls and slabs observed in the ground floor
