**CONSRVATION AND PRESERVATION OF COLONIAL  
FACADES IN HISTORIC URBAN NEIGHBORHOODS WITH  
SPECIAL REFERENCE TO SLAVE ISLAND**

**A thesis presented to the University of Moratuwa, as  
Master of Science degree in Architectural Conservation of  
Monuments and Sites.**

**JEEWANTHA MAGAMAGE**

**11<sup>TH</sup> MAY, 2010.**

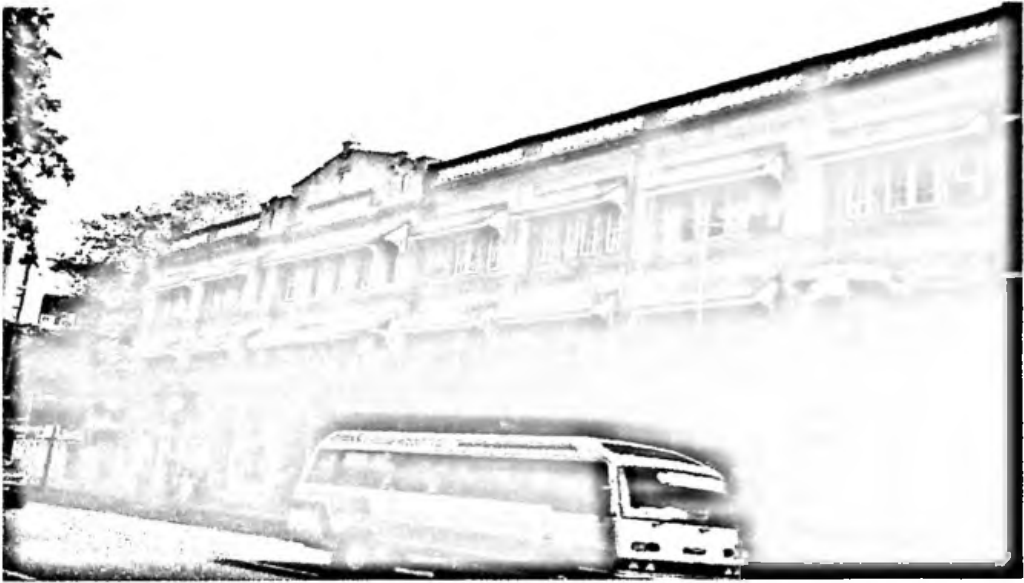
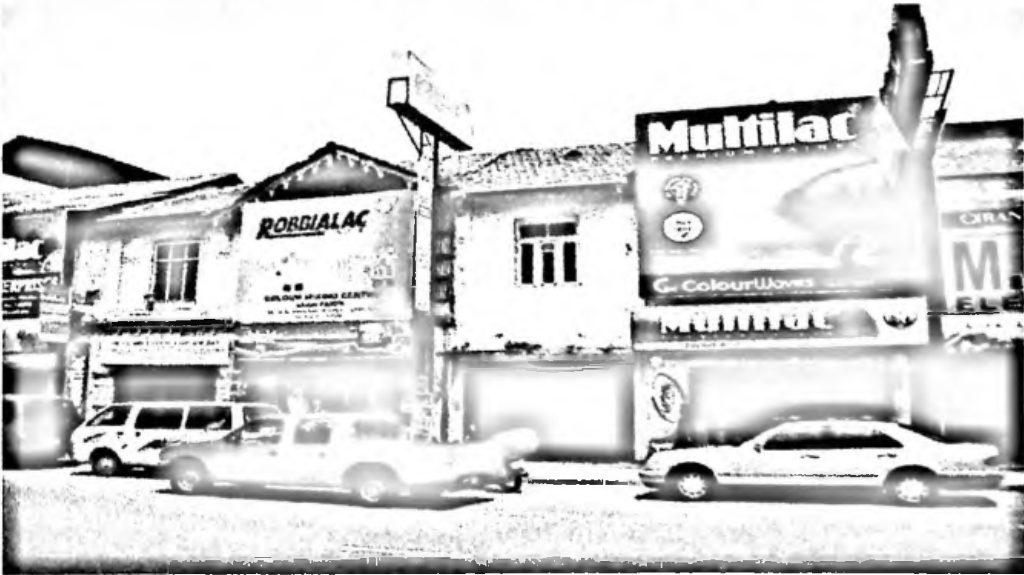
Figure 1.6  
Historically, most identified neighborhoods incorporate certain traditional elements with over decades have served both an aesthetic and functional purposes.

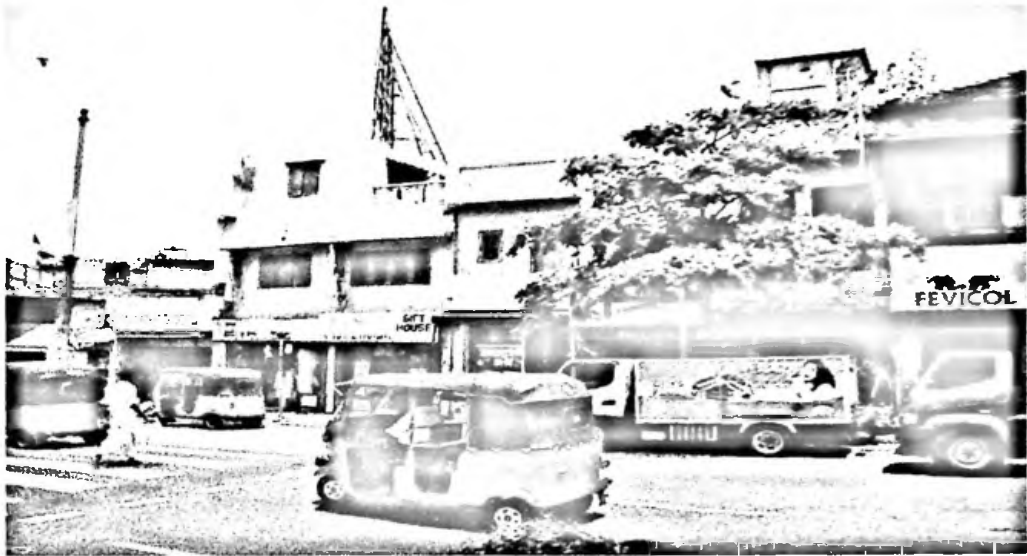
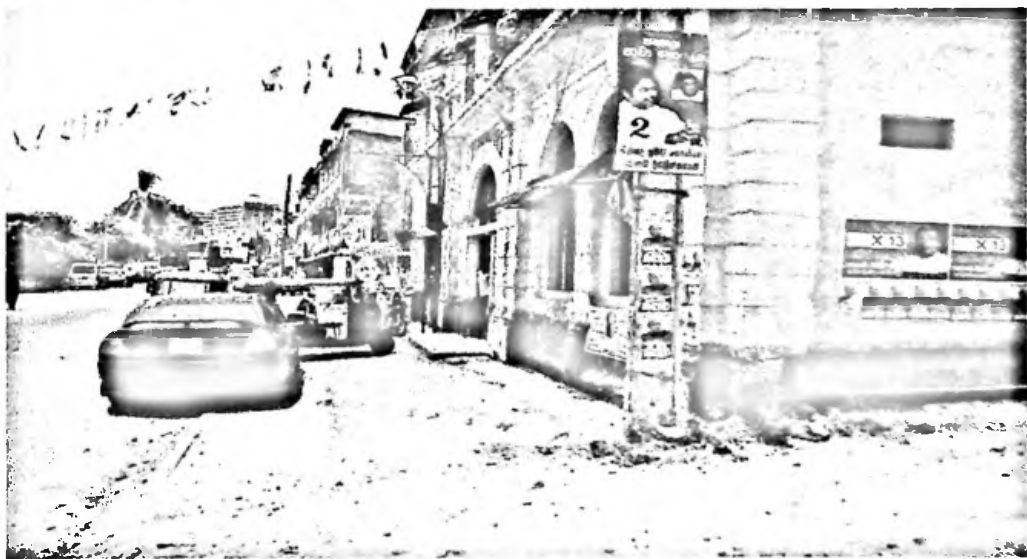
Figure 1.7

Relation to the landscape, the buildings are huddled together giving mass connection to urban side above their roofs

The particular features related to these area are especially the grid layout pattern of roads organize the built forms as well as the urban spaces. The character of the streetscape retains its individuality in changing from urban to clusters through the visual relationship. (Figure 1.7) therefore the change from one to the other is so natural and gradual. Slave Island area in its setting, as for the first urban area centre reveals its colonial (colonized) impertinence. "Buildings should respond to the scale of their site and to the rigors of the elements." (7)

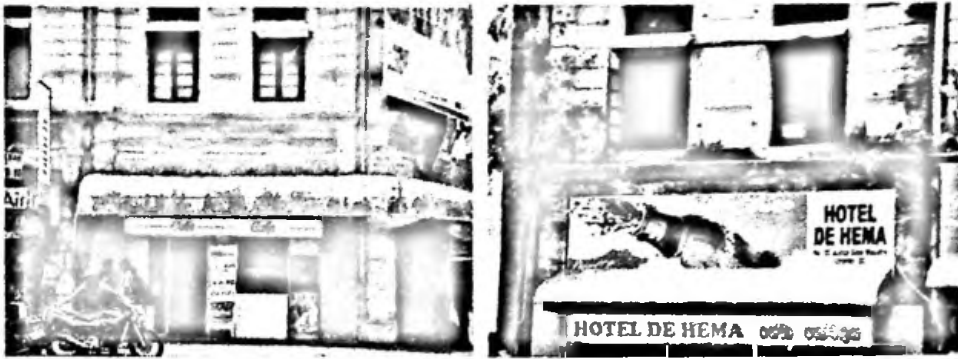
Figure 2.4

Has been modified, historical building form using modern materials.

The building that we have selected to our study namely "soyza building" has a horizontal rectangle shape with the middle part projecting symmetrically. (Figure 2.3) (Figure 2.4) The building by the outlook of form seems strong yet a close inspection may reveal that it's actually very poor in strength. The cracks in the walls are proof to that.

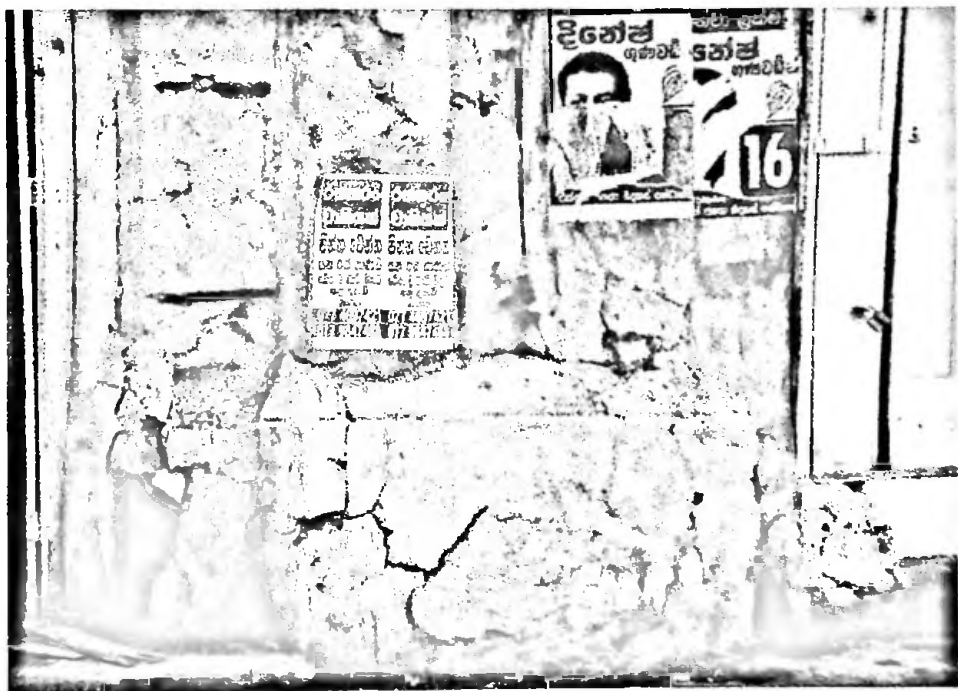
Figure 2.5

Possible causes of structural damage to a building form include intrinsic causes such as improper design or setting and poor construction and extrinsic causes such as application of lodes that the building was not designed to carry and the changers in its surroundings. (Figure 2.5)

Cracked wall caused by uneven settlement in the foundation of the building, and deformation of the building

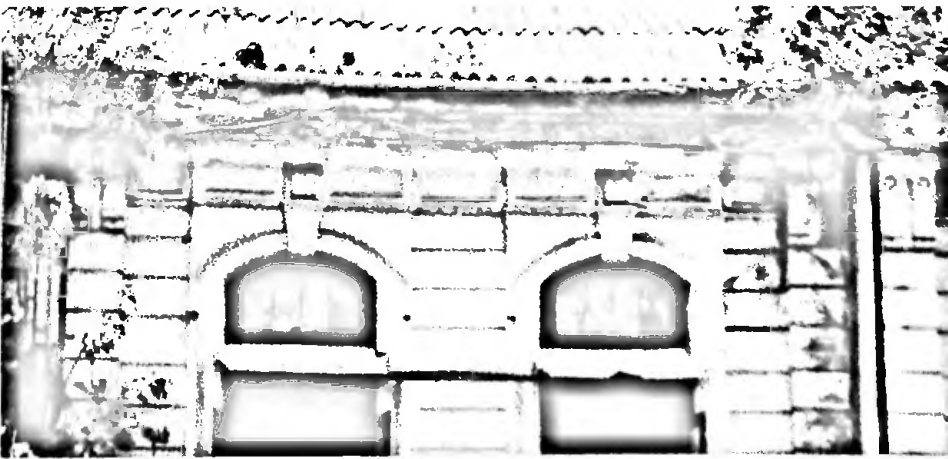
Figure 2.7

The roof of the building is finished with asbestos roofing sheet and half round tile and 75% newly constructed, yet historical roof form is still present with poor maintenance. It's down pipes and gutters are also in very poor condition, leaking the flowing water into wall crevices making base ground for various plants. The parapet wall is in a bad condition due to collection of water between the parapet wall and the roof.

Historical roof with mordent roofing sheet, also it's down pipes and gutters are also in very poor condition, leaking the flowing water into wall crevices making base ground for various plants

It is especially important to verify that downspouts are functioning properly, if they are broken or corroded, materials in the walls may reach advanced stages of deterioration before any trouble is suspected.

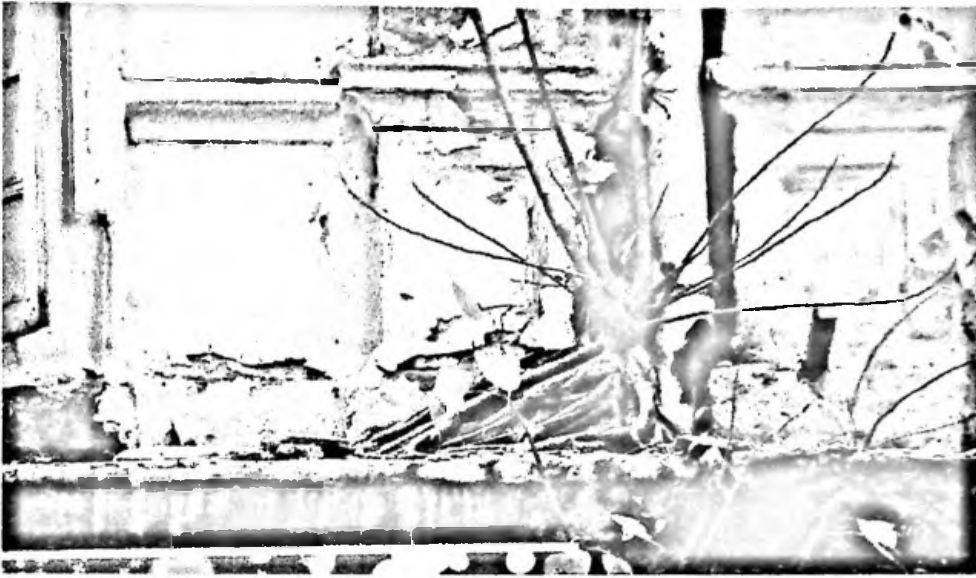
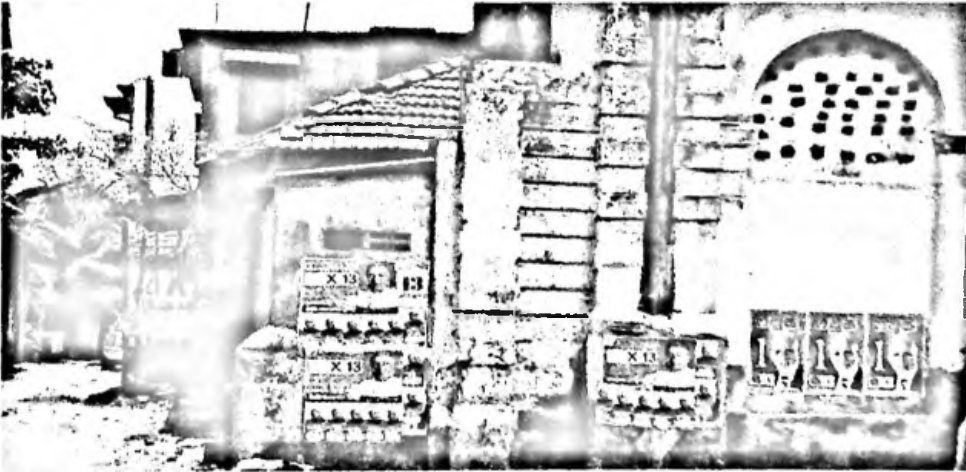
Figure 2.8a.

The presence of efflorescence on a wall shows the places where water is living the building and may indicate that excessive water is entering the wall at other locations

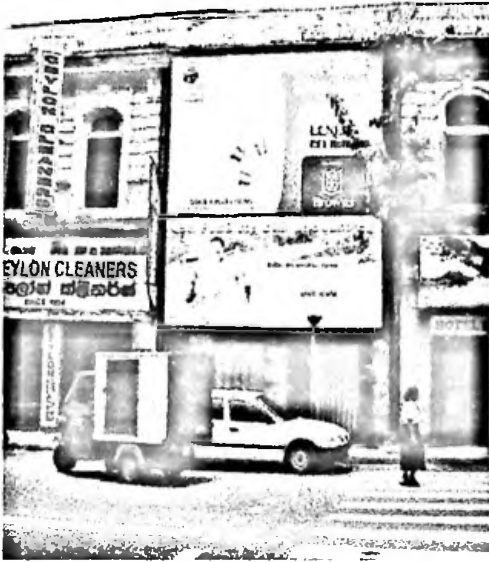
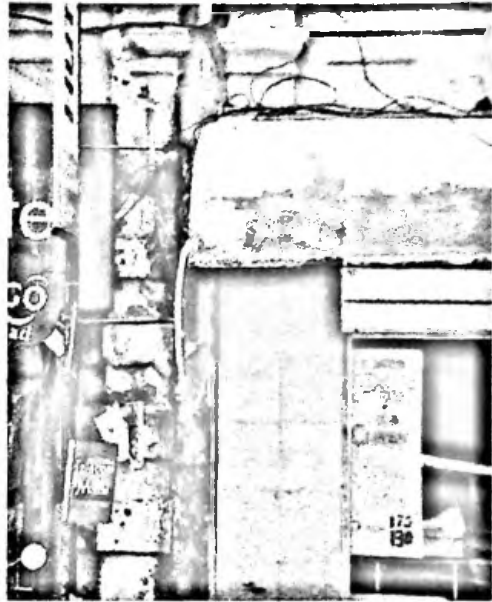
Figure 2.8c

The ground floor symmetrical archers are placed as main entrance and upper floor windows are with sills. The façade is covered by signboards of present occupants and different types of canopies have been installed. While most of the down pipes have been corroded which is a results of growing plants in thru, this has results in walls being cracked from some places. Due to the bad organization with eclectic, telephone connection, result of walls being complicated and damaged. To remedy these decayed walls some occupants have resorted to using modern decorative solutions such as aluminum, glass panels and claddings. Hence, the original façade of the building has been obstructed. (Figure 2.8) (Figure 2.8a) (Figure 2.8b) (Figure 2.8c) (Figure 2.8d)

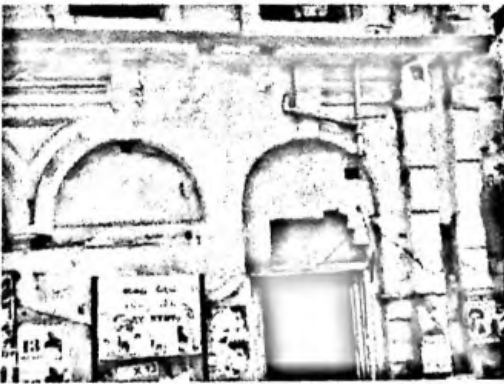
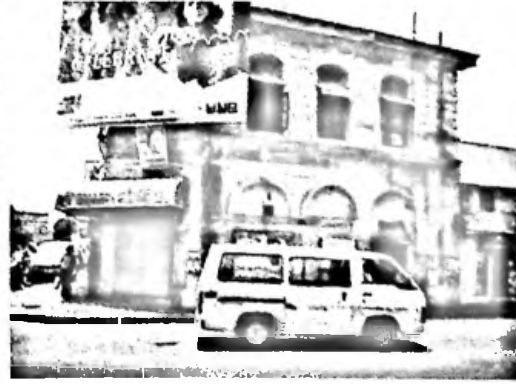
Figure 2.8d

Due to the poor maintenance system and incorrect repairing methods, result of walls being vanishing historical decorations. And also totally obstruct on historical façade due to the hanging large size sings.

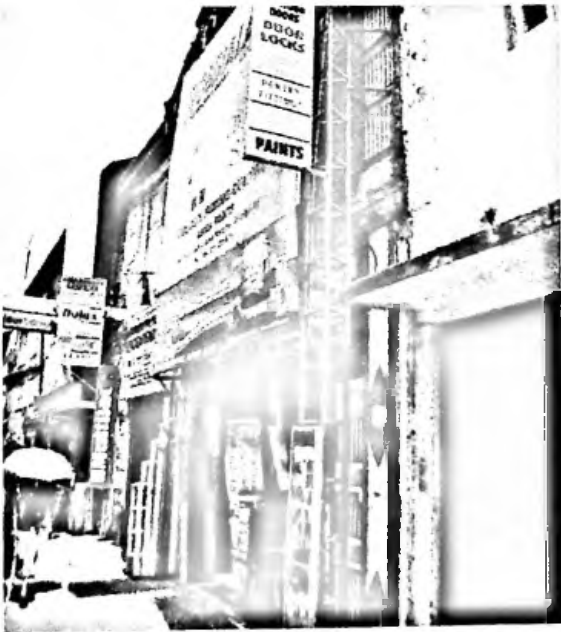
Figure 2.9

The original floor has been fully demolished and newly finished with colored cement and still the floor is in a bad condition with cracks and it's uneven.

What is notable is that different occupants have used various materials to finish the floor according to their taste and the uniformity of the floor is not present. Further the gap between the floor and the pavement is very low, upper residential areas floor is not in a condition to house resident. (Figure 2.9)

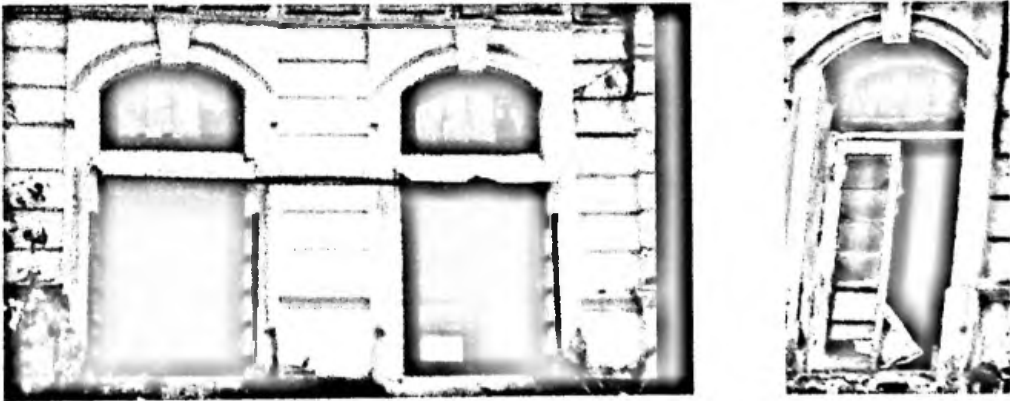
Figure 2.10

Symmetrical arches of the ground floor are being used as entrance for shops after modifying them with different types of doors such as roller doors, collapsible doors, aluminum and wooden doors. There are no evidences historical entrance ways, upper floor windows are present in the historical form yet they have been weathered and not in a useable condition. Some windows are with different types of canopies without uniformity. (Figure 2.10) (Figure 2.10a)

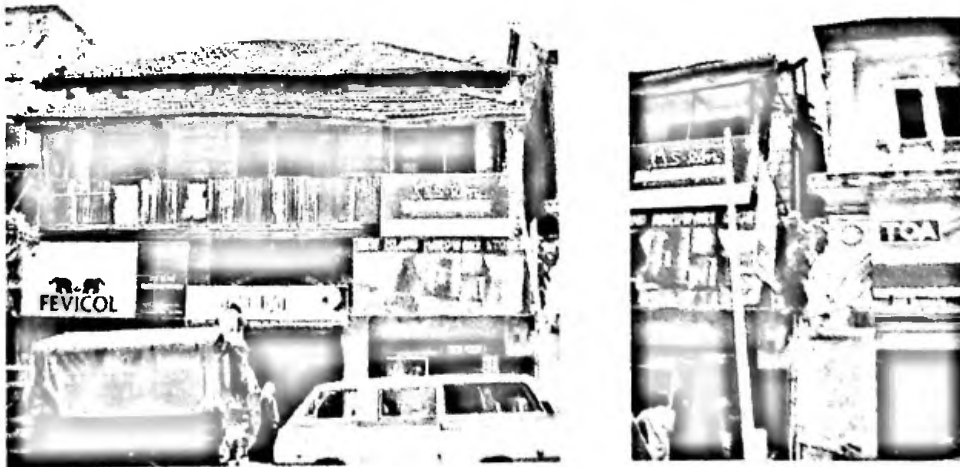
Figure 2.11

The Up stair balcony with bulgy shape due to main steel beams with poor strength and Most of the Reinforced steel beams with cement plaster layers are with scaling condition. (Figure 2.11) (Figure 2.11a)

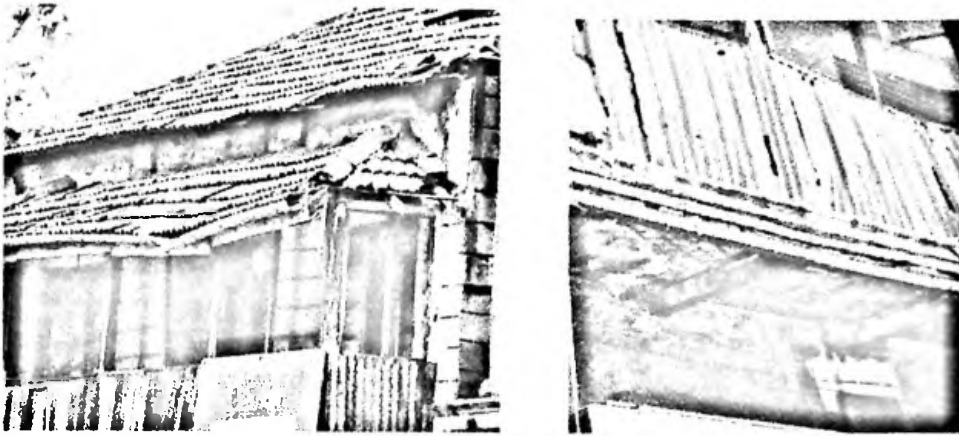
Figure 2.11a

If movement occurs because of this failure, cracks may open and further deterioration occurs. Steel, concrete, and brick masonry have different thermal coefficients; they change dimensions at different rates with fluctuating temperature. Up stair balcony with bulgy shape due to main steel beams with poor strength and Most of the Reinforced steel beams with cement plaster layers are with scaling condition.

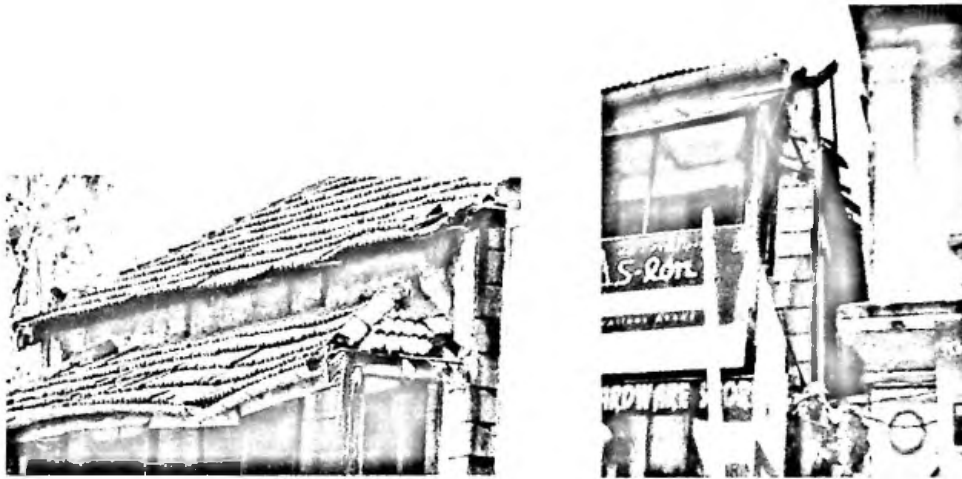
Figure 2.12

Right side of the roof are highly dilapidated and exposed to rain water and Gutters are not maintained, also parts are missing.

Due to poor drain system making base ground for various plants.  
(Figure 2.12)

Right side of the roof are highly dilapidated and exposed to rain water and Gutters are not maintained, also parts are missing. Due to poor drain system making base ground for various plants. The roof of the building is finished with Calicut tile and, yet historical roof form is still present with poor maintenance and poor strength. It's down pipes and gutters are also in very poor condition.

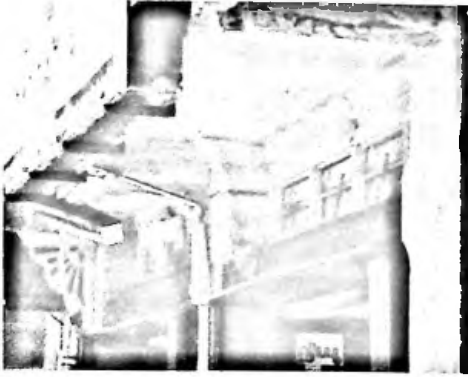
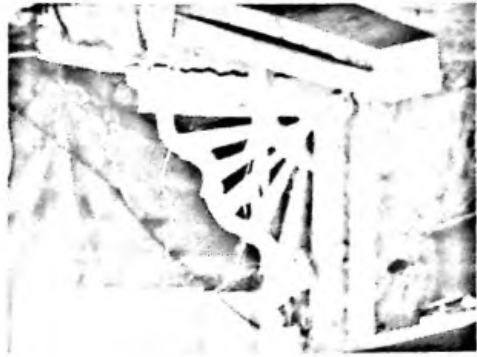
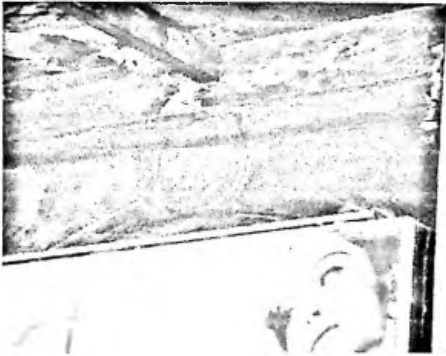
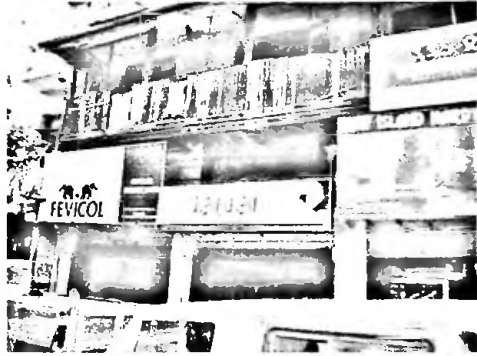
Figure 2.13

Small cement cast decorations are percent but with the scaling condition. Most of the decorations are damaged and peeling of due to the hanging of the signage

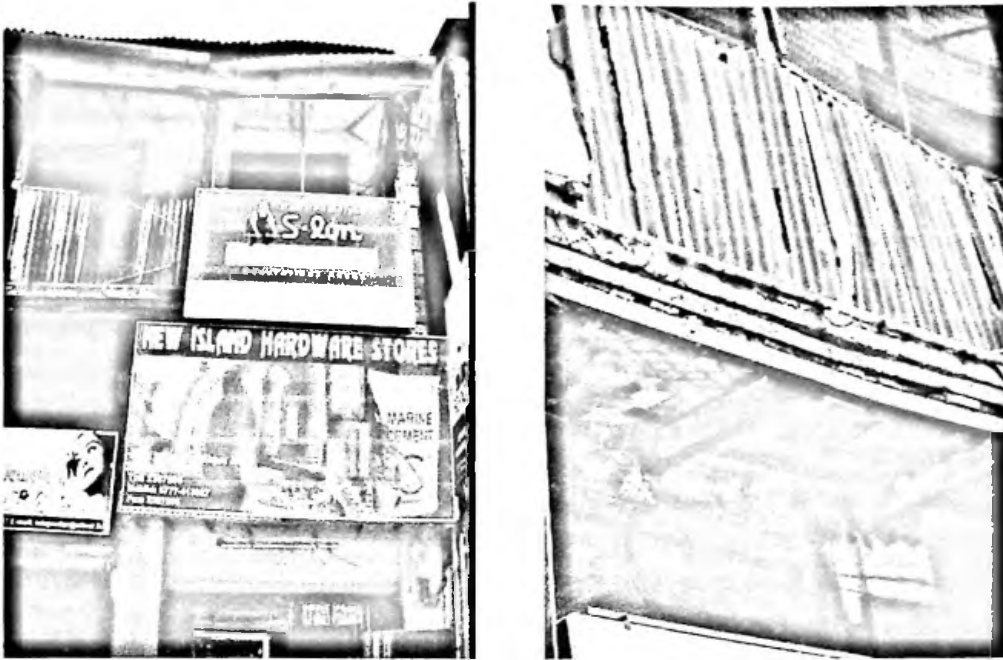
Figure 2.14

Most of the façade decorations of this building have been dropped from the surface. Further, some points have been repaired removing the decoration. These steps have hastened the destruction of the historical decorations and the evidences of this building.

Further, due to the mismatch in plaster compound that has been used for these repairs and the historical plaster, the remaining historical plaster is in danger of falling off.

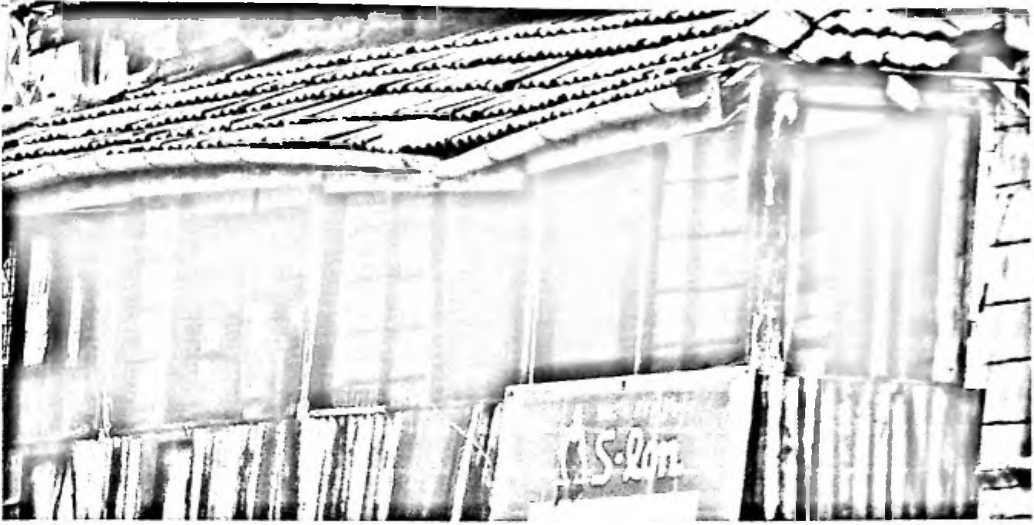
Figure 2.15

There are no evidences historical entrance ways, upper floor windows are present in the historical form yet they have been weathered and not in a useable condition. (Figure 2.15)

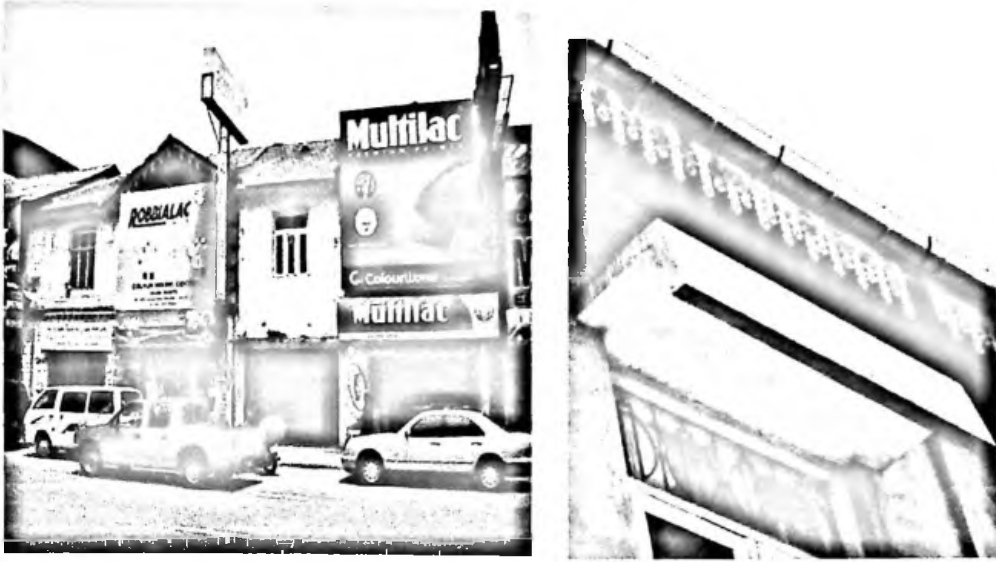
Figure 2.16

The building has been additionally modified from its historical glory using steel canopies and roller doors which totally obstruct its historical building form and also commercial signage's.

The historical building form outlook of from seems strong, but more modifications are available due to the owners commercial trends and Owners are not concerning about the historical building, only the concerning for business.

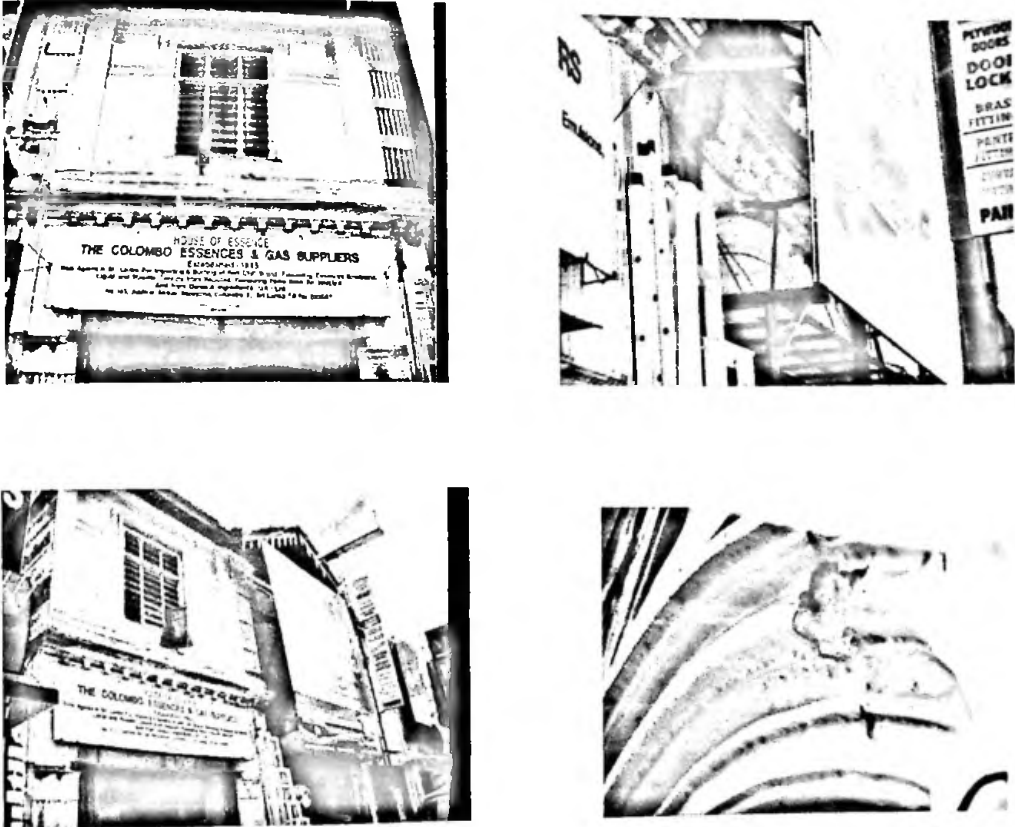
Figure 2.18

Small cement cast decorations are percent but with the scaling condition. Most of the decorations are damaged and peeling of due to the hanging of the signage. (Figure 2.18)

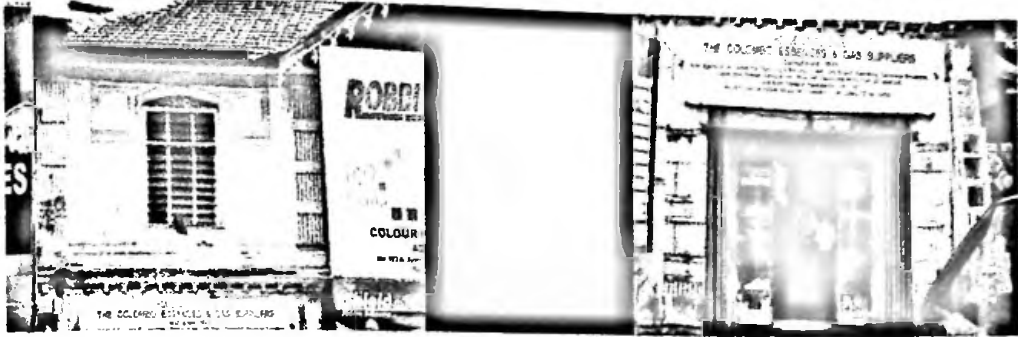
Figure 2.20

The windows decorations are still remaining. Upper floor Windows with the three slashes and windows with the two patterns and used as an each other. (Figure 2.20)

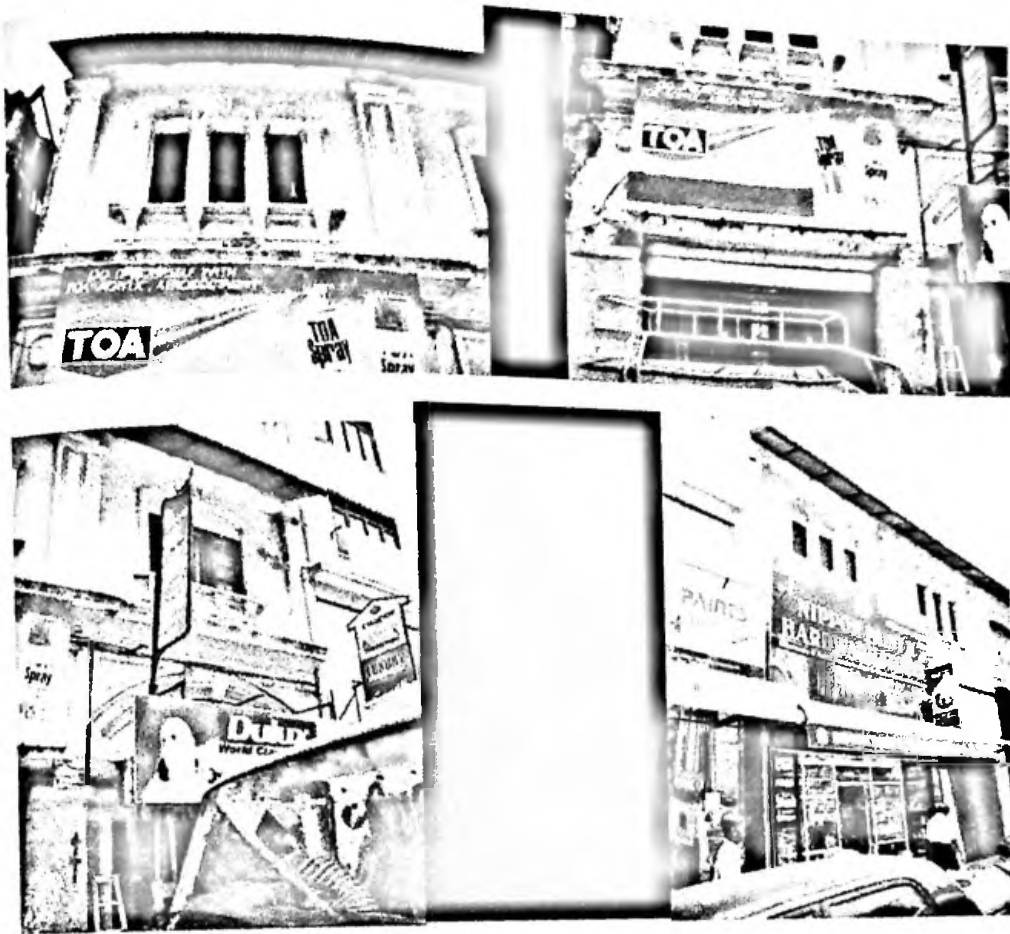
Figure 2.23

Most of the front decoration plaster is scaling due to poor maintenance while in some extreme instance the total plasters have been peeled exposing the bricks in side. Decorative window's frames and Symmetrical decorative pillars are remaining (Figure 2.23)

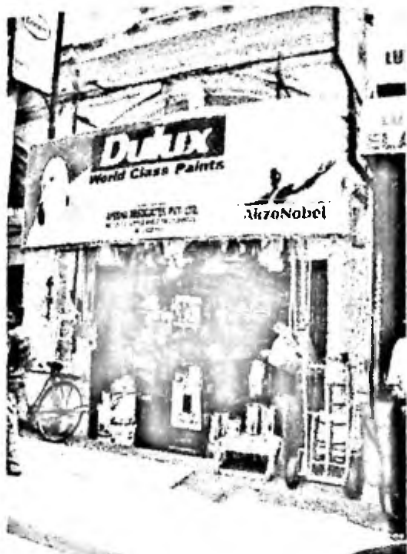
Figure 2.24

Further the gap between the floor and the pavement is very low, upper residential areas floor is not in a condition to house resident. Upper floor wooden structures with cement floor and they used as storage. (Figure 2.24)

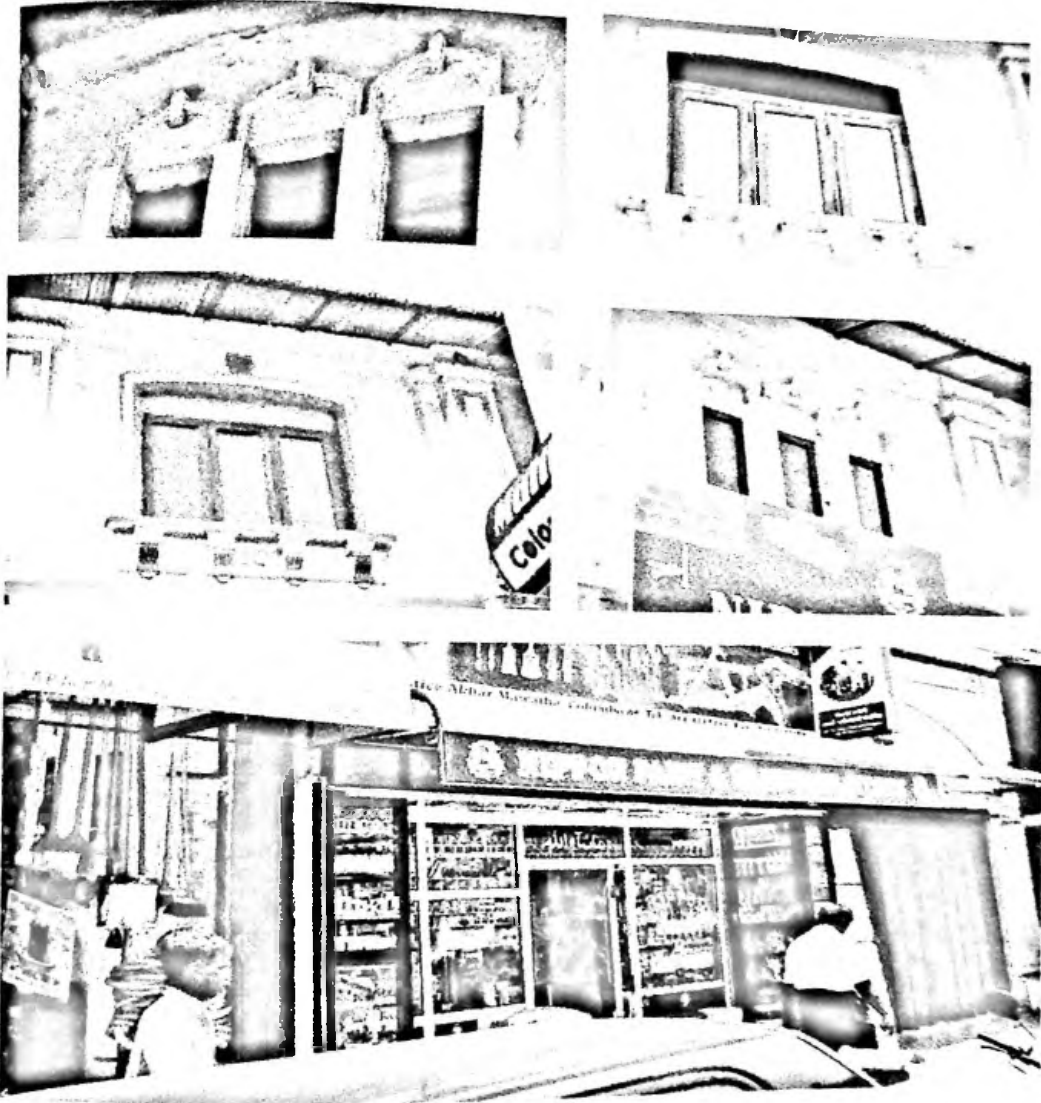
Figure 2.25

Upper floor Windows with the three slashes and windows with the two patterns and used as an each other. There are different types of doors in the ground floor of these buildings. The owners have installed doors to suit the businesses that they are doing. (Figure 2.25)

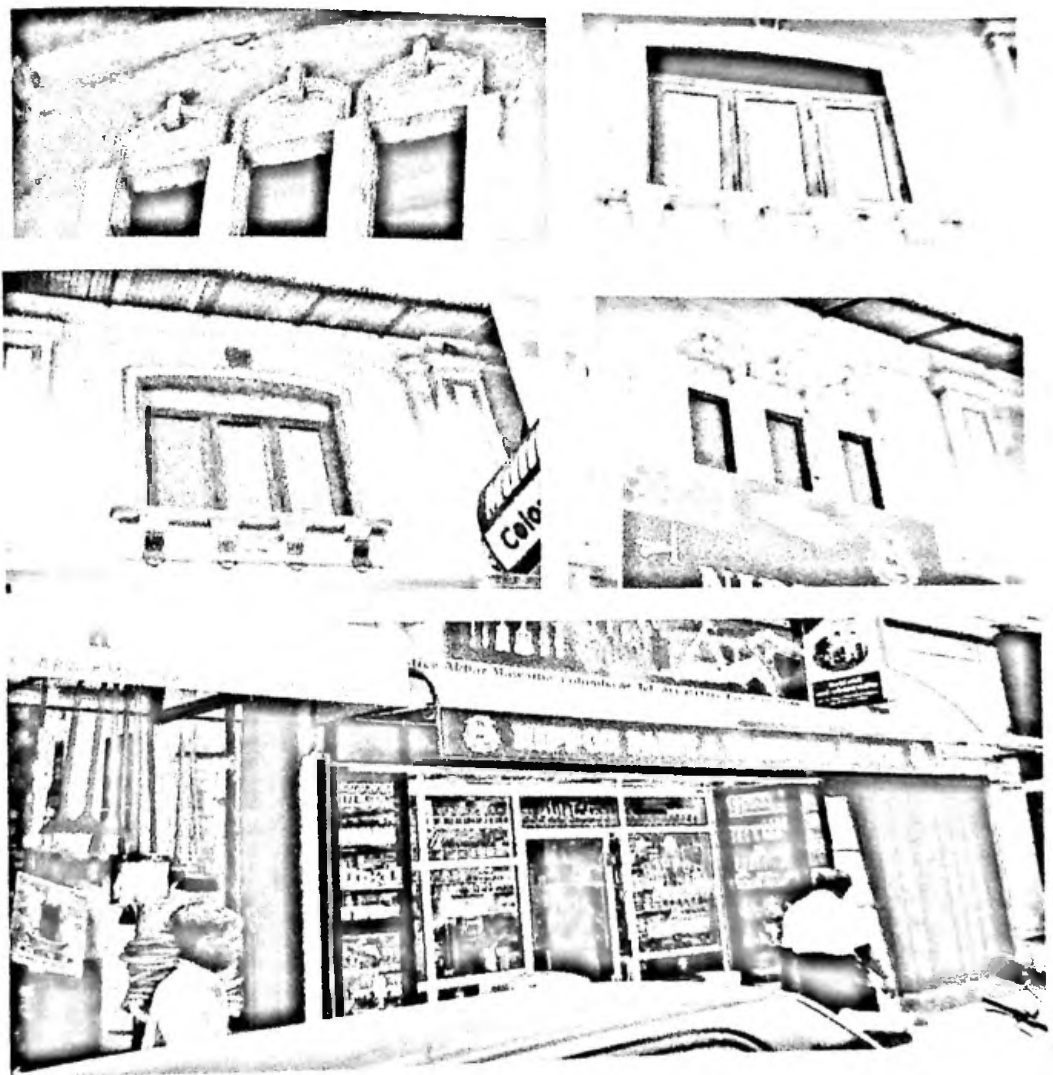
Figure 2.25

Upper floor Windows with the three slashes and windows with the two patterns and used as an each other. There are different types of doors in the ground floor of these buildings. The owners have installed doors to suit the businesses that they are doing. (Figure 2.25)

There are different types of doors in the ground floor of these buildings. The owners have installed doors to suit the businesses that they are doing.

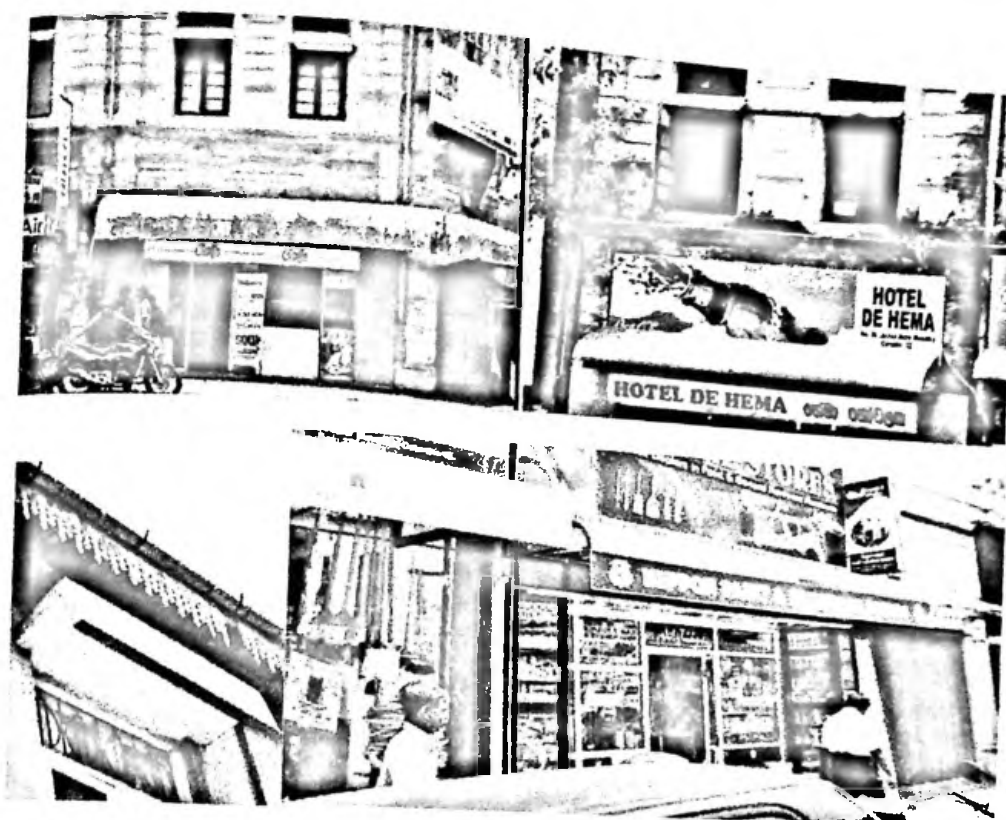
Figure 3.3

Using canopies is the next main deformation. This can be considered a necessity when the present usage is factored.

The new items should be documented and can be easily identifiable. (Figure 3.3) (Figure 3.3a)

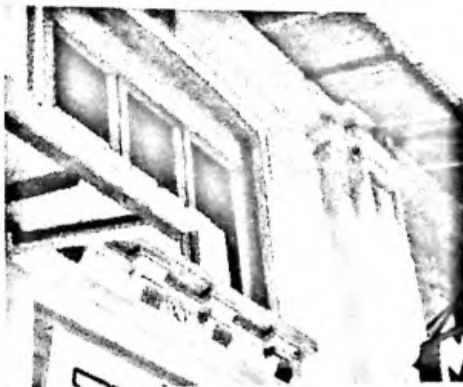
Figure 3.4

When compared to the other buildings the occupants of the Soyza building have installed canopies to the windows of the upper storey of the building. The reason behind this is the narrower eave of the roof of the building which requires a canopy to protect from harsh sunlight and rain. The other two buildings (Building No 137 and 140) roofs have been reconstructed with a broader eave thereby eliminating the need for a canopy. (Figure 3.4)

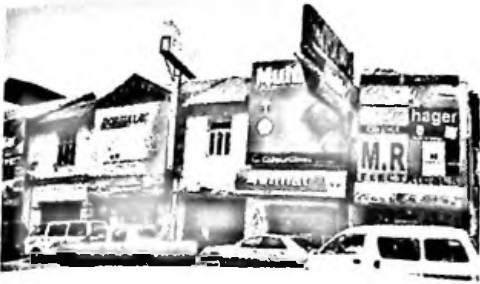
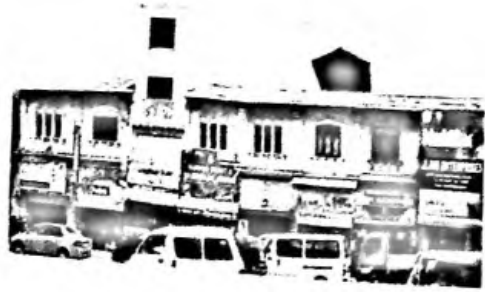
Among the four buildings the Soyza and the (Building No 125) are intact with their historical roof and roof form yet in a very weak condition. When compared with the modified roof of the Soyza building the roofs of the other buildings look very similar though all the roofs are somewhat modified. Except for Soyza and the (Building No 125), roofs of other two buildings (Building No 137 and 140) have been modified from its historical form. (Figure 3.5) (Figure 3.5a)

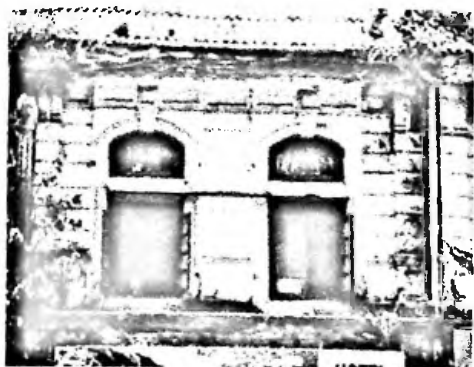
Soyza building –narrow eave

Since the eave of the Soyza building is much narrower the upper storey walls are heavily decayed. Further, to protect them from the direct sunlight and rain they have resorted to canopies. (Figure 3.6)

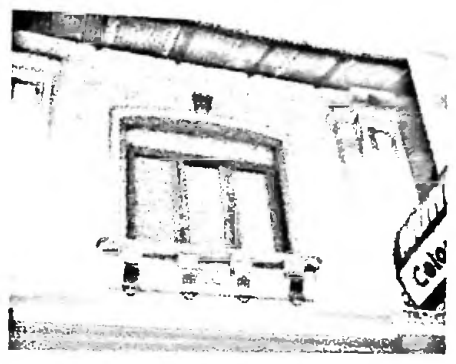
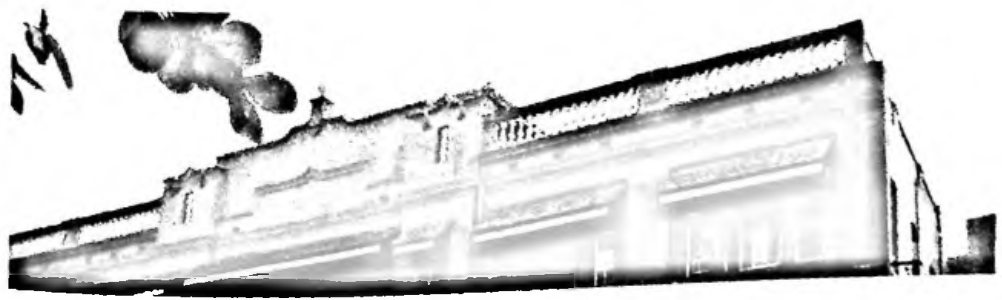
Figure 3.7

No 137 without the parapet wall

Nippon hotel

Our concern here is conserving this streetscape while presenting answers to the problems faced by present occupants of these buildings. That is recreating the historical roof form of these buildings by building back the parapet walls of these buildings (Building No 137), taking examples from the neighboring Buildings, such as Nippon Hotel. This way the colonial streetscape of this area can be retained for future. (Figure 3.7)

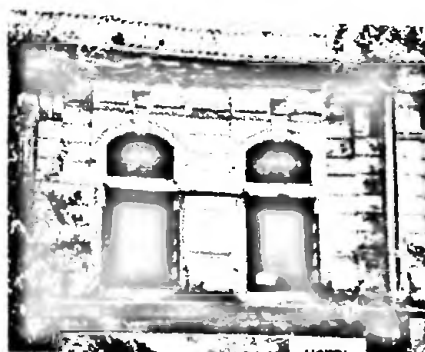
Figure 3.8

The other major concern is by giving them the historical roof form back by adding the parapet wall the eave of the roof will be reduced, thereby exposing the walls and windows to weather as experienced by the Soyza building. This can be remedied by adding the same canopies adopted by the occupants of the soyza building. (Figure 3.8)

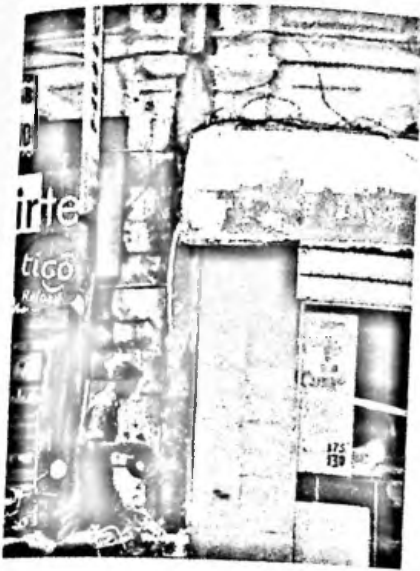
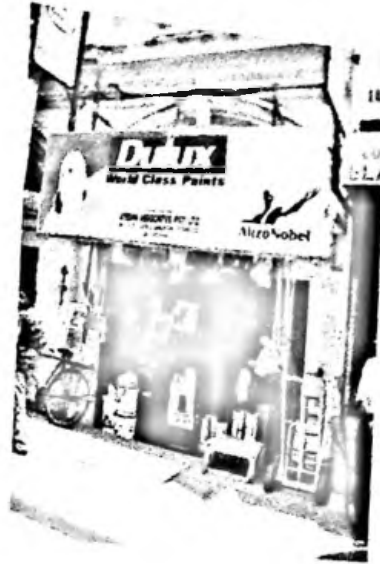
Figure 3.12

There are different types of doors in the ground floor of these buildings. The owners have installed doors to suit the businesses that they are doing. Therefore, the streetscape has complicated beyond recognition.

These irregular door styles should be changed to their original form with the consultation of the present owners so that their businesses won't get hindered due to this. (Figure 3.12)

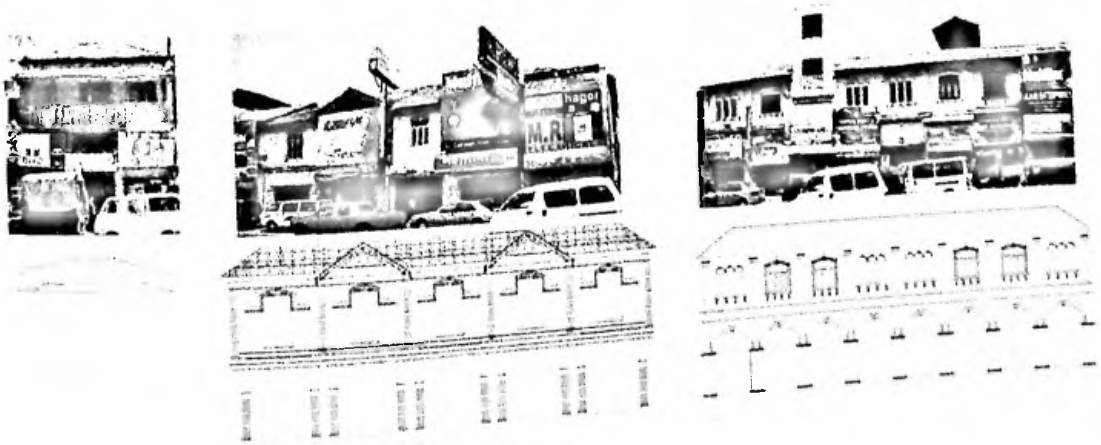
Figure 3.13

A close study can reveal some important evidences of their door and window styles. Those evidences should be identified and they should be changed to suit the present usage of the buildings

The expertise can be sought from the wood conservator because according to architectural conservation ethics the new additions should be identifiable and should be properly documented. (Figure 3.12a) (Figure 3.13)

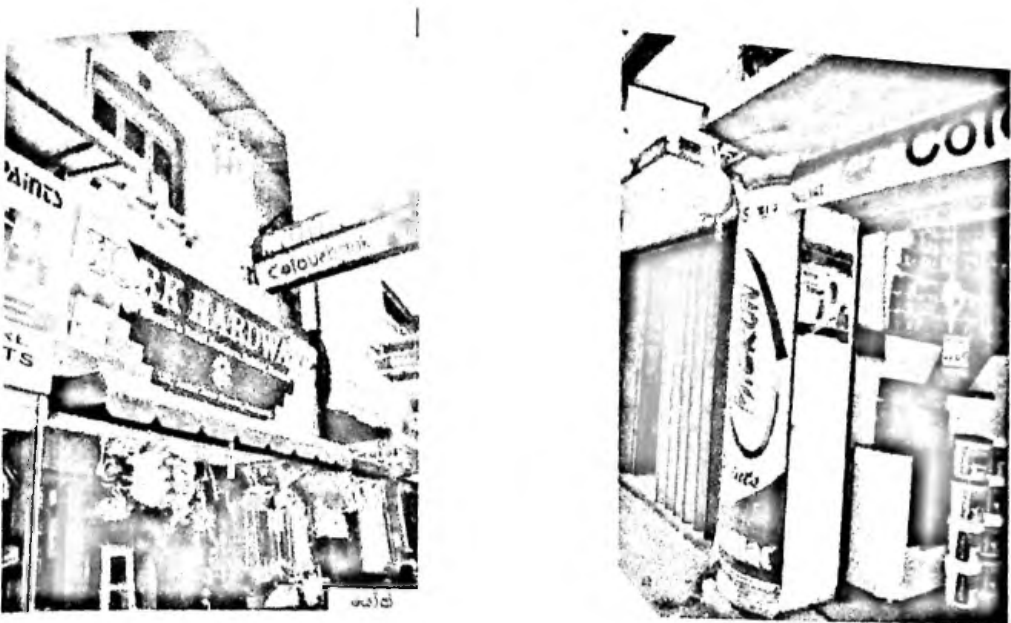
Figure 3.14

The entry way and the related windows are not uniform in all these buildings presently due to changes that have been effected to match the commercial purposes of these buildings thereby changing the historical view of the building. (Figure 14)
