# Dynamics of the Madu-Ganga Estuary

De Silva UHNH, Somasiri RBHP, Jayasekara NNL, Ratnayake AS,  
Dushyantha N, Weththasinghe SM, Samaradivakara GVI,  
Vijitha AVP and \*Ratnayake NP

Department of Earth Resources Engineering, University of Moratuwa, Sri Lanka  
\*Corresponding author - nalinratna2010@gmail.com

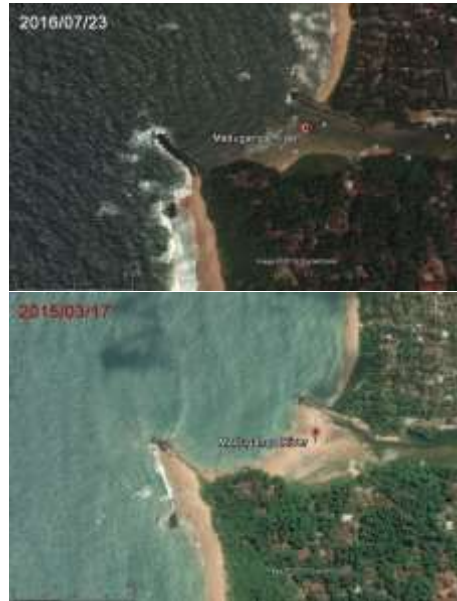
Figure 2 - Satellite images show Madu-Ganga Estuary opened (2016-07-23) and closed (2015-03-17) status

sea-level high stands [3,4,5]. In addition, the present geomorphological features indicate seasonal opened/closed conditions of the estuary mouth (Fig. 2). Such geomorphological changes are especially sensitive to water quality and the estuary [6,7,8,9]. To provide socioeconomic trajectories, it is important to know hydrodynamics and sediment dynamics in the Madu-Ganga Estuary. Therefore, in this study, the authors investigate water quality variations and sediment distributions in Madu-Ganga Estuary. In addition, satellite images were used for identifying erosion/accretion directions of sediments near to the estuary mouth.

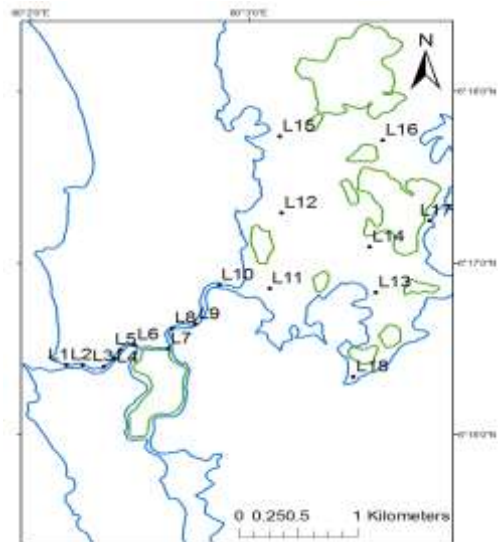
Figure 3 - Sampling locations for water quality measurements and sediment samples

Four field works were carried out between September 2016 and February 2017. Therefore, these field works cover both southwest and northeast monsoons. Sampling locations were selected as per the Figure 3.

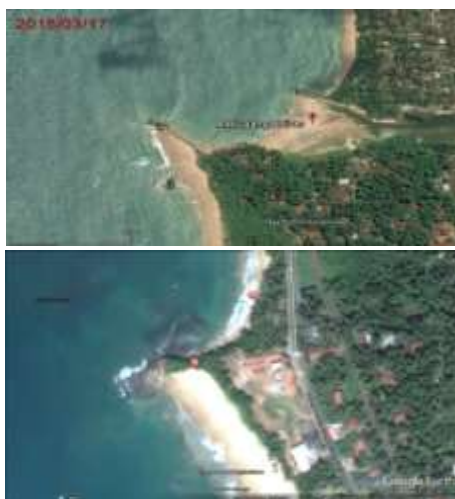
Sediment transportation directions were identified the surrounding coast using the time series satellite images (Fig. 4). It clearly indicates a significant amount of sand deposition in the southern part of the estuary mouth. Therefore, this pattern probably suggests the prominent clockwise (south to north) nearshore sediment transportation by longshore currents.

Figure 4 - Satellite images show sand deposition by longshore currents

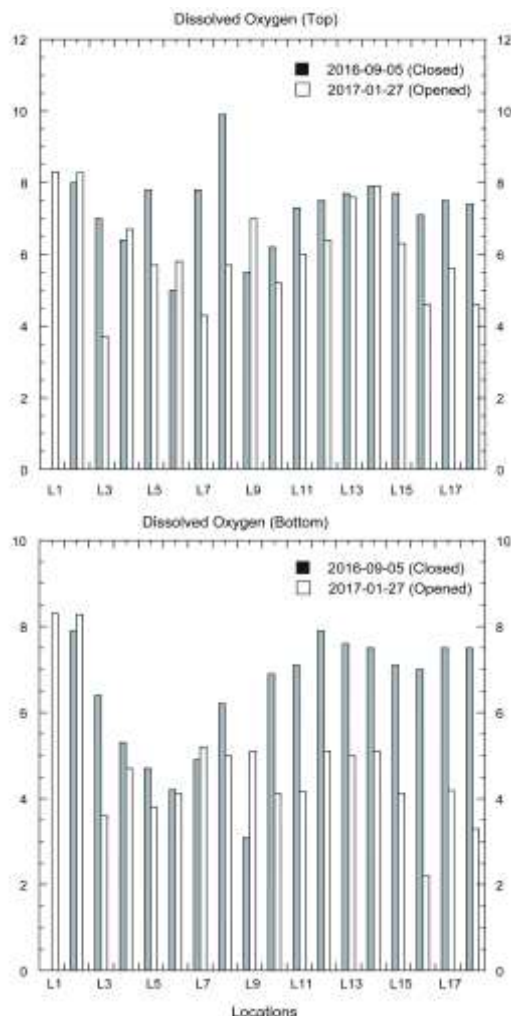
Dissolved oxygen values are high under estuary mouth opened condition in surface water samples. Similarly, dissolved oxygen values are

increased under estuary mouth opened condition in bottom water samples (Fig. 5). Therefore, water quality parameters can be seriously polluted under the estuary mouth closed condition.

Figure 5 - Dissolved oxygen variation in surface and bottom water samples

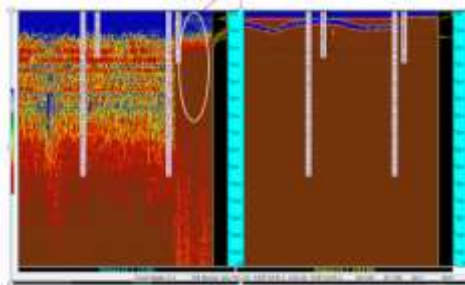
Figure 7 - Sub-bottom profiler and bathymetry images

Sediment layers can be clearly seen along Madu-Ganga Estuary. Therefore, these sedimentary layers are most probably an indication for estuary mouth opened and closed conditions (Fig 7). However, sediment layers are complex near to marine-terrestrial interface of sediments.

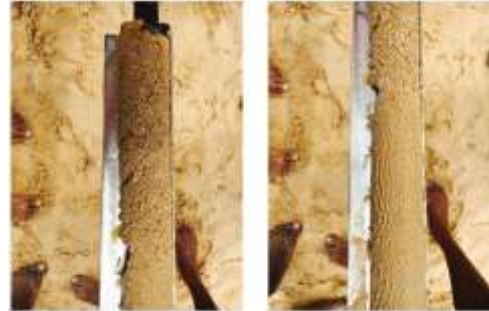
The estuary mouth is mainly composed of marine sand (Fig. 8). These sands can predominantly transport by longshore currents during the southwest monsoon, as

discussed earlier. In addition, it mainly consists of loosened and compacted sands in the upper and the lower parts of the core samples, respectively (Fig.8).

Figure 8 - Core samples taken from push corer near to the river mouth
