# CHAPTER 01 -INTRODUCTION

## 1.1 General Background

Southern Expressway is the first access control expressway in Sri Lanka. The route from Kottawa to Matara was initially opened to the public from Kottawa – Pinnaduwa in 2011 November, while the extended section from Pinnaduwa - Godagamawas was opened to the public on March 2014.

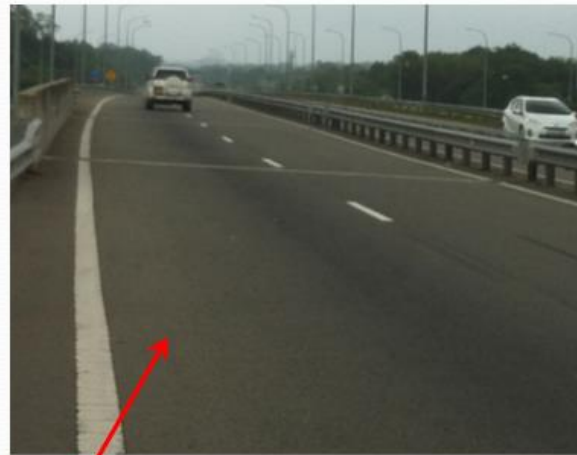
Surface water collection due to rain has been identified at some spots. Therefore, the geometry of those locations has to be investigated. Following Figure 4.16 gives the cross-fall variation at prone locations.

New Location	Cross Fall	
	LHS	RHS
5.856	2.5	-2.5
5.876	2.134	-2.13
5.896	1.578	-1.58
5.916	1.023	-1.02
5.936	0.467	-0.47
5.946	0.189	-0.19
5.956	-0.09	0.088
5.976	-0.64	0.644
5.996	-1.2	1.199
6.016	-1.76	1.755
6.036	-2.31	2.311
6.046	-2.5	2.5

If rain prevails when a driver uses the expressway there is an inducement of shock when passing such locations and a sudden application of break can cause the vehicle to slide without control. The hydroplaning action also can be the cause for the accidents on such segments.

- Rain was the main factor which has caused many accidents in the accident prone areas. During the site inspection it has been observed that some areas were stagnated with water during the rainy period due to geometric variations. Corrections have to be implemented as an urgent safety requirement.

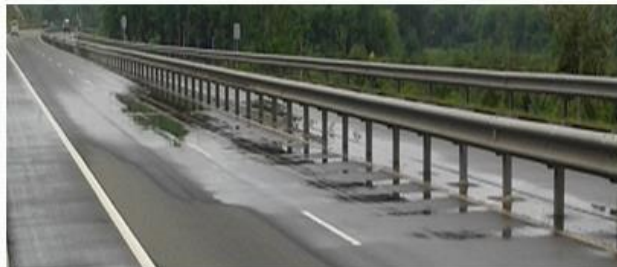
❖ **8.0-8.1 (RHS) – 23 Accidents**

New Location	Cross Fall	
	LHS	RHS
8.046	-2.5	2.5
8.056	-2.36	2.355
8.076	-1.8	1.8
8.096	-1.24	1.244
8.116	-0.69	0.688
8.136	-0.13	0.133
8.146	0.145	-0.15
8.156	0.423	-0.42
8.166	0.7	-0.7
8.176	0.978	-0.98

- **58.7-58.8 (LHS) – 17 Accidents**
- **55.15-55.25 & 55.25-55.35 (LHS) – 27**
- **20.85-20.95 (RHS) & 20.95-21.05 (LHS) – 31**

Same cross fall as above pattern

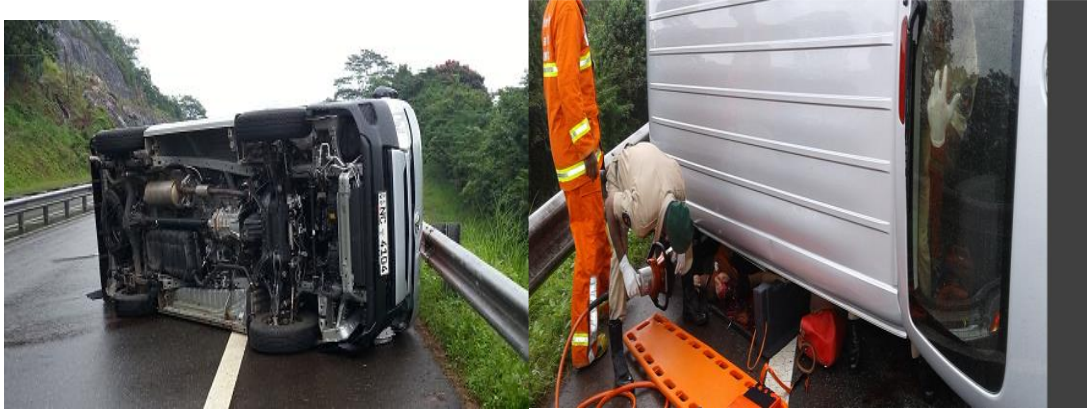
Figure 4.22: Accident at 73.15Km (LHS)

One fatal accident from the sample has been selected for the case study. The driver had fallen asleep during the journey and as a result had met with an accident. It was raining at that moment and the vehicle had slipped and crashed on the embankment guardrail at first. Then had crashed again with the center median guardrail and rest at the outer lane of carriageway, with one fatality as shown in Figure 4.22

Following observations were made for the above incident.

- 1) Factors that had influenced the accident: Fatigue/drowsiness and the rainy weather condition (Human and Environment)
- 2) Factors that had influenced the injury: The way the vehicle had crashed and the fact that the driver had not used the seat belt.

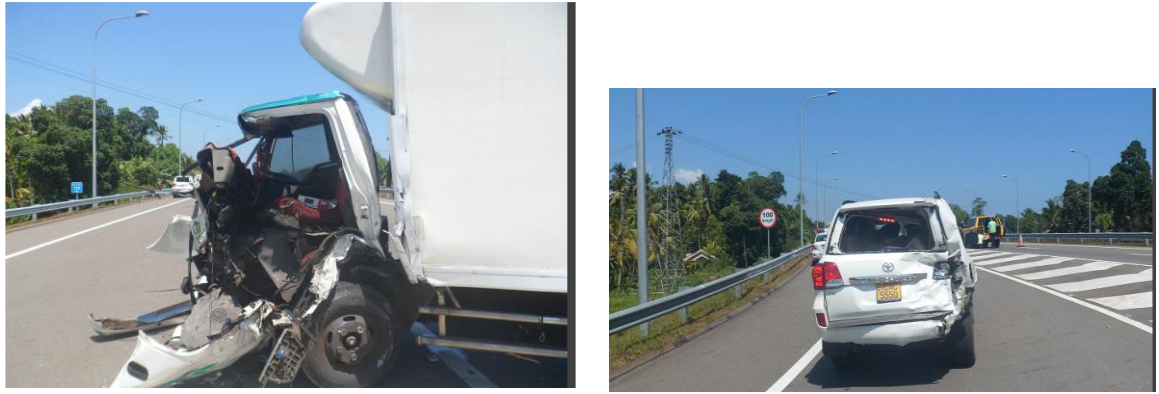
Figure 4.23: Accident at 114.92Km (LHS)

A jeep had just moved from the relevant exit and stopped at the shoulder nearby the entrance at the merging point to the expressway. Then the driver had tried to reverse his vehicle in order to exit. Suddenly, a lorry had come and crashed with the rear side of jeep. (Video stream also has been inspected). Damage to the two vehicles is shown in Figure 4.23.

- 1) Factors that had influenced the accident: Reversing (Human) when reversing is strictly prohibited in the expressway and Carelessness/Negligence of the driver (Human).
- 2) Factors that had influenced the injury: Driver had not used the seat belt and the impact that had occurred due to the high speed.

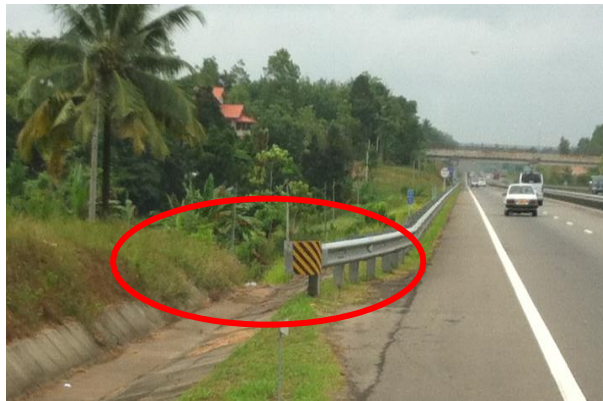
Figure 4.25: Guardrail opening

1. Usage of seat belts.
2. Crash severity.
3. Crash pattern:
  - a. Crashing on side and center guardrails
  - b. Vehicles going off road from guardrail openings. (Figure 4.25)

- Seat belt is the main safety provider for the driver and passengers. So expressway users have to be enforced to wear the seat belts during the journey. Areas in which guard rails are open, and end terminals should be avoided, along with vehicles that had broken down or come to a halt on the expressway. Then the severity of the injury can be minimized.

14. Guardrail end terminal should be avoided to minimize the severity of injuries. Embankment guardrail opening sections should be closed. Figure 6.4 illustrates the new arrangement of such a guardrail section.

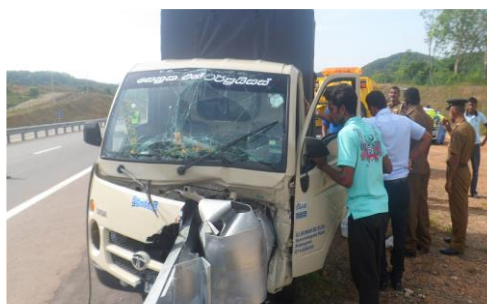
Figure 4.26: Guardrail end terminal/buffer

- c. Crashing with the guardrail end buffer. (Figure 4.26)

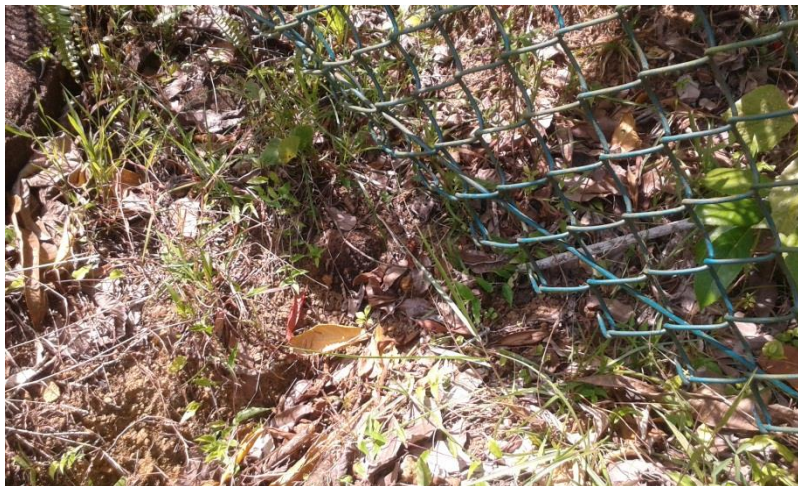
Figure 6.1: ROW fence

3. Animal collisions are avoidable. Dogs, pigs, iguana and most of animals have entered the expressway from the ROW fence bottom. ROW fence is damaged at most of the areas due to poor maintenance. As such, frequent inspections of the ROW fence shall be carried out and such openings shall be closed. A concrete layer can be applied at the bottom of the fence to seal the gaps. (Figure 6.1 show the ROW section)
