**IMPROVEMENT OF DEUTZ MARINE ENGINES TO
REDUCE CYLINDER LINER FAILURE DURING
TRANSIENT CONDITIONS**

Department of Mechanical Engineering

University of Moratuwa

Thesis submitted in partial fulfilment of the requirements for the
Degree of Master of Engineering in Manufacturing Systems Engineering

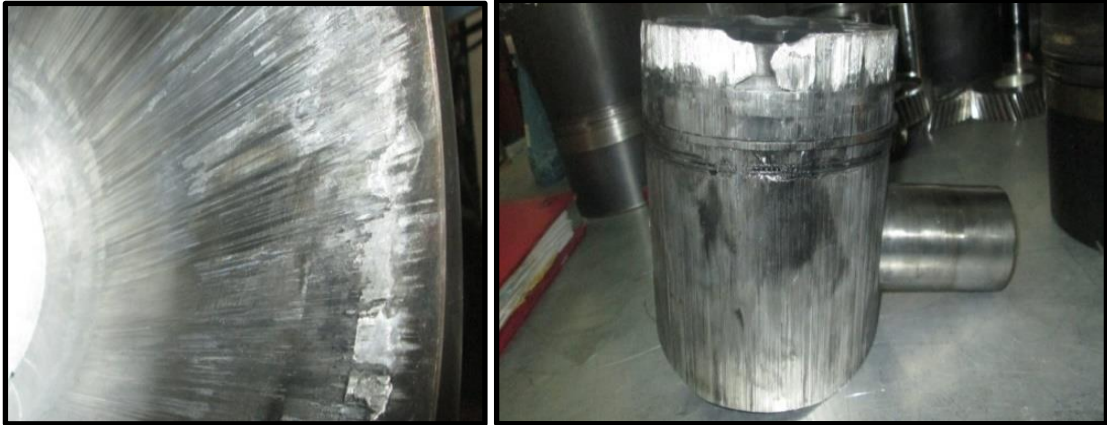
Figure 2.1: Cylinder Liner and Piston subjected to heavy seizure

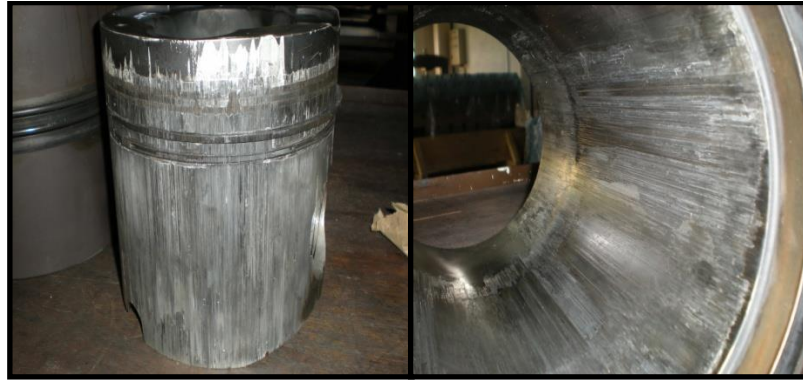
When examined, the nature of most of the liner seizure, patterns and scrape marks are similar to each other. The seizure marks can be found on both the pressure side and on the counter pressure side of the cylinder liner. Around the skirt of the piston there are several different areas of seizure marks which are all identical in nature. The only difference is that some cylinder units are subjected to heavy seizure while some are at the initial stages. The following photographs indicate some common pattern of seizure of this engine.

Figure 2.2: Nature of seizure

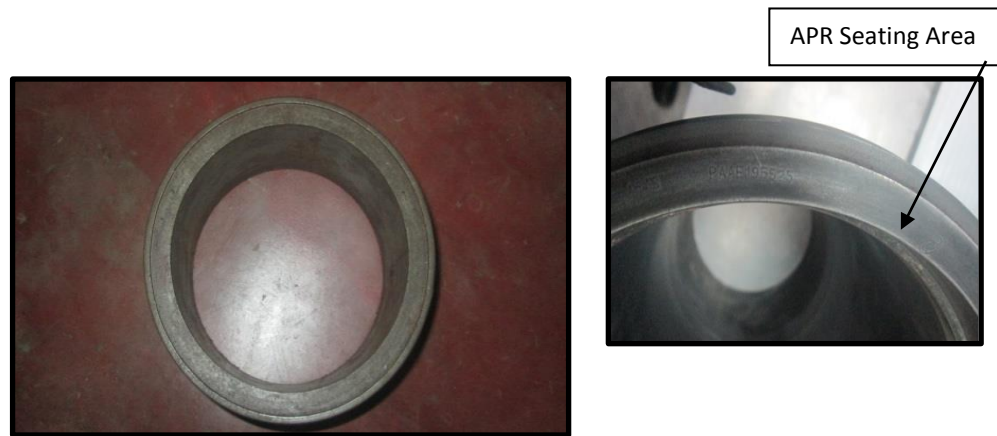
Figure 2.3: Cylinder Liner without APR and with APR

The function of the APR is to prevent bore polishing and thus reducing the lube oil consumption. The APR is fitted at the top of the cylinder liner and it can prevent the formation of coke layer, which smooth the running surface of the cylinder liner. Based on the recommendation, the SLN introduced APR Cylinder liners for all the Deutz TBD 620 engines. Simultaneously with this modification, other components of the cylinder unit such as piston, connecting rod and small end bearing of connecting rod were also upgraded by the OEM as follows:

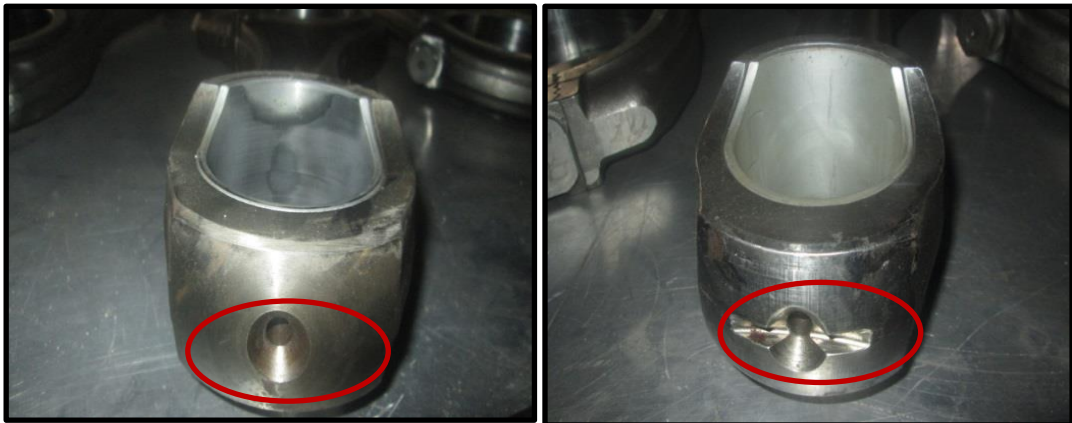
b. **Connecting Rod** - Even though the number of holes underneath the piston was reduced, the OEM has tried to improve lubrication of the connecting rod small end bearing and Gudgeon pin by introducing a slot on the connecting rod. By doing this, the OEM has focused on the proper lubrication of the Small End Bearing of the connecting rod. Because, during some cylinder liner seizures, the SLN observed that the Gudgeon Pin suffered seizures with the small end bearing of the connecting rod.

Figure 2.5: Initial arrangement and Upgraded Version

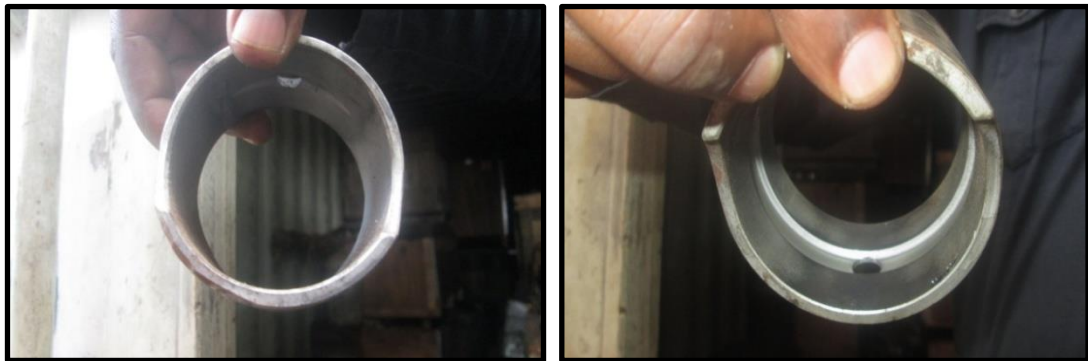
Oil groove is only a slot Oil groove around the shell

Figure 2.6: Initial Bearing and Upgraded bearing

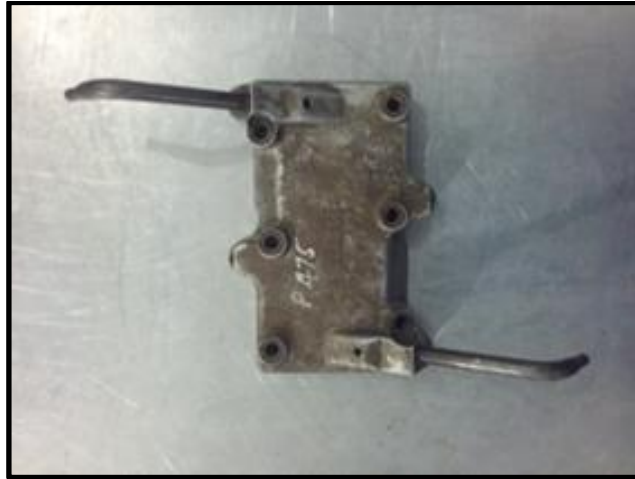
After the main gallery, the lubricating oil flows into the pistons and also splash around the inner surface of the cylinder liner through the cooling nozzles. Excess lubricating oil on the inner surface of the cylinder liner is scraped down and falls to the sump by using the oil scraper ring of the piston.

Figure 2.11: Piston cooling nozzles

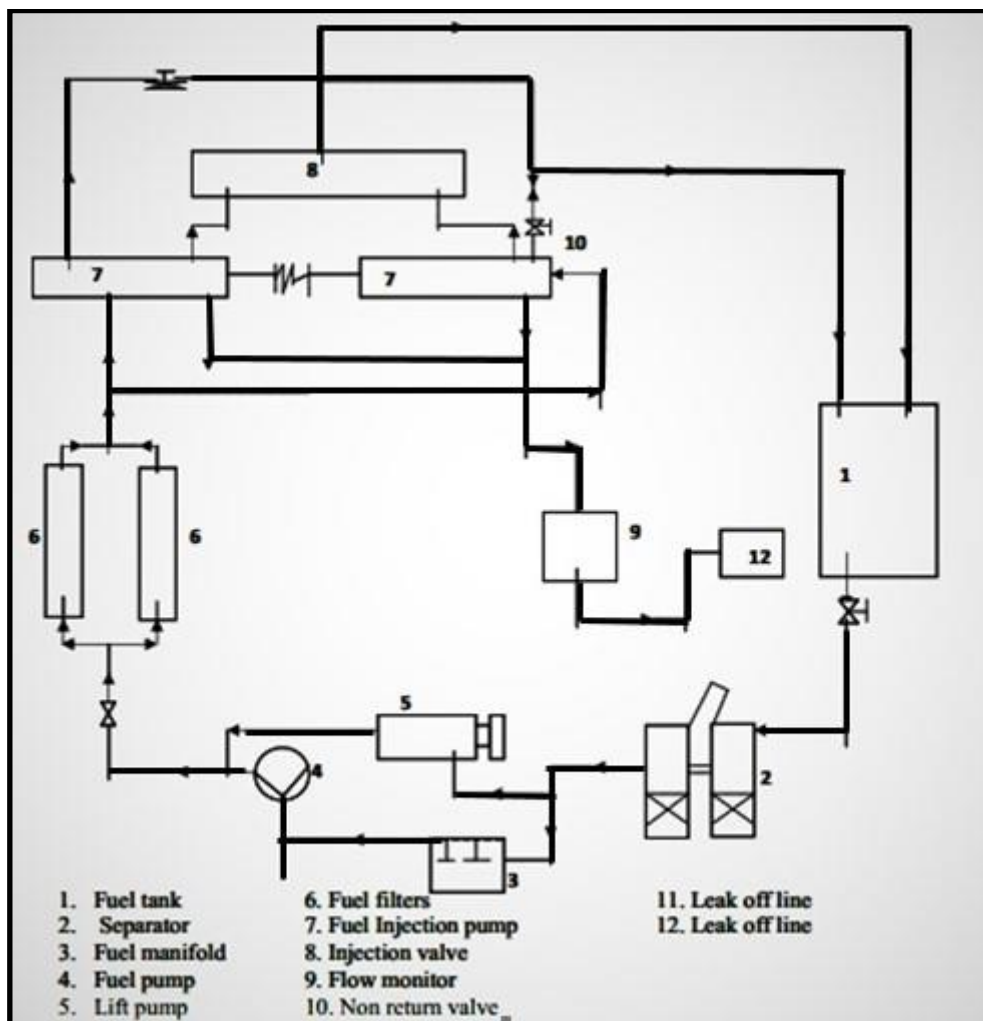
Figure 2.16: Fuel system diagram [1]

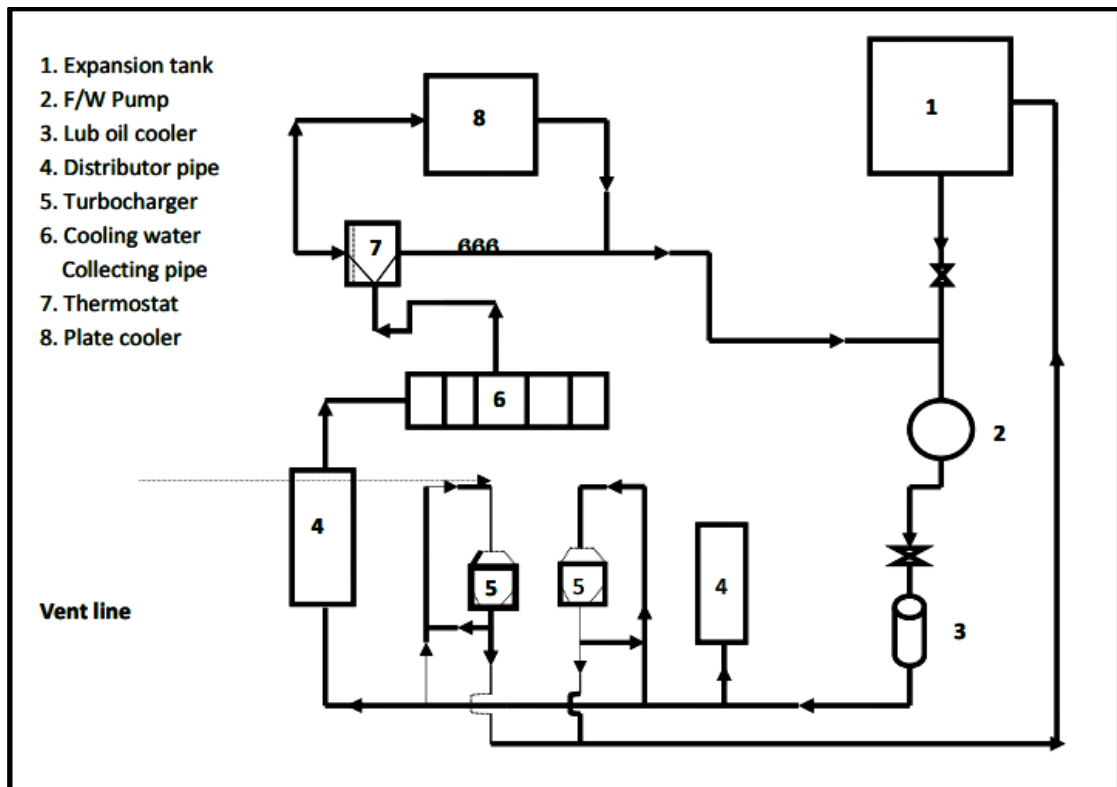
Figure 2.22: Coolant system diagram [1]

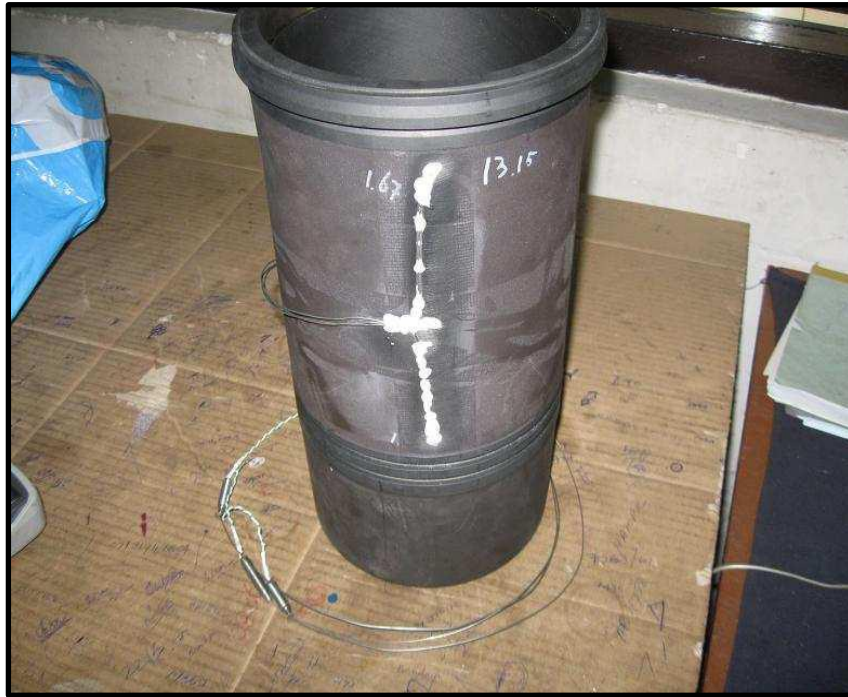
In order to record the line temperatures, an instrumented liner was prepared as follows, and equipped with three thermocouples. These thermocouples were distributed evenly on the water side of the liner, where the tip of the thermocouple was installed approximately halfway into the liner wall.

Figure 3.1: Instrumented Cylinder Liner

Figure 3.2: Instrumented liner with mounting distances of thermo couples

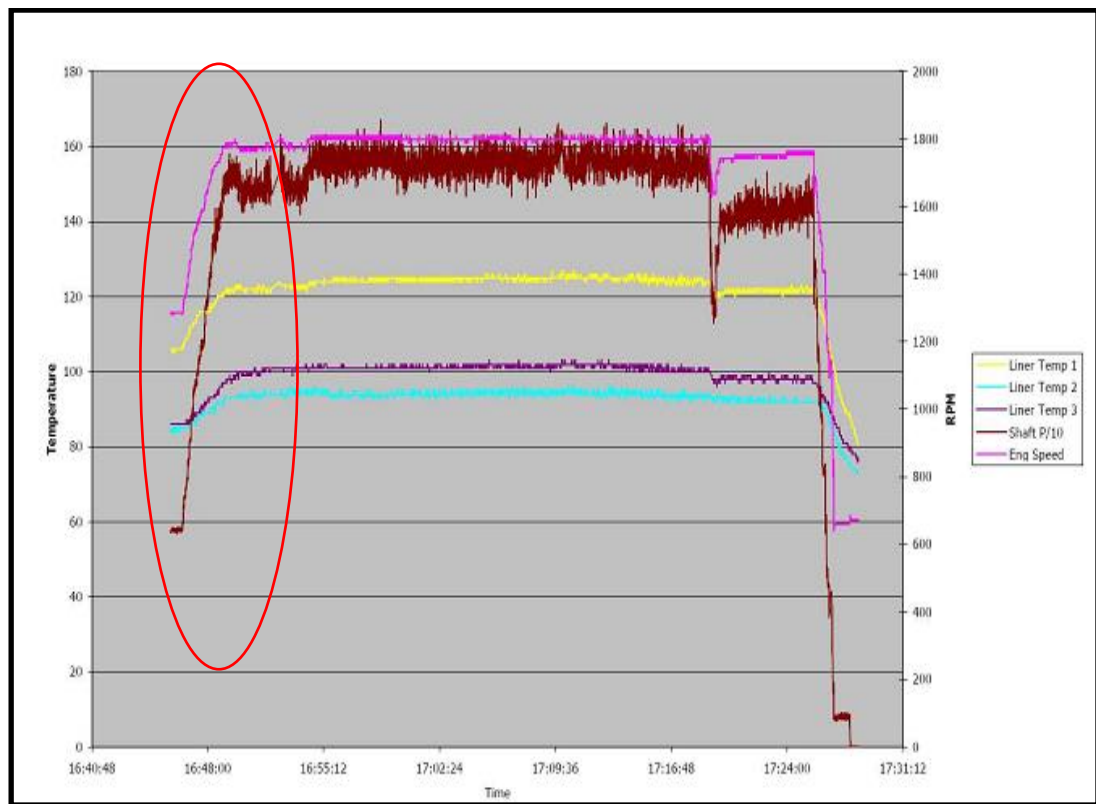
The following Graph shows the recorded parameters when the engine is run at 1800 rpm, steady state condition at 100% load.

Figure 3.4: Liner temperatures, shaft speed and engine speed (steady state)

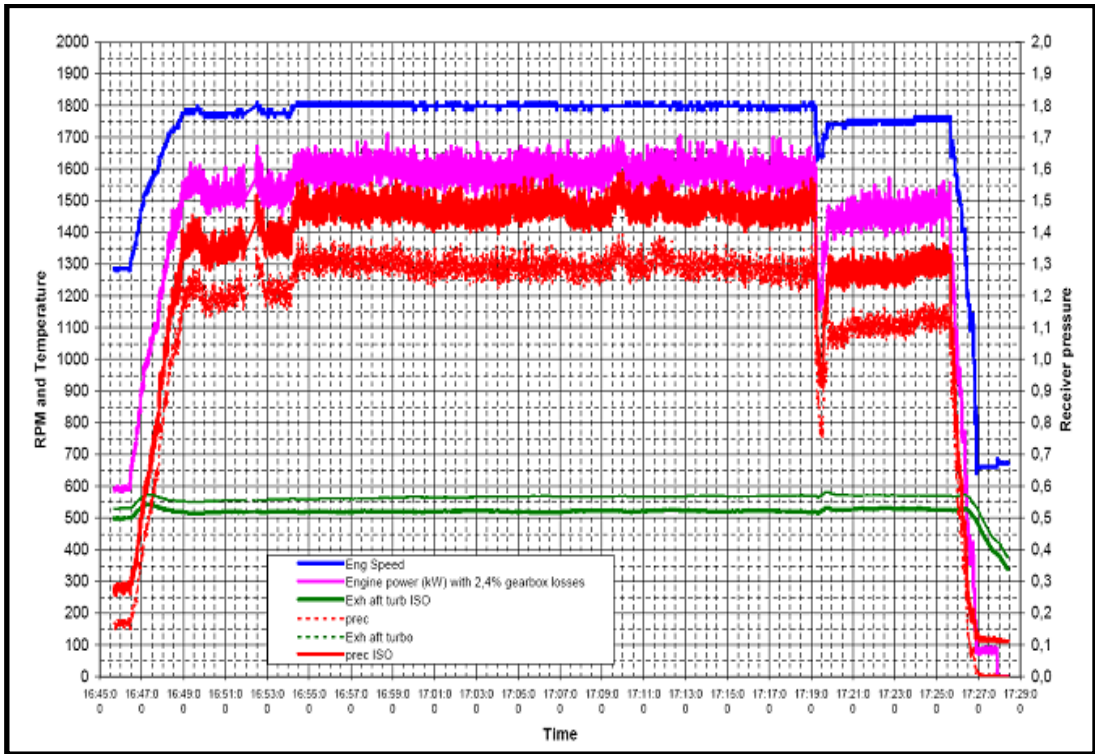
Figure 3.6: Engine speed, Exhaust gas and receiver pressures

The exhaust gas temperature showed an slight increase compared to the factory acceptance test, new condition of this engine, but that is a phenomenon to be expected (normal wear of the engine with age).

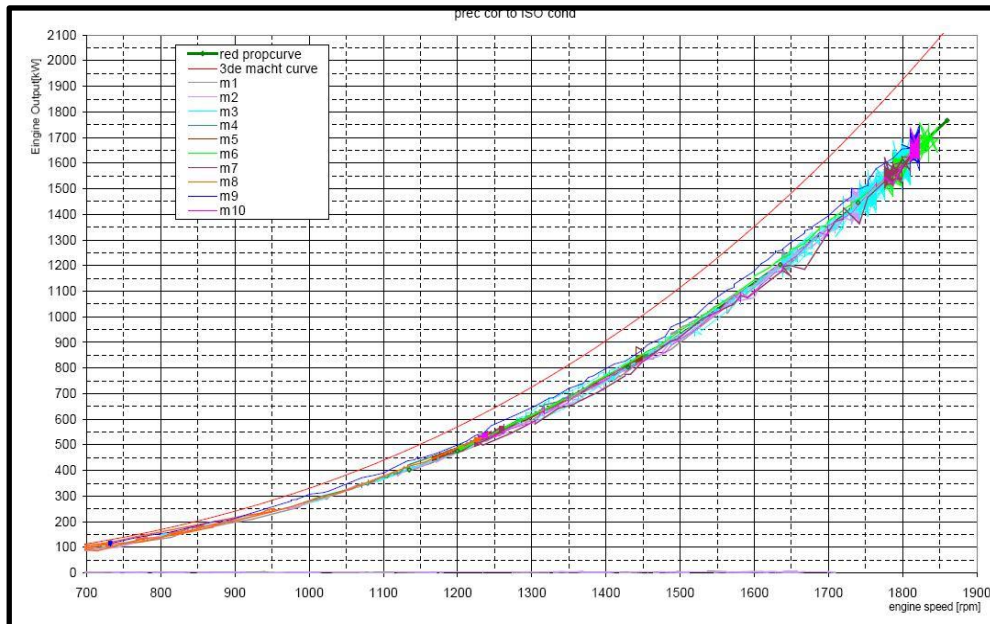
Figure 3.7: Comparison measurement step 1-9 with theoretical power curve

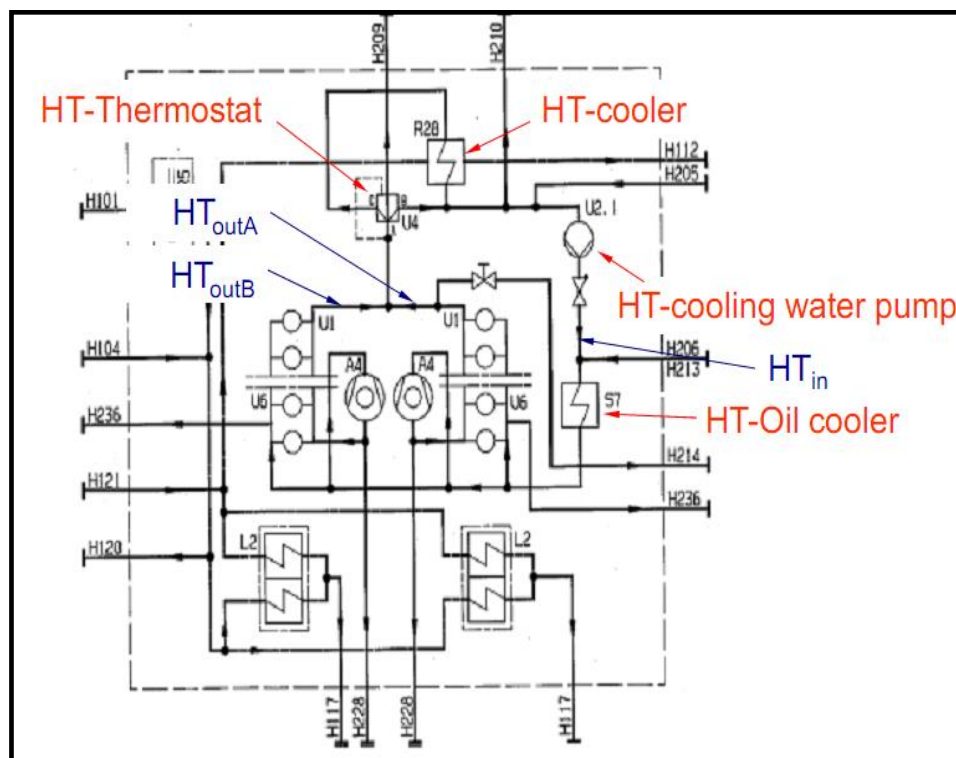
Within these measurements, no significant deviations have been discovered, other than the cooling water temperature, which could directly affect the performance of the cylinder liner. When increasing load of the engine rpm from 700-1800, even though it has taken 33 seconds, the HT cooling water temperature out still at approximately 63 °C. This load variation of the engine was carried out in 45 seconds and still HT cooling water temperature out was increased only up to approximately 66°C. The cooling water out of the engine has to be approximately (80-82)°C at this stage within (30-40) seconds duration. However, it took much longer, approximately 60 seconds to reach this value.

Figure 3.8 HT in and out of the engine [1]

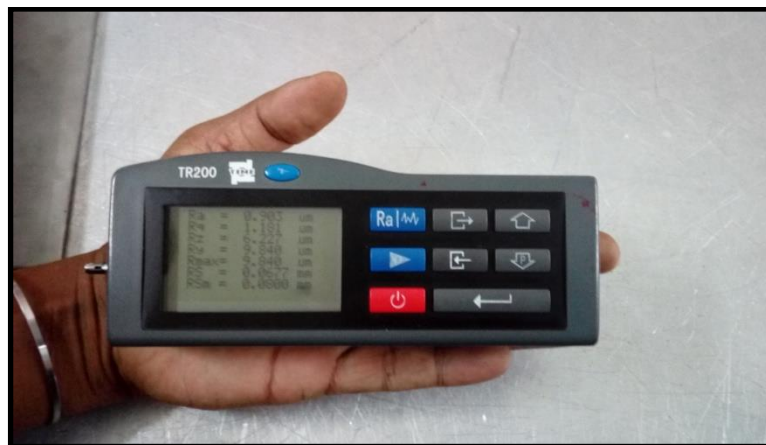
Figure 3.12: Surface Texture Measuring Tool

The aim of this analysis is to examine the surface texture of cylinder liners of Deutz TBD 620 engines. For this analysis, the honing roughness of the Deutz engine was compared with the other types of engines available on-board a FAC in the SLN's MTU 396 engines. During the analysis, six new cylinder liners from the stocks for each brand of engines were examined and the Surface Texture Measuring Tool was used to obtain the readings.

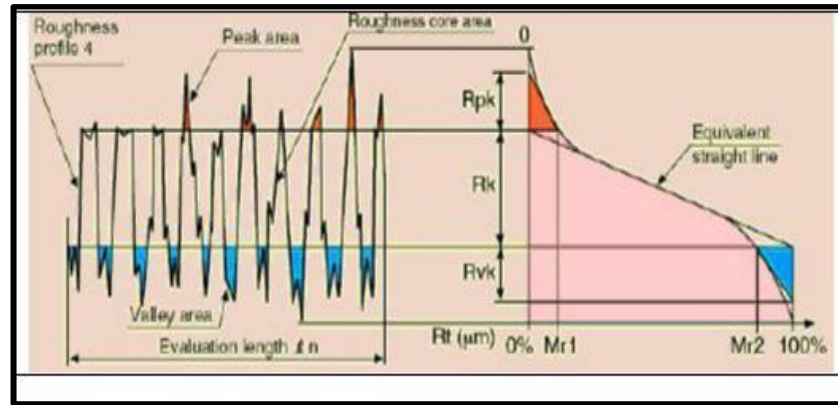
An example of the determination of a honing roughness according Abbott is given in the following figure. This figure shows the roughness of a surface. This roughness can be divided into 3 areas, R_{pk} , R_k and R_{vk} .

Figure 3.13: Abbott Curve -Profile to explain R_k , R_{pk} , R_{vk} [64]

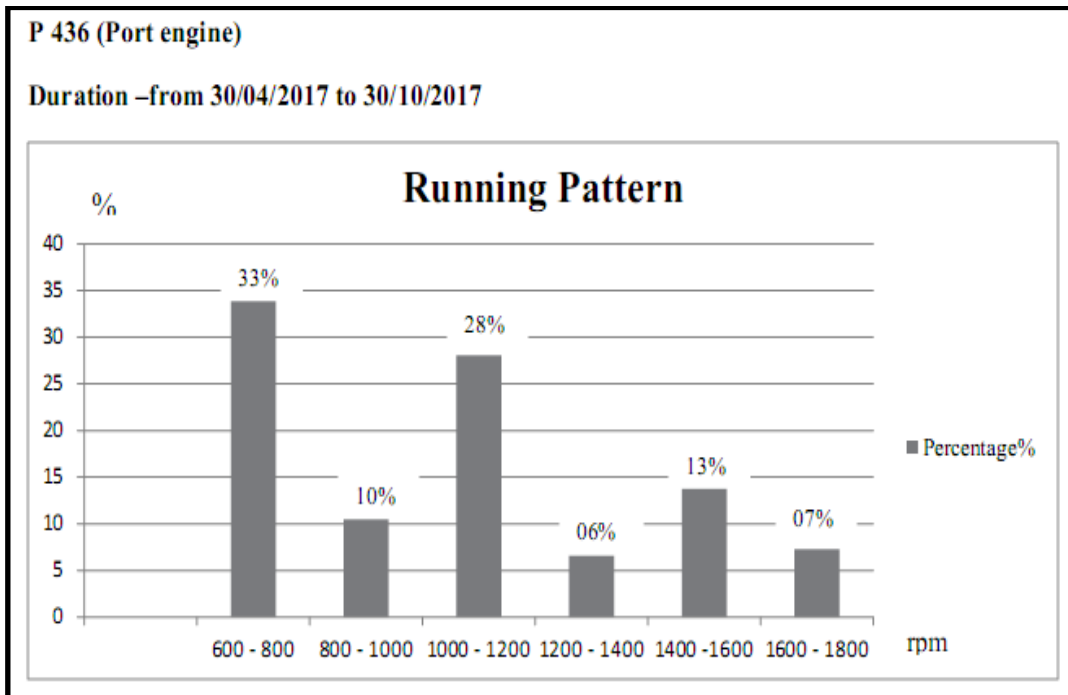
Figure 3.16: Load profile of P 436 Port main engine

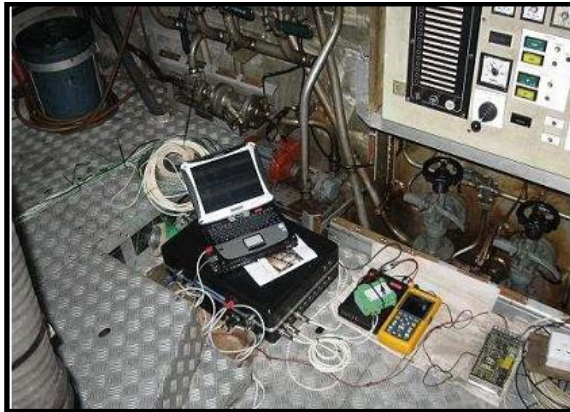
Figure 5.6: Recording final data from Data Logger

After installing on the craft, the cooling water behaviour was checked by installing thermo couples to the cylinder liner. The parameter was recorded by using the data logger. The craft was operated at a steady state condition and load variations. The recorded data is as follows:
