**EFFECTIVENESS OF SUBSURFACE DRAINAGE AND
VEGETATION IN ENHANCING THE SLOPE STABILITY:
A COMPREHENSIVE CASE STUDY ON
BADLUSIRIGAMA LANDSLIDE**

Thesis submitted in partial fulfilment of the requirements for the degree Master of
Engineering in Foundation Engineering and Earth Retaining Systems

Department of Civil Engineering

University of Moratuwa

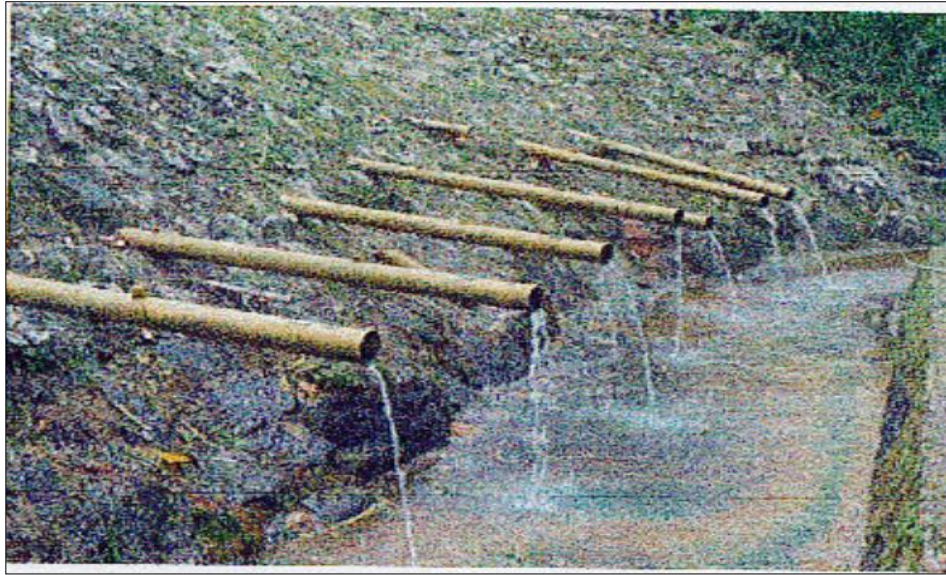
The case study has shown the effective use of long subsurface drains as a drainage blanket beneath the slide to stabilize the slide. Adoption of directional drilling technique has enabled the installation of long drains in compatible with subsurface conditions so as to attain the maximum efficiency. Apart from that, rectification of Watawala landslide is a good example which illustrates the effective use of sub surface geological, hydrological and geomorphological conditions along with the structural measures of slope stabilization. The system of drains function even today although there are some reports of blockages (Figure 2.21).

Figure 2.21: Photograph taken at Watawala in June 2018

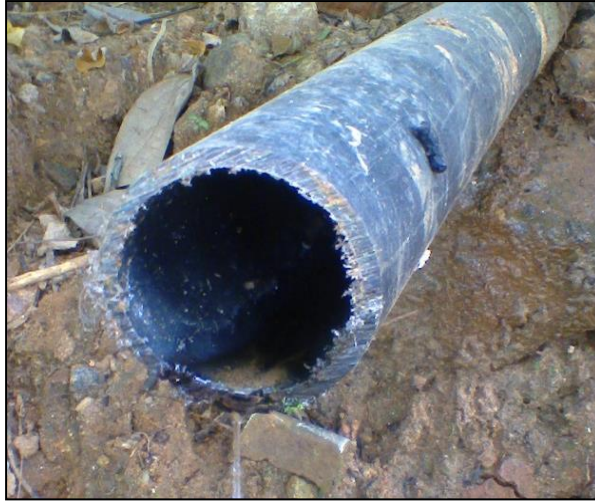
Observations from the piezometers installed in the boreholes were also considered when designing the subsurface drains. Figure 2.23 shows outlet of a subsurface drain installed at the site

Figure 2.23 Outlet of a subsurface drain installed at the site

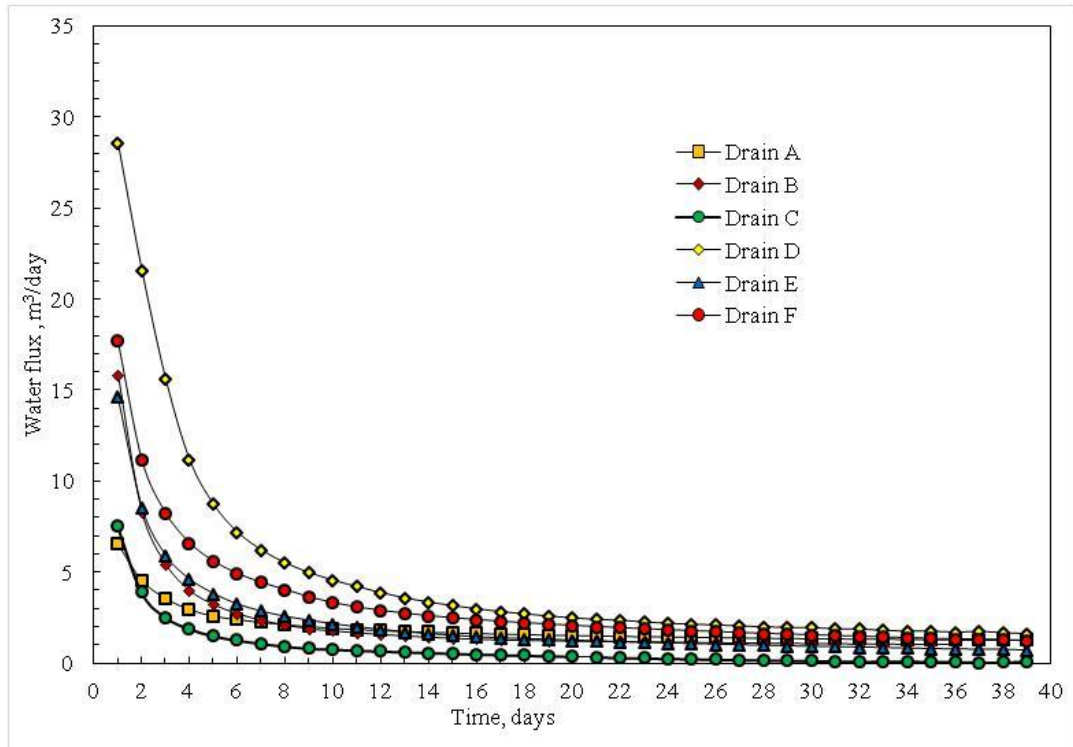
Figure 5.11 Variation of flux rate through drains for Case 1
