**SYSTEMATIC APPROACH TO INTEGRATED MINE
BENCH OPTIMIZATION IN SOIL AND ROCK OF
SRI LANKAN OPEN PIT MINES – A CASE STUDY**

Degree of Master of Engineering

Department of Civil Engineering

University of Moratuwa
Sri Lanka

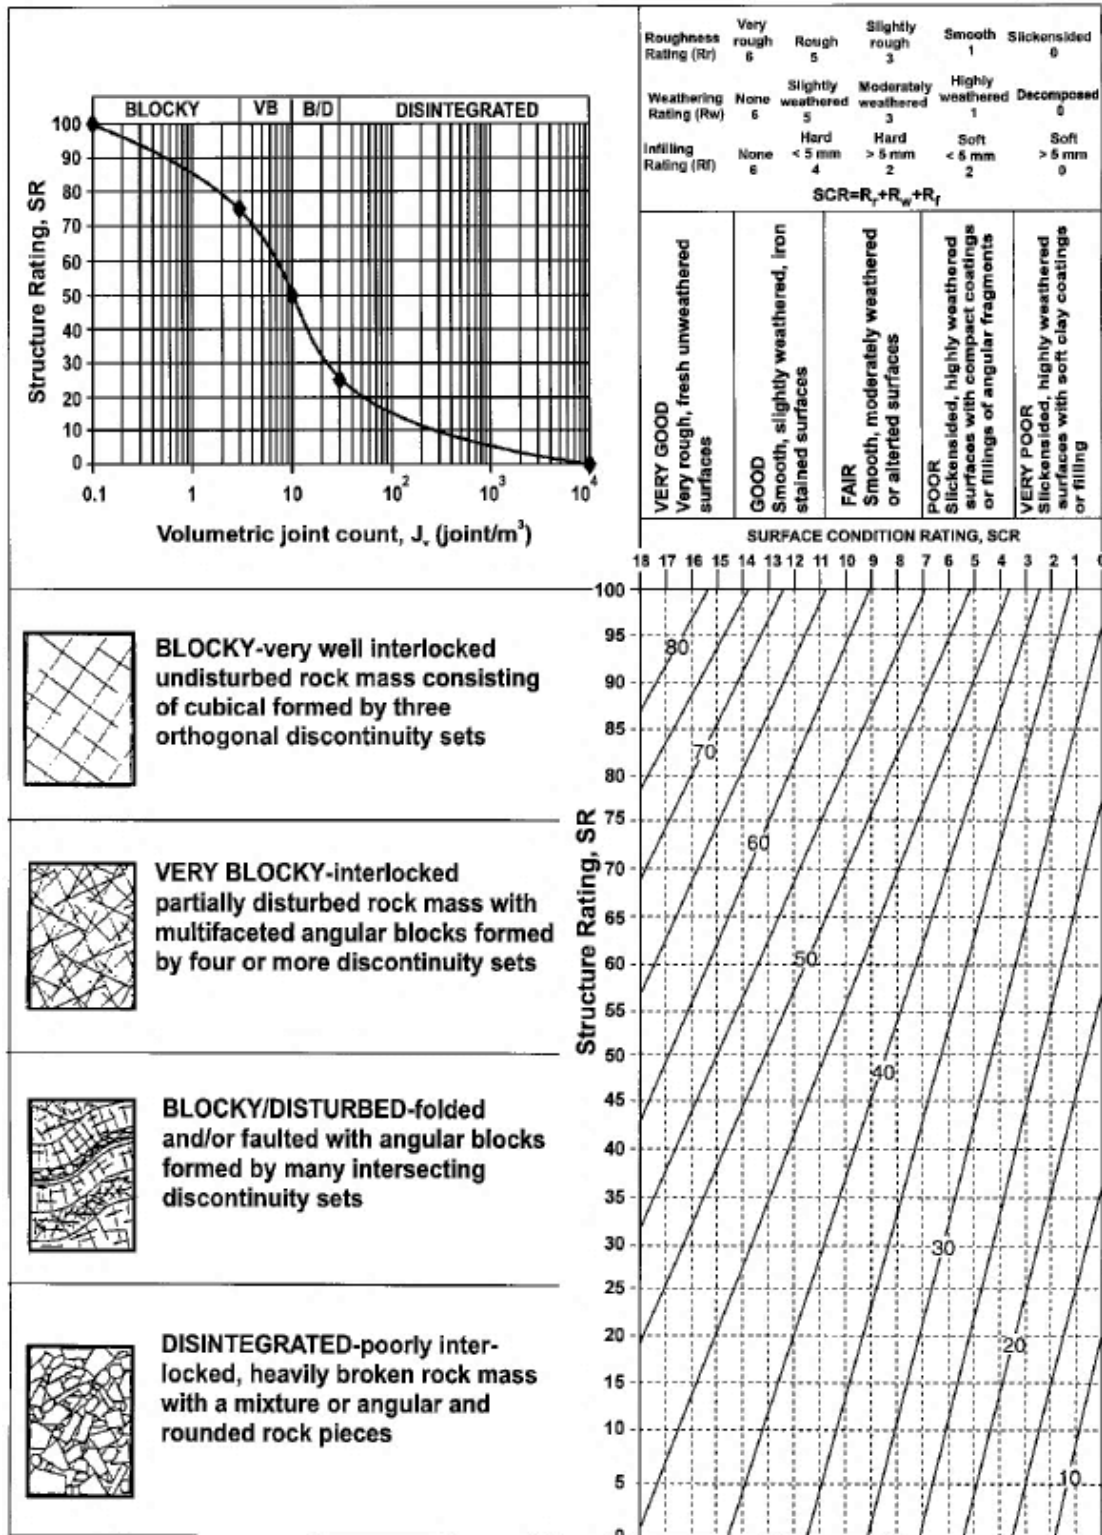
Figure 2-6: The modified GSI classification

The Geological Strength Index (GSI) system facilitates a path to enumerate the strength and the deformation parameters of a rock mass based on visual observation of the rock surfaces and structural geological characteristics of a rock mass. Hoek (1994) and Hoek et al, (1995) presented the Geological Strength Index as a tool for collecting field observations for facilitate strength parameters of rock mass. This system enables to estimate the rock mass quality under different geological conditions by field observations and the Figure 2-6 illustrates the modified Geological Strength Index classification system which was suggested by Sonmez and Ulusay (1999).

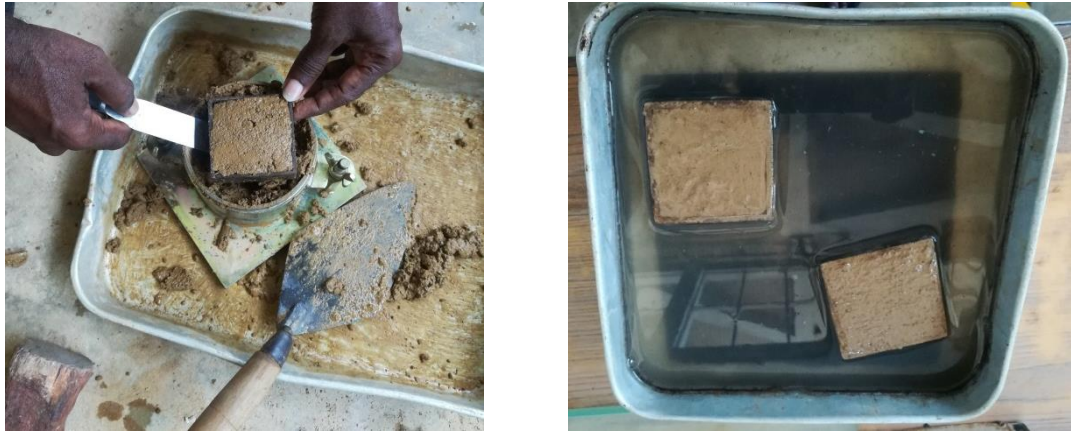
Figure 3-4: Sample preparation for direct shear test

Disturbed soil samples generally do not represent the actual site conditions. But, direct shear test can be carried out for a known density to simulate the natural site conditions. The maximum dry density and the optimum moisture content of the soil in concern can be obtained by conducting the Proctor compaction test. However, soil on the site may not be compacted to a maximum dry density although there is a possibility for compaction up to a certain level due to heavy vehicle movement. Considering this fact and preserving the conservativeness, 95% of maximum dry density was taken as the site compaction level and soil samples were subsequently compacted to achieve 95% of maximum dry density indicated by Proctor compaction test. Compacted soil samples were then collected into the core cutters and were dipped in water for 48 hours to achieve a fully saturated condition before carrying out the direct shear test.

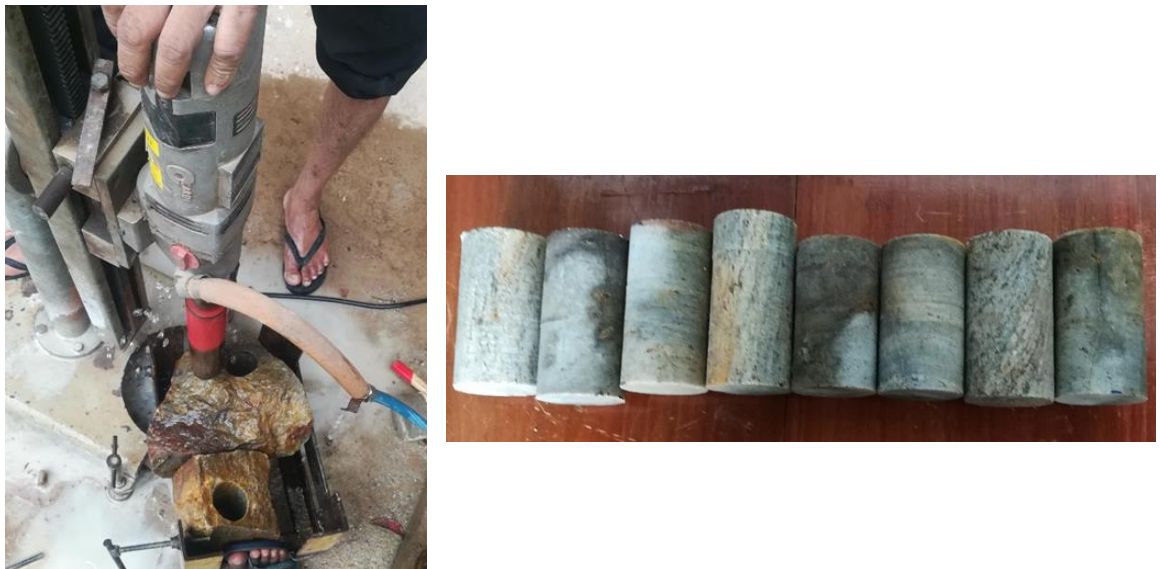
Figure 3-5: Preparation of core sample

60×60×25mm cubic specimens were cut from highly weathered rock samples employing a micro cutter machine. Similar to the procedure for soil samples, highly weathered rock samples were also saturated before performing the direct shear test. Further, rock core samples of diameter 5 cm and height 10 cm were obtained using a mobile rock core cutter to perform UCS test.

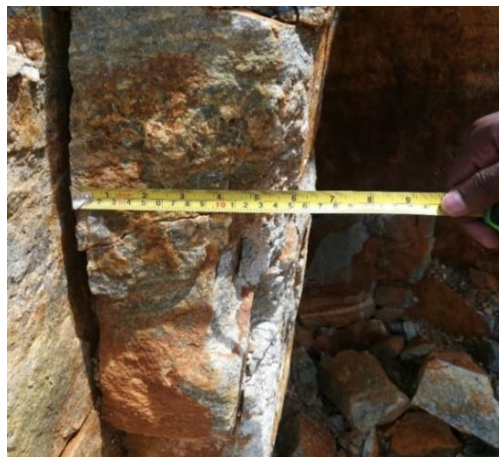
Figure 3-14: Measuring of joint sets spacing

Spacing within a joint set is approximately same, but when there are several joint sets with the same dip, measuring of joint spacing was much more difficult. In such cases, the joint spacing was drawn to scale and the joint sets were differentiated.

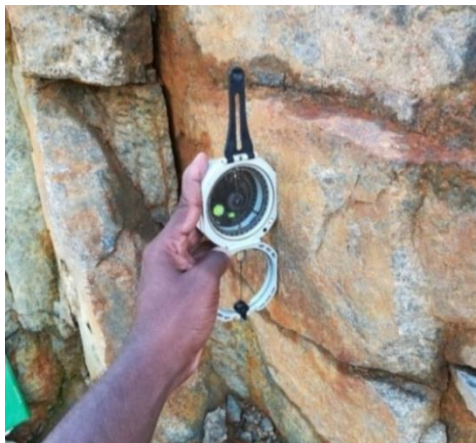
Figure 3-17: Measuring of dip angle of discontinuity

To measure the dip of the discontinuity plane, compass was put with its side against the rock (Figure 3-17). It was done easily by rotating the compass by 90 degrees angle. Then clinometer was rotated until tube bubble was centered. After centering, clinometer value was recorded as the dip of the discontinuity.

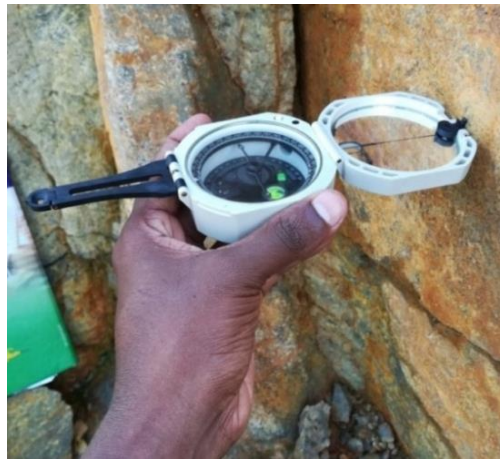
Figure 3-18: Obtaining of dip direction

To obtain dip direction, compass front was directed to the dipping direction of the discontinuity (Figure 3-18). Then needle direction was measured as SW, NW, NE, SE etc. The field observation sheets of discontinuities are attached in the ANNEX - C.

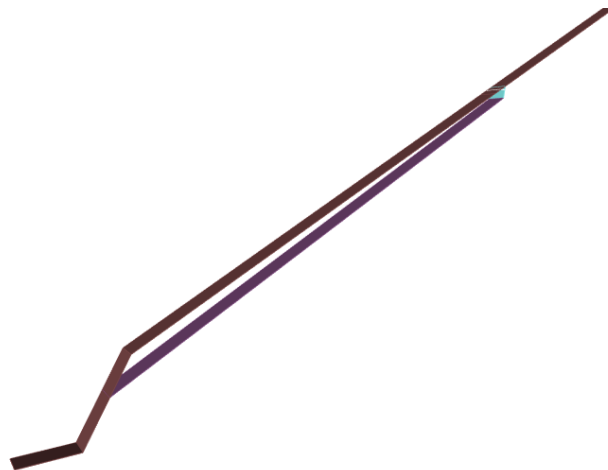
Figure 3-25: Isometric view of slope geometry.

Isometric view of slope geometry can be seen (Figure 3-25). Thereafter properties of slip surface and tension crack would be input (Figure 3-26) and ground water condition should be defined (Figure 3-27). There after rock slope analysis is carried out by the software (Figure 3-28).

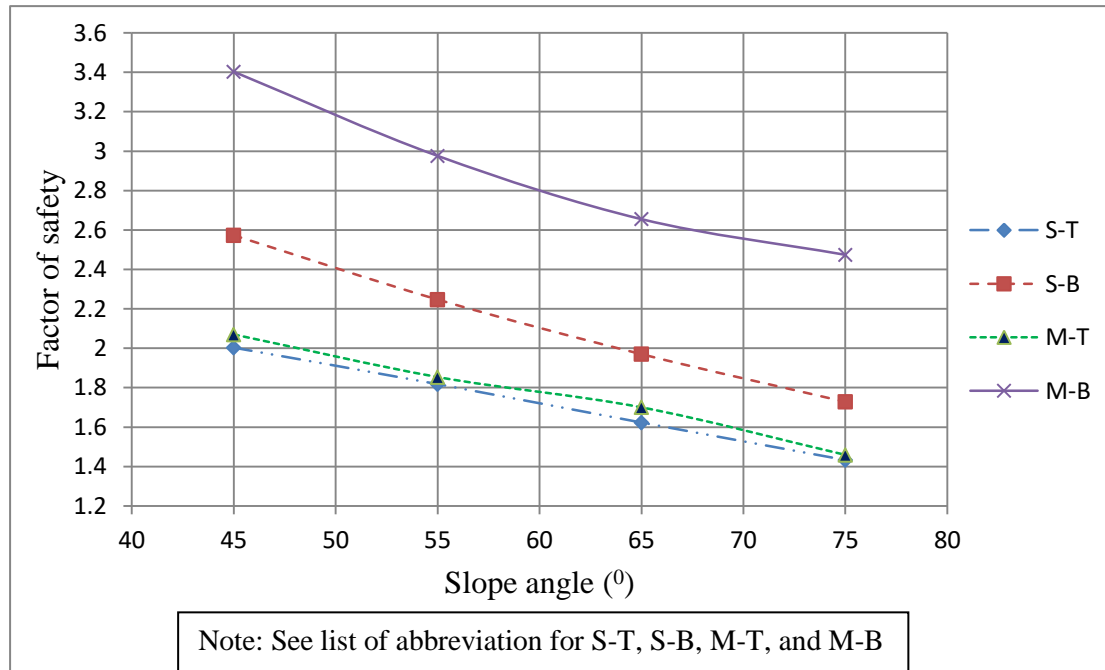
Figure 5-2: Variation of factor of safety with bench angle

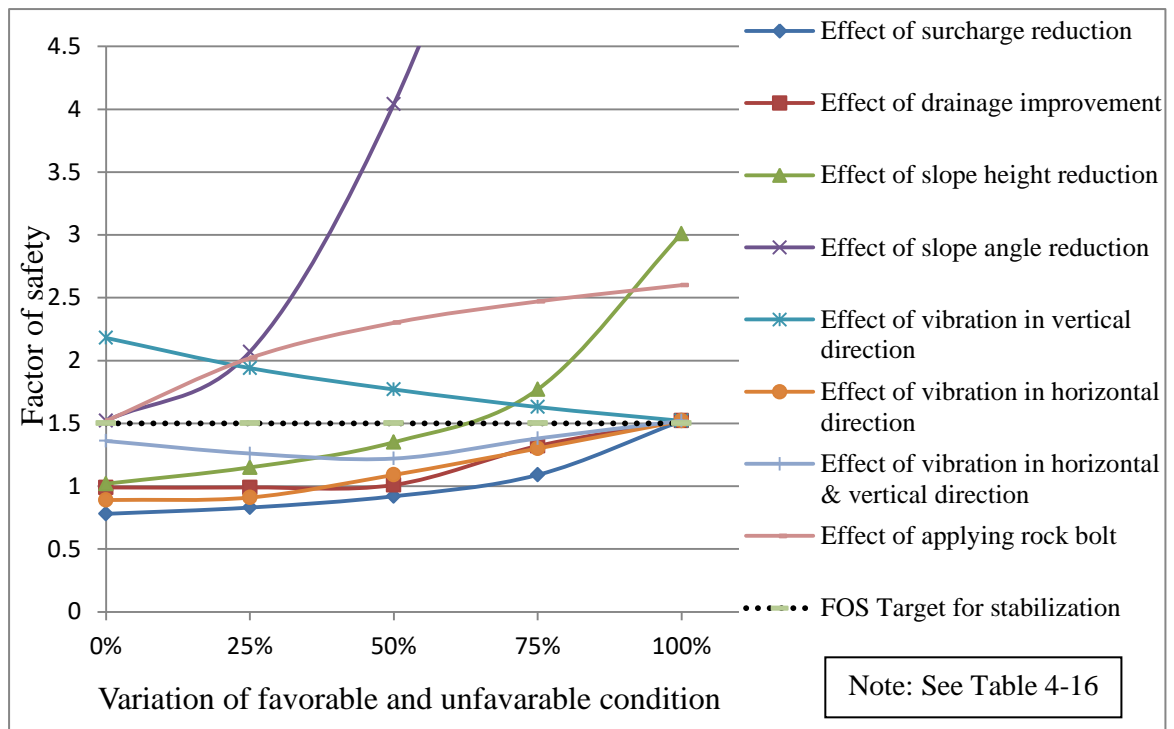
Figure 5-9: Variation of factor of safety with percentage improvement of favorable and unfavorable conditions for wedge failure

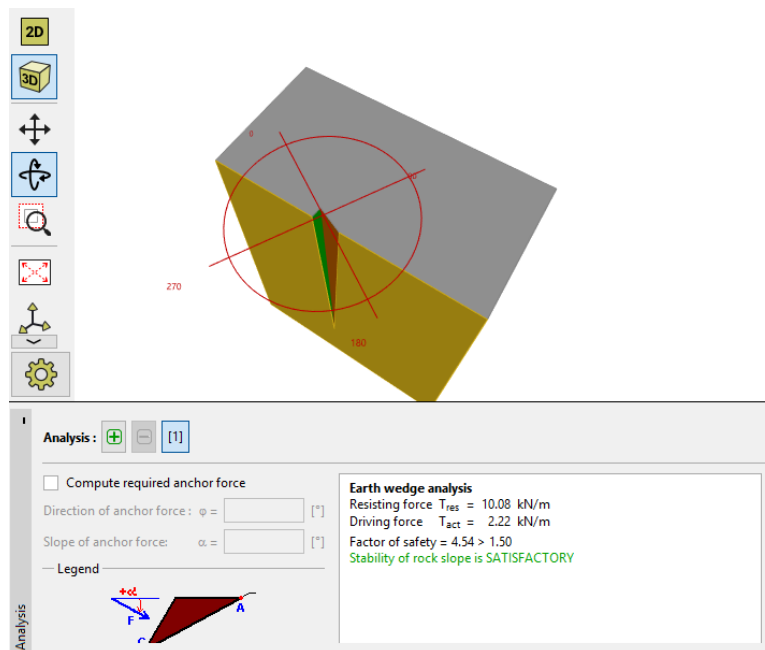
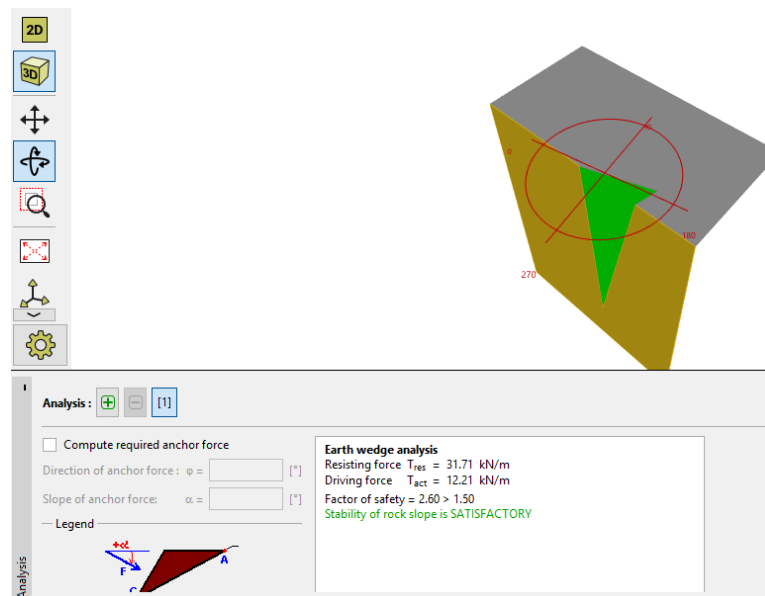
Stability analysis without both surcharge and ground water table
