**CRITICAL EVALUATION ON WATERPROOFING  
PRACTICES IN THE INDUSTRY**

Department of Mechanical Engineering

University of Moratuwa

Thesis/Dissertation submitted in partial fulfillment of the requirements for  
the degree of Master of Science in Building Services Engineering

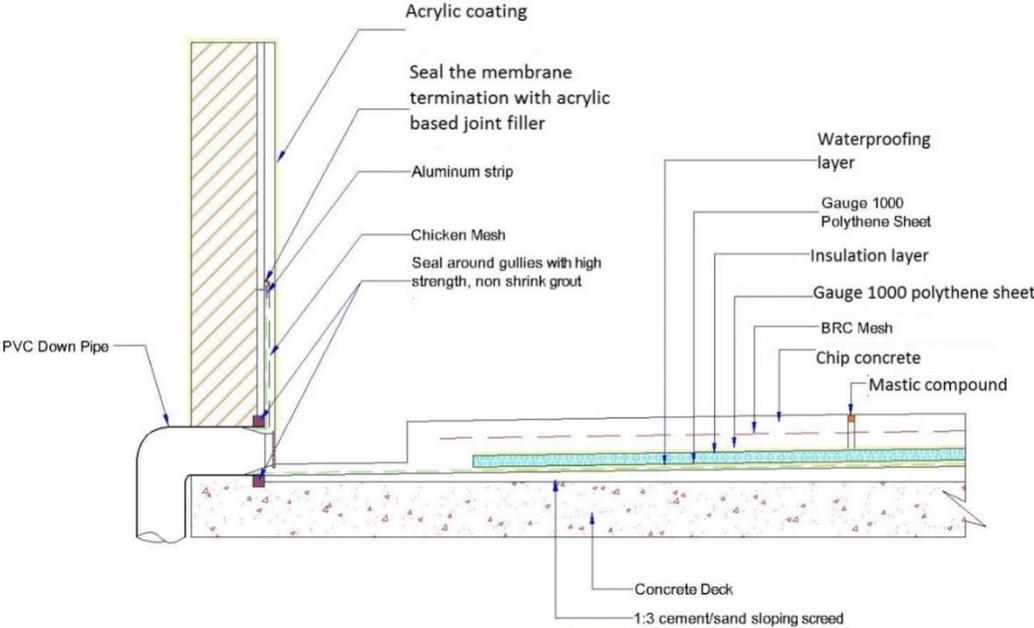
Figure 2-2 : Rooftop Waterproofing

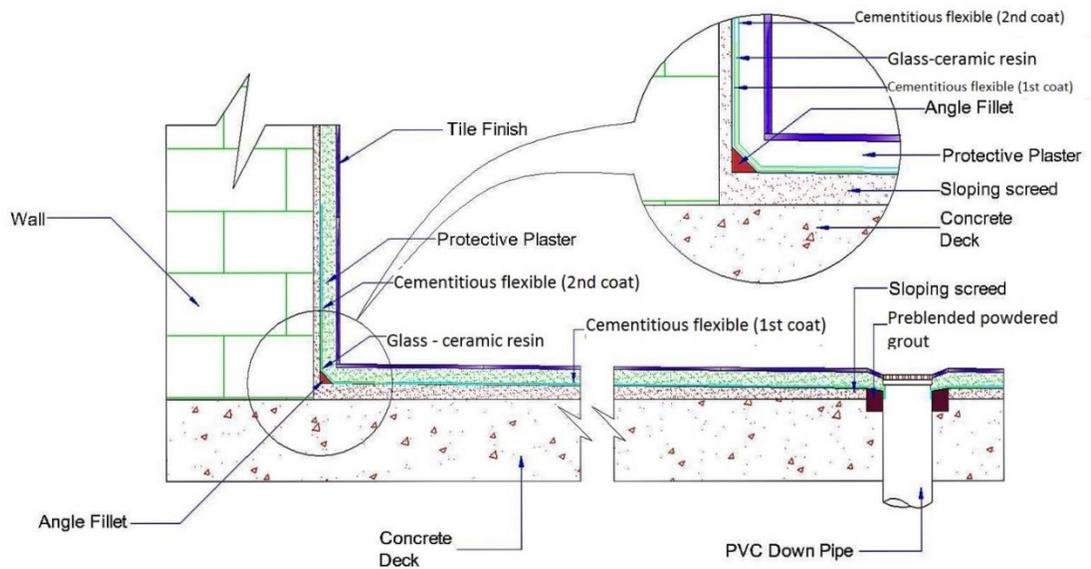
Figure 2-4: Waterproofing of Bathrooms and Toilets (Single Layer System)

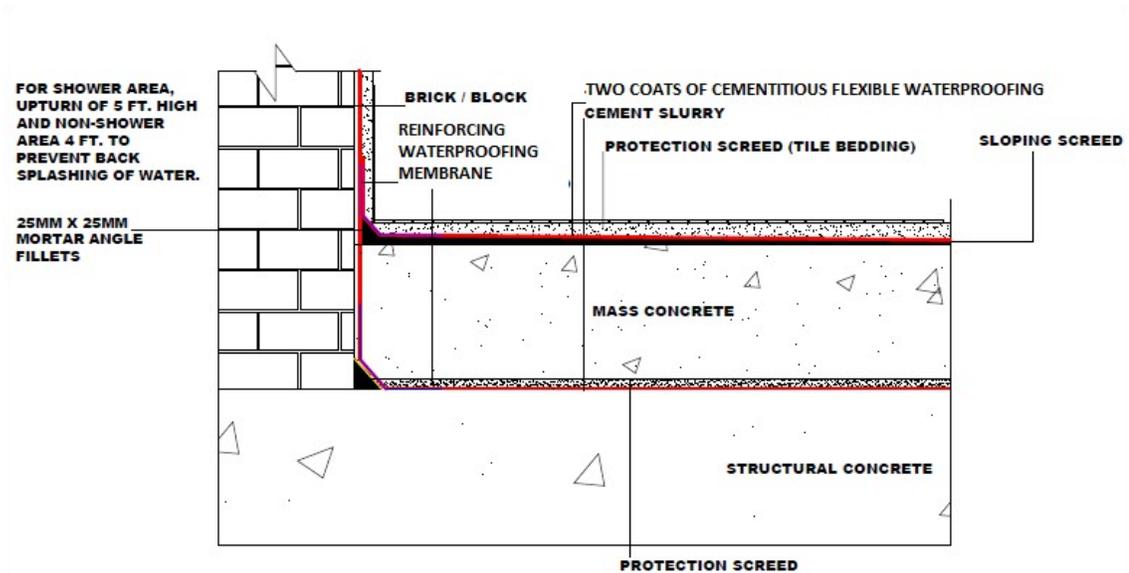
Figure 2-5: Waterproofing of Bathrooms and Toilets (Double Layer System)

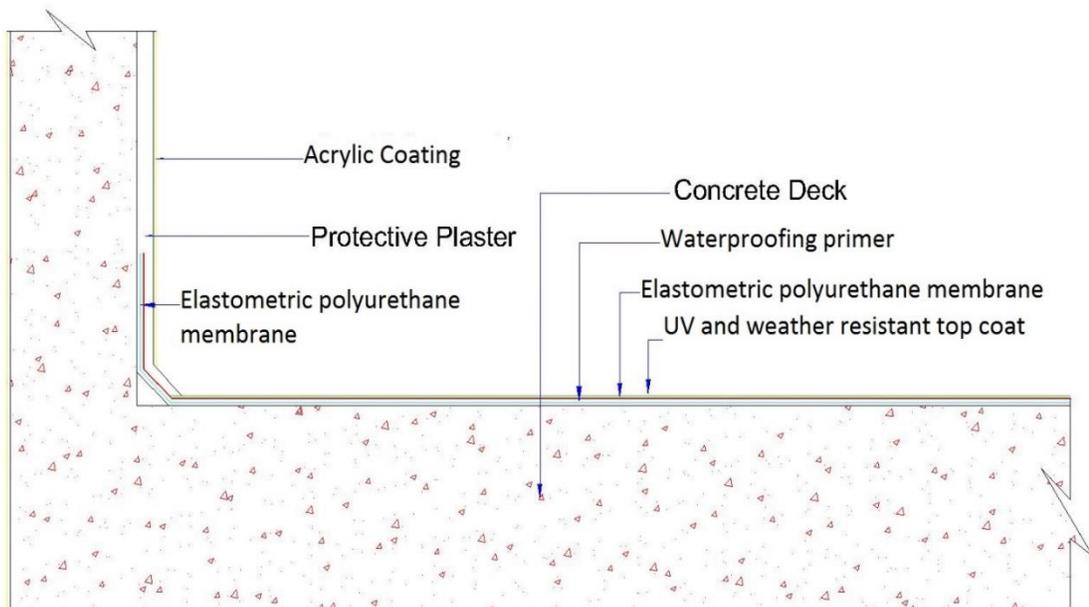
Figure 2-6: Waterproofing of Exposed Driveways and Ramp Slabs

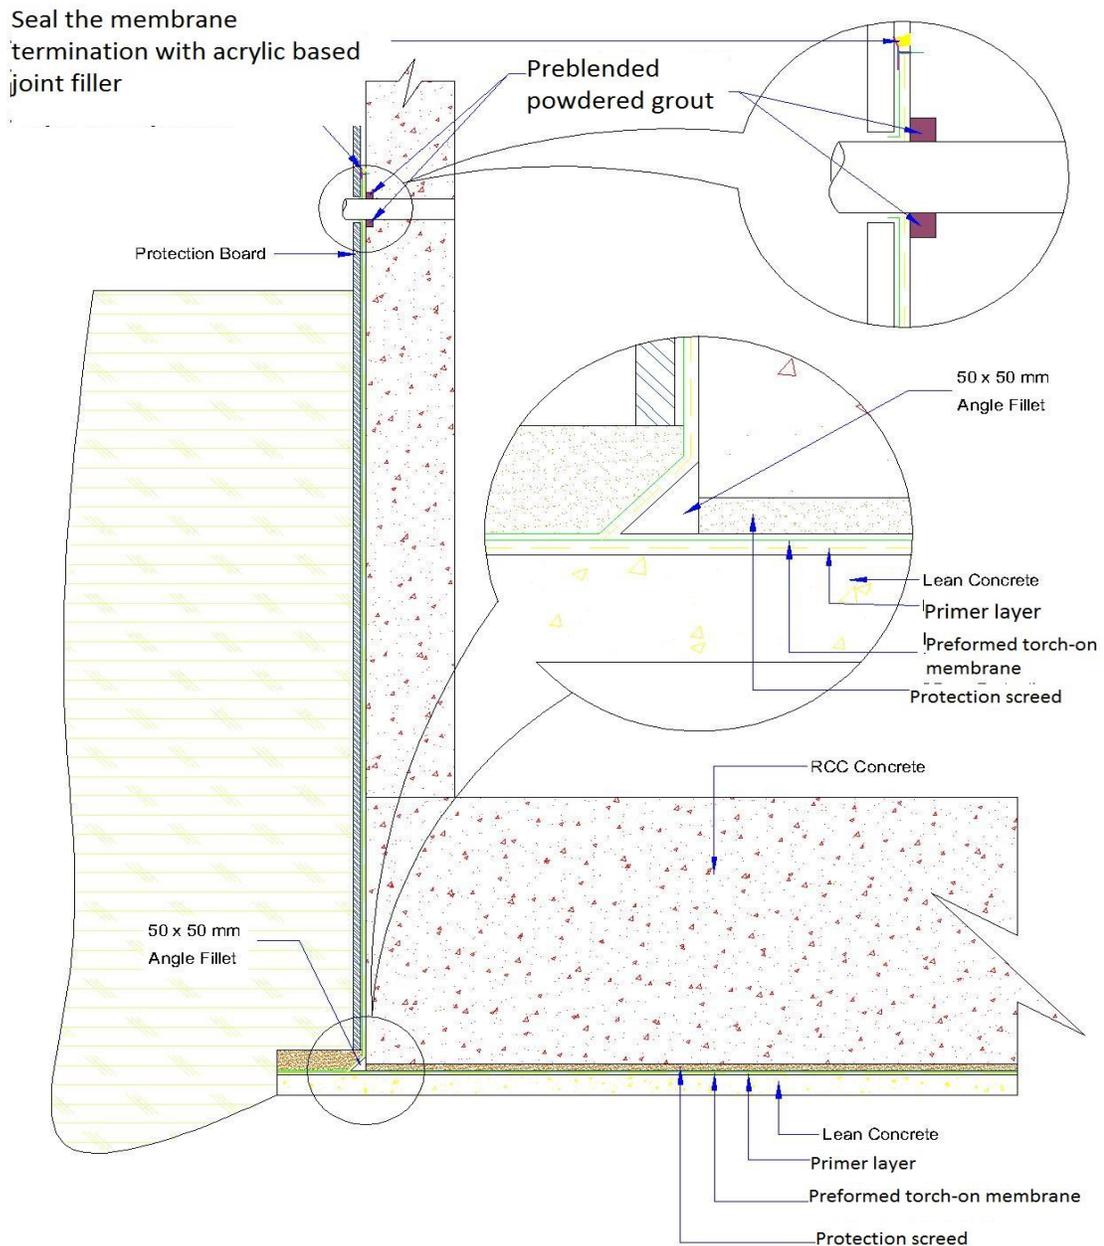
Figure 2-7: External Waterproofing of Basements, Underground Sumps, Swimming Pools, Lifts, Tanks and Reservoirs

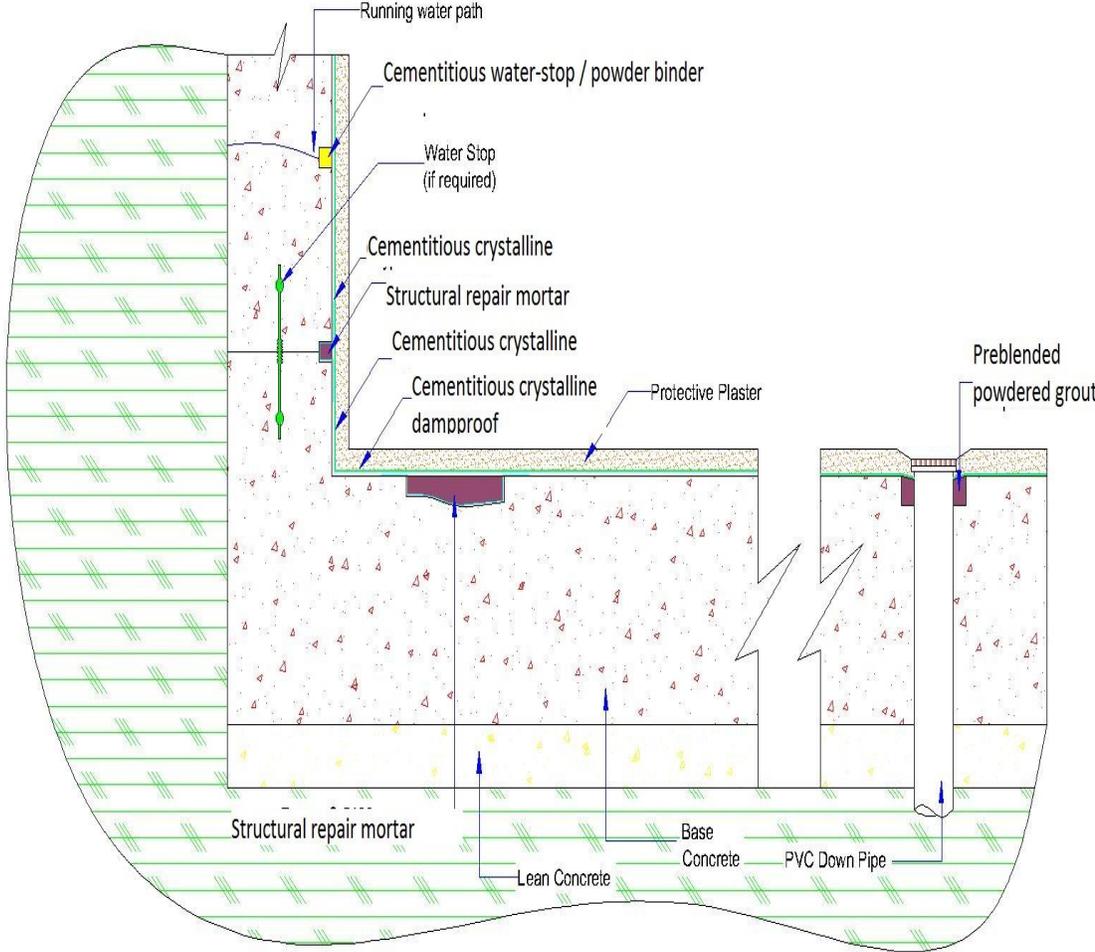
Figure 2-8: Internal Waterproofing of Basements, Underground Sumps, Swimming Pools, Lifts, Tanks and Reservoirs

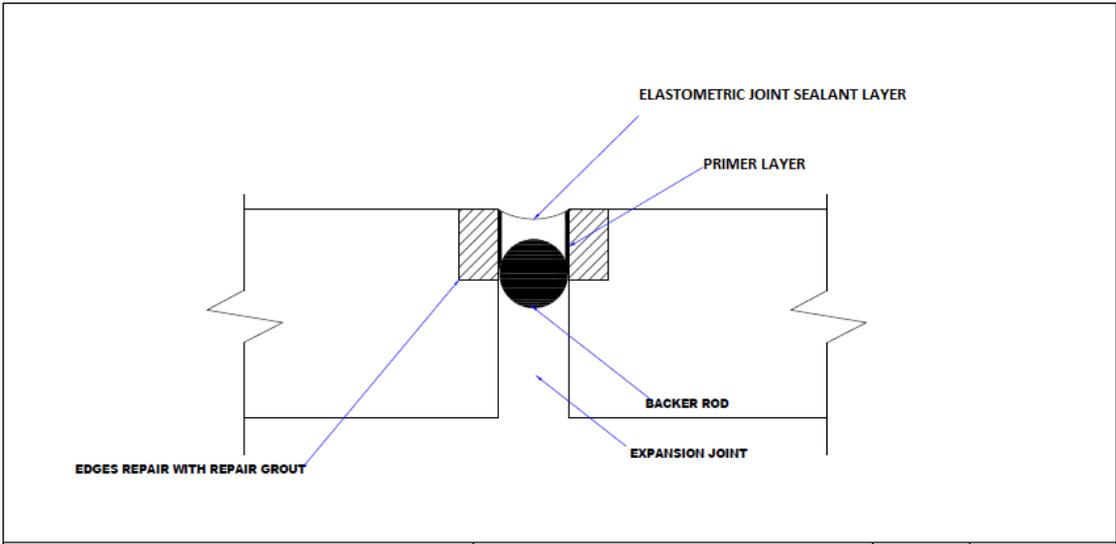
Figure 2-9: Sealing of Expansion Joints

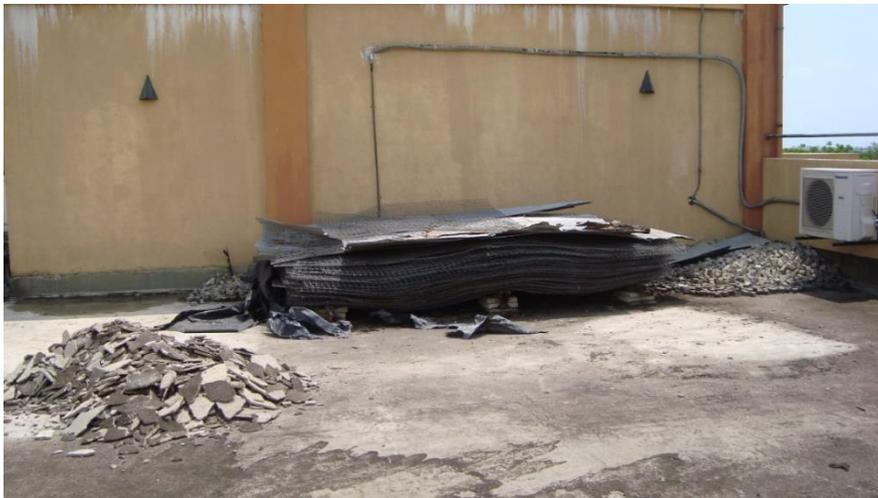
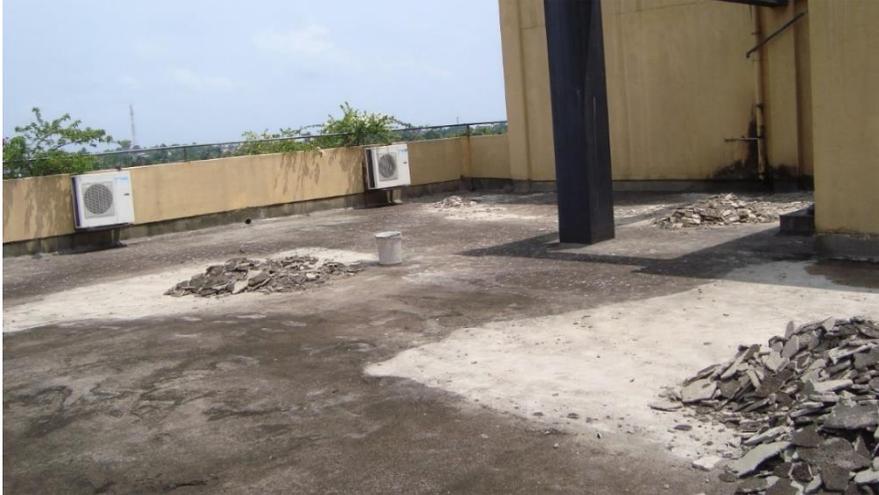
Figure 4-1: Deteriorated surface of the rooftop of the Mechanical Engineering Department new building - 1

Figure 4-2: Deteriorated surface of the rooftop of the Mechanical Engineering Department new building - 2

In this case, ponded water collected beneath the floor surface was removed by breaking into the surface. This is a good example of addressing the root cause itself. Other measures would not have sufficed here.

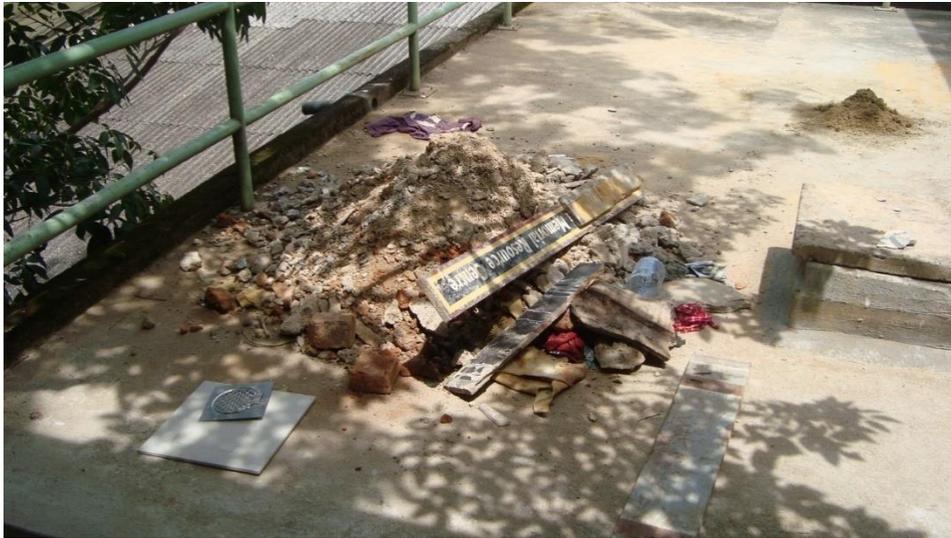
Figure 4-10: Remedial action taken to prevent water leakage

In the following figure, the remedial action needed was very simple. That included only the placement of a covering, in this case a piece of slab over the location which leaked water into the canteen located beneath this surface.

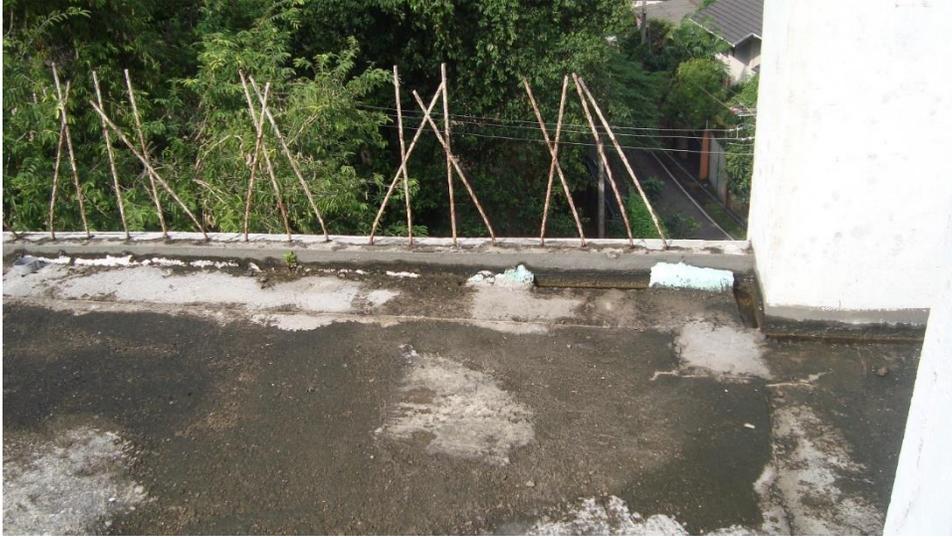
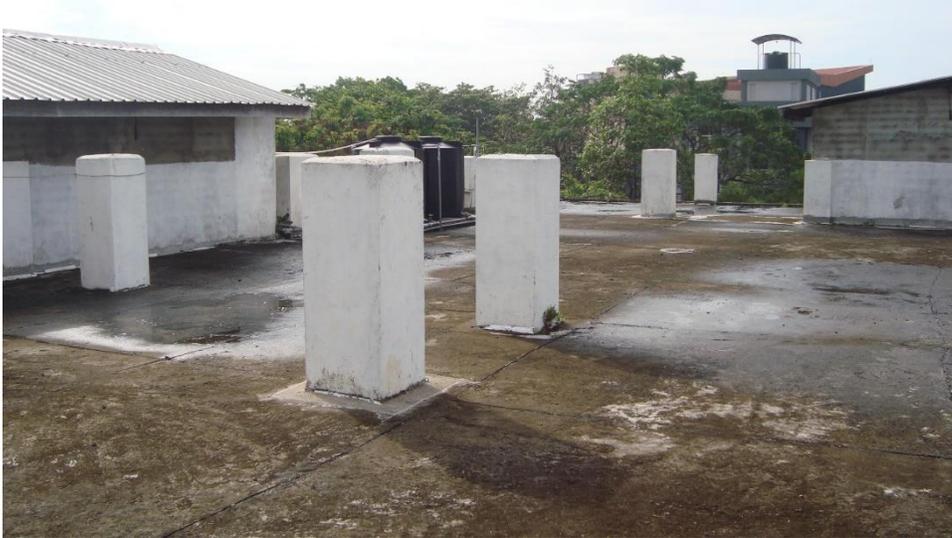
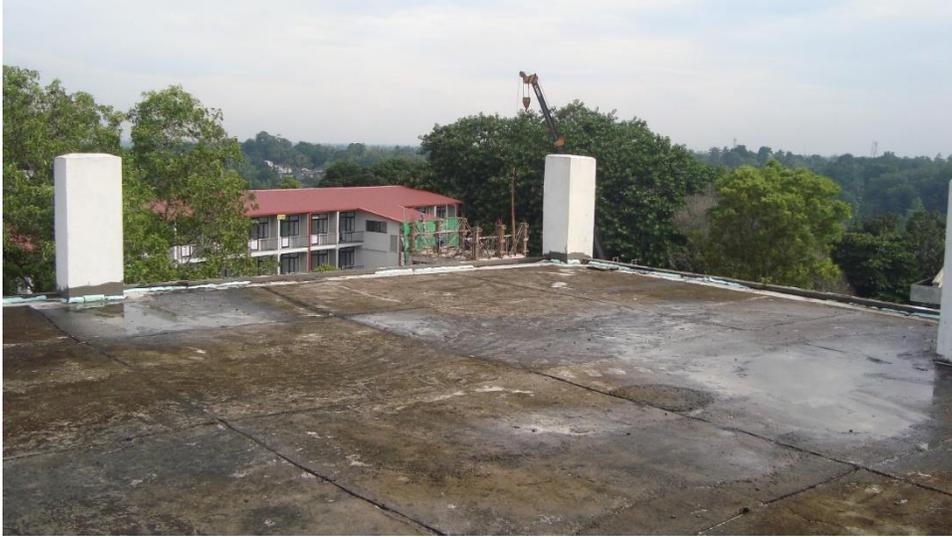
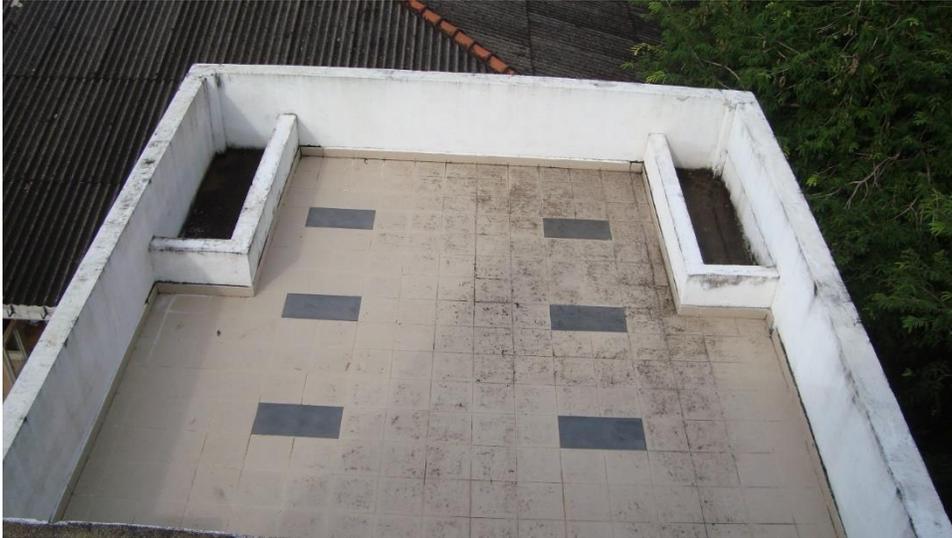
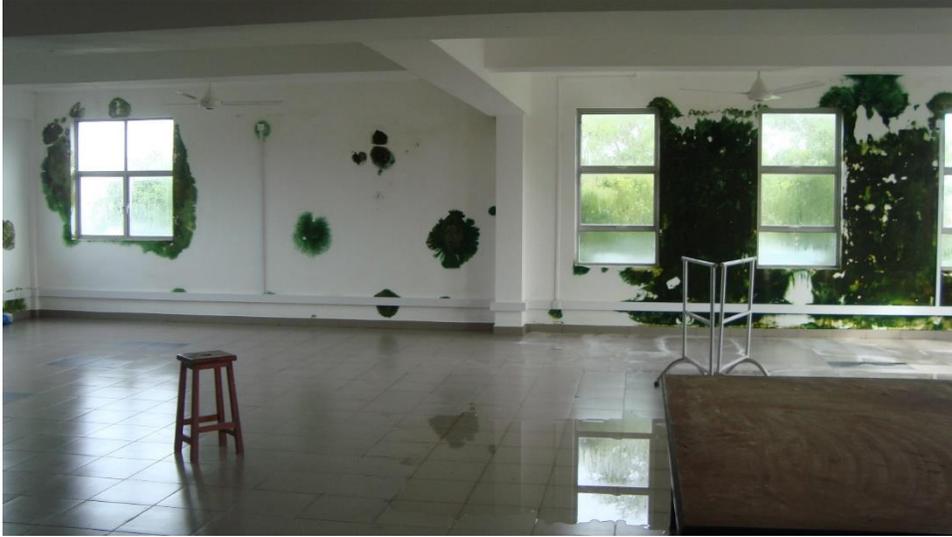
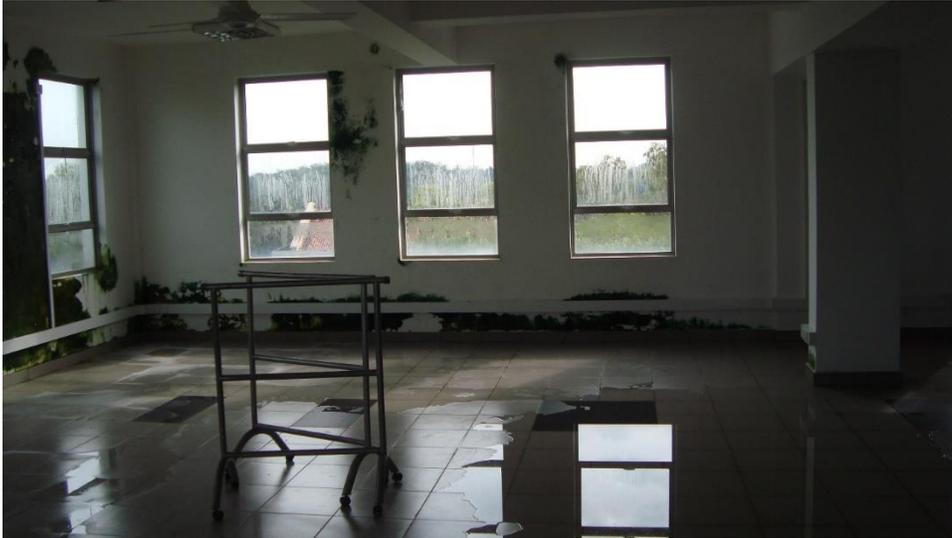
Figure 4-11: Deteriorated surface of the new building of the Textile Engineering department - 1

Figure 4-12: Deteriorated surface of the new building of the Textile Engineering department - 2

Figure 4-13: Deteriorated surface of the new building of the Textile Engineering department - 3

Figure 4-14: Deteriorated surface of the new building of the Textile Engineering department - 4

Figure 4-15: Deteriorated surface of the new building of the Textile Engineering department - 5

Figure 4-16: Deteriorated surface of the new building of the Textile Engineering department - 6

- Upper floors of the new building of the Department of Textile Engineering. Here the problem identification took more than two to three tries by the contractor. Then a specialist in the field was recruited to find the root cause and address the issue. The design itself had not provided for sufficient drainage. Stagnant water ponds on the rooftop was the cause for the issue in the whole building. Remedying that fixed the issue completely.

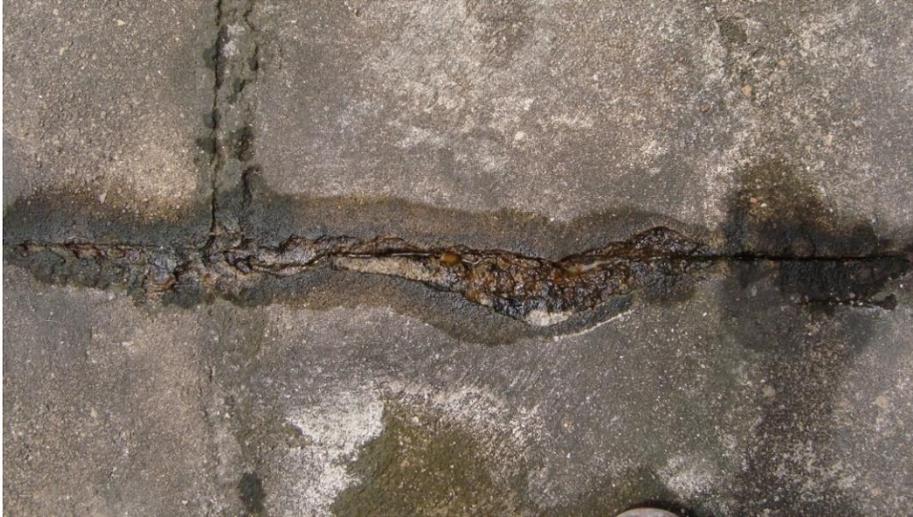
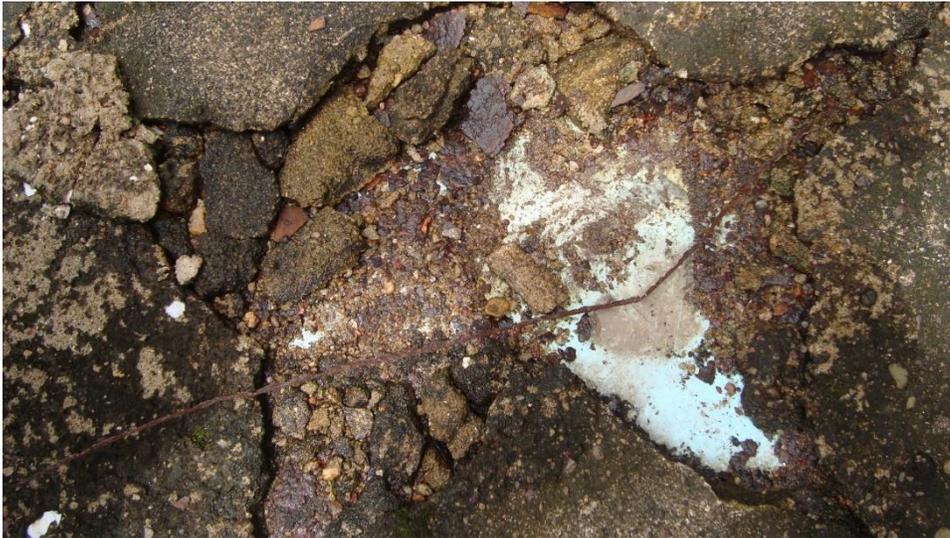
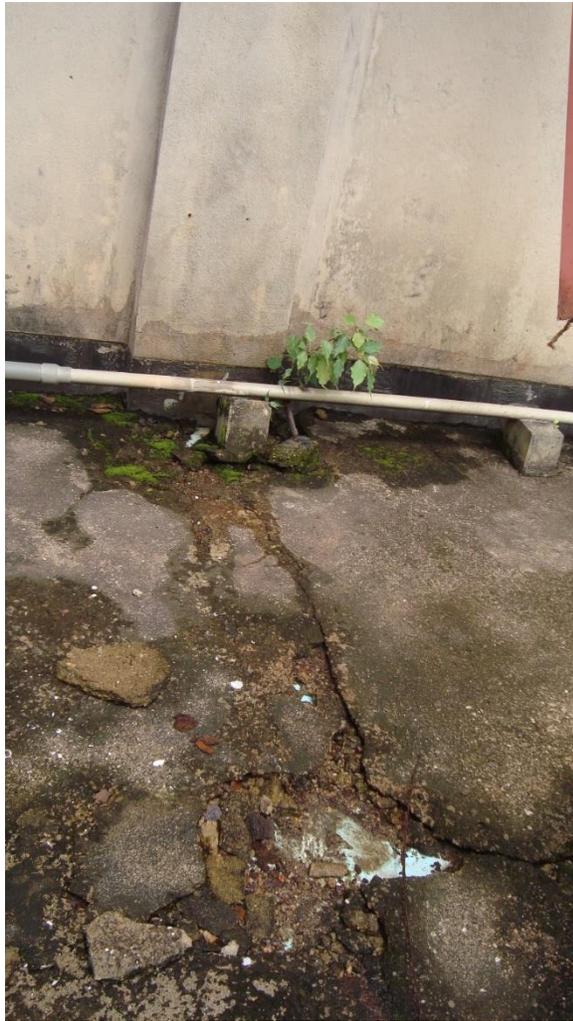
Figure 4-19: Deteriorated surface of the rooftop of the IT faculty old building - 1

Figure 4-20: Deteriorated surface of the rooftop of the IT faculty old building - 2

Figure 4-21: Deteriorated surface of the rooftop of the IT faculty old building - 3

- Washrooms and rooftops of the old building of the IT Faculty. The waterproofing component was not addressed by the contractor after the building was handed over to the client. Therefore, the issue was left for the client to address.

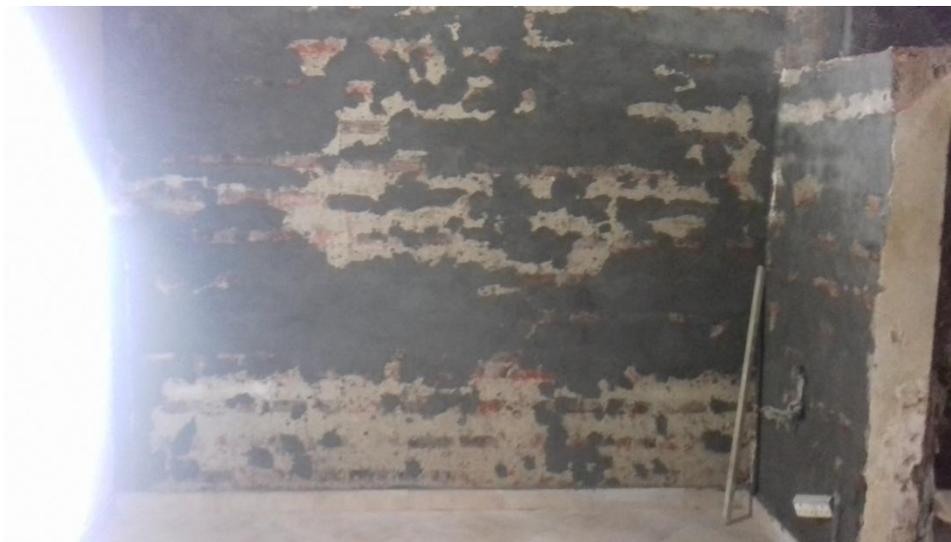
Figure 4-22: Initial surface with the deteriorated plaster chipped off and catch up plaster applied

1. The deteriorated plaster was chipped off.
2. Catch up plaster was applied for inspection.

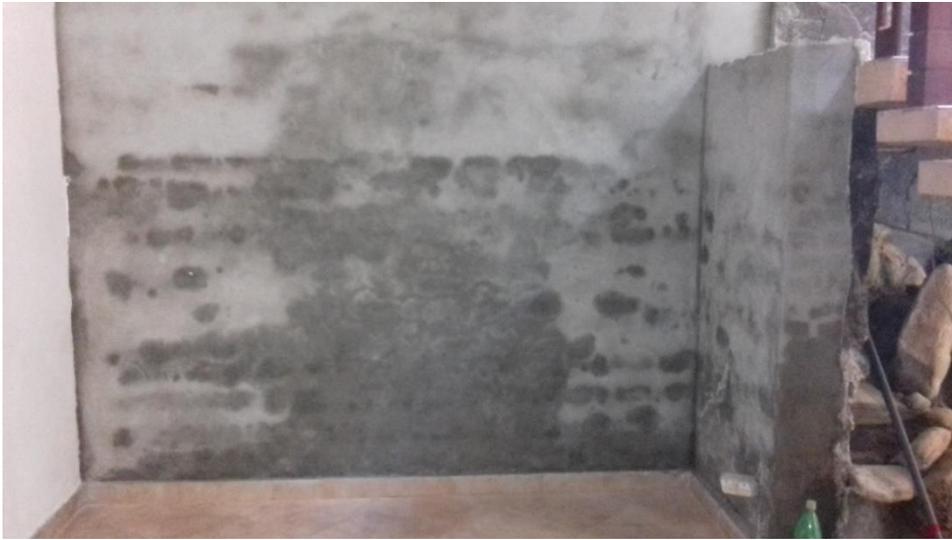
Figure 4-23: After surface preparation for waterproofing

3. Surface preparation was done by applying a thin plaster to prepare the surface for waterproofing.

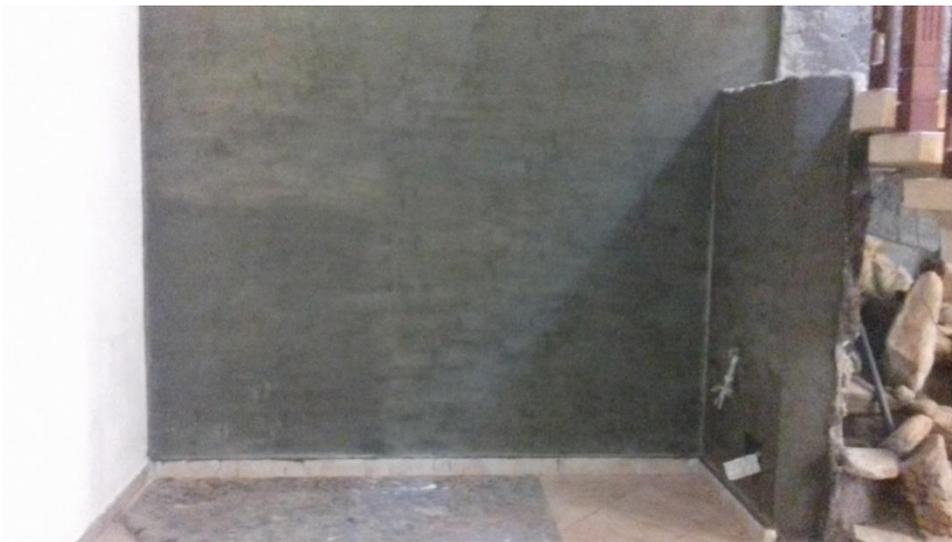
Figure 4-24: After application of waterproofing

4. The waterproofing product was applied.

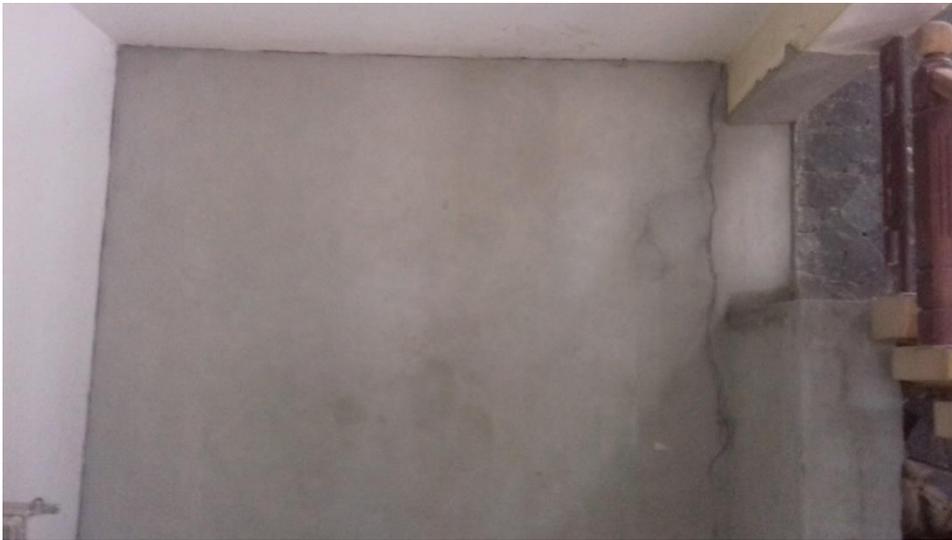
Figure 4-26: After application of cover plaster - 2

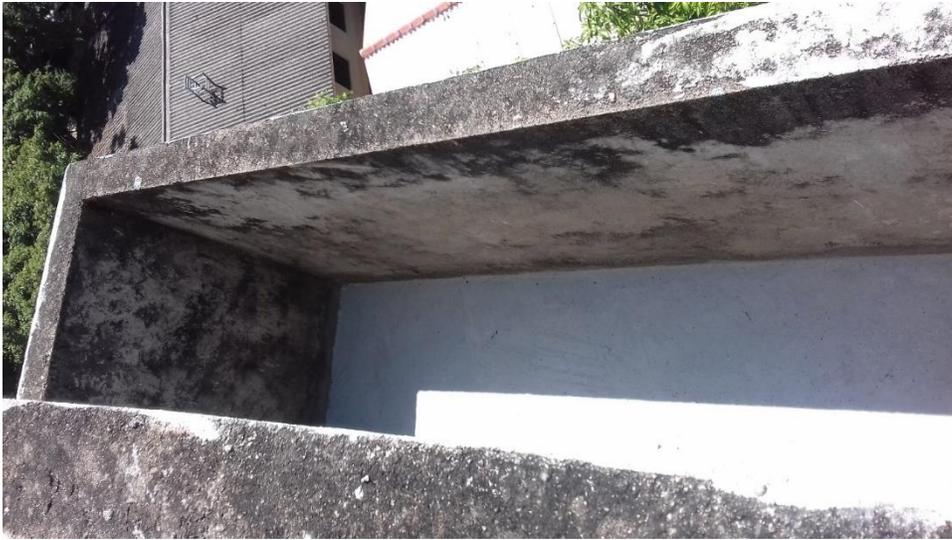
Figure 4-29: Another problematic inaccessible narrow strip of slab area

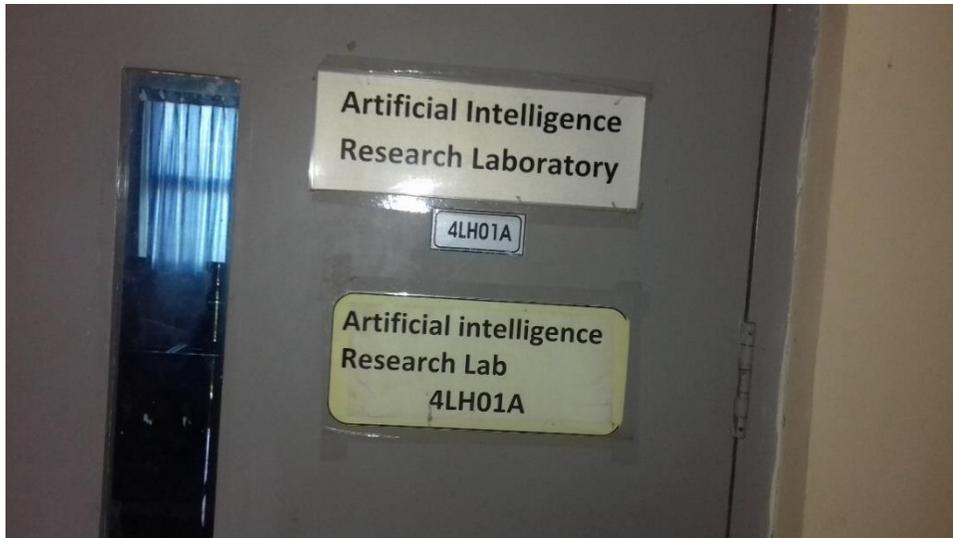
The open slab area above tends to retain water after a heavy rain or such as proper means for drainage have not been allocated initially. Due to this holding of water, the collected water leaks on to the labs situated under that area.

Figure 4-31: Labs onto which water leaks from the considered area

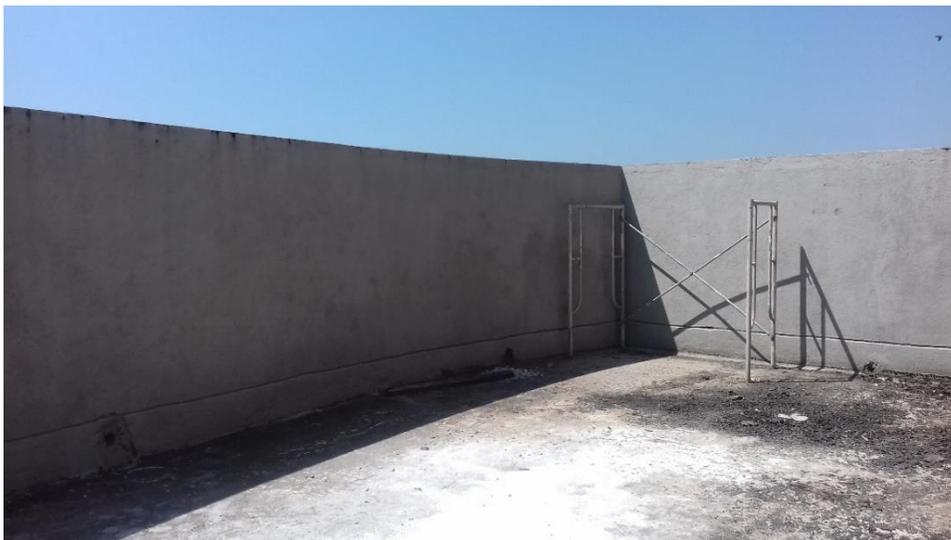
Moreover, a health hazard also comes to play due to the breeding of mosquitoes in the retained water.

Figure 4-32: The area poses a health issue by being a breeding ground for mosquitoes

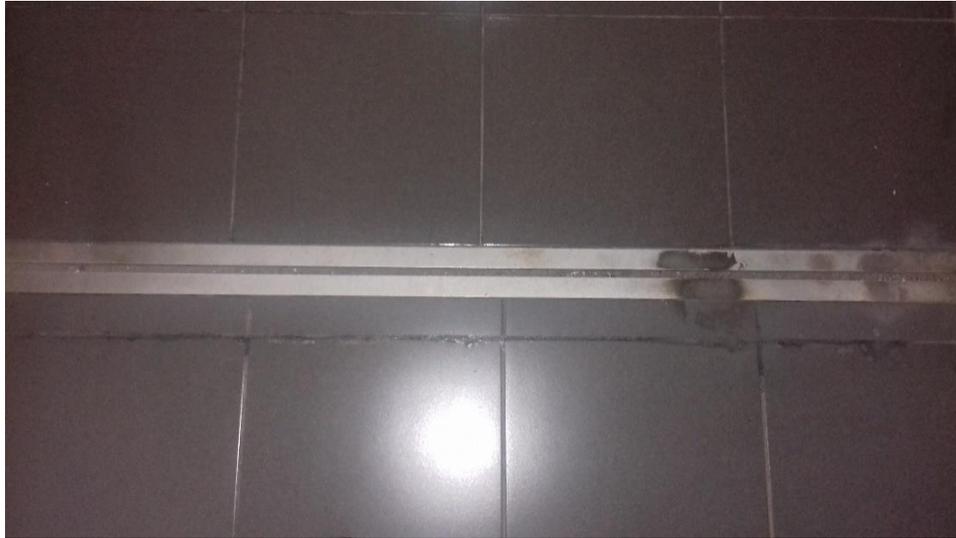
Figure 4-45: Construction joint line in floor level of 7<sup>th</sup> floor

Case Study IV was conducted at Flower Court House apartment complex comprising of ground plus seven floors located in Colombo 07. A waterproofing issue was brought to light in the building when water from the rooftop started to leak through the walls to the lower floors. Here, passive waterproofing design at construction joints at initial stages would have prevented this issue from occurring.

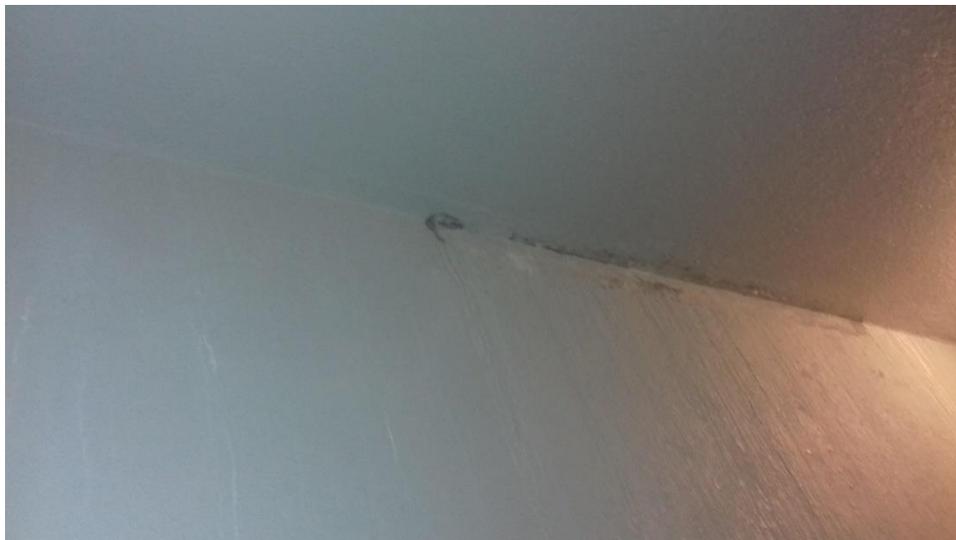
Figure 4-46: Water seepage from construction joint line at slab level of 7<sup>th</sup> floor -

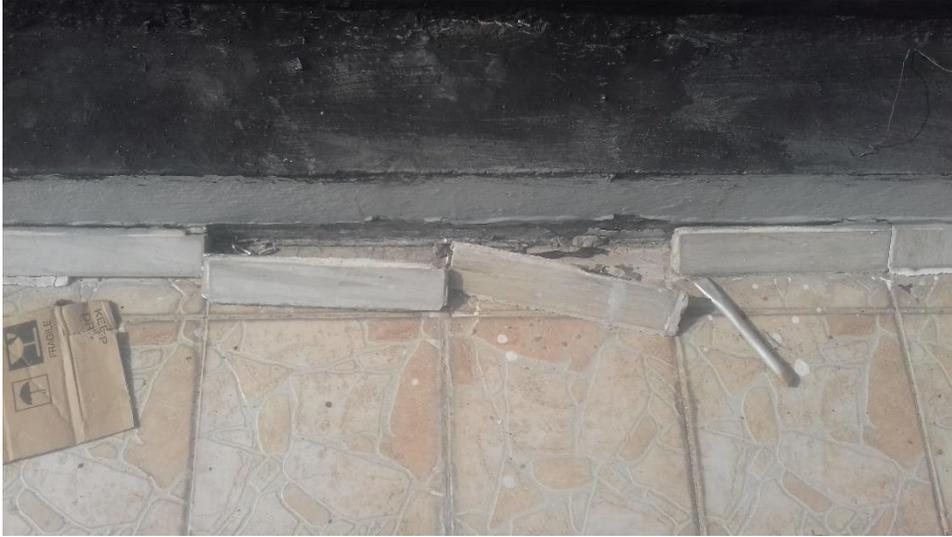
Figure 4-51: Rooftop deteriorated tile skirting expelled

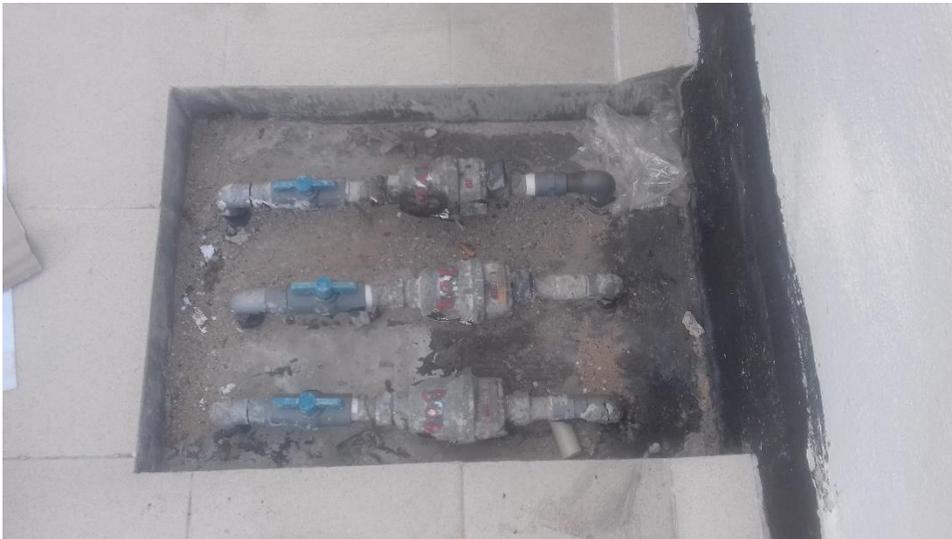
Figure 4-52: Rooftop location of water meters prone to collection of water

In the following figure, the area is waterproofed using applicatory methods and apart from that as an additional precaution another drainpipe is put in place to drain out any water that may otherwise turn stagnant after years of collection. This is a good example of passive waterproofing in practice.

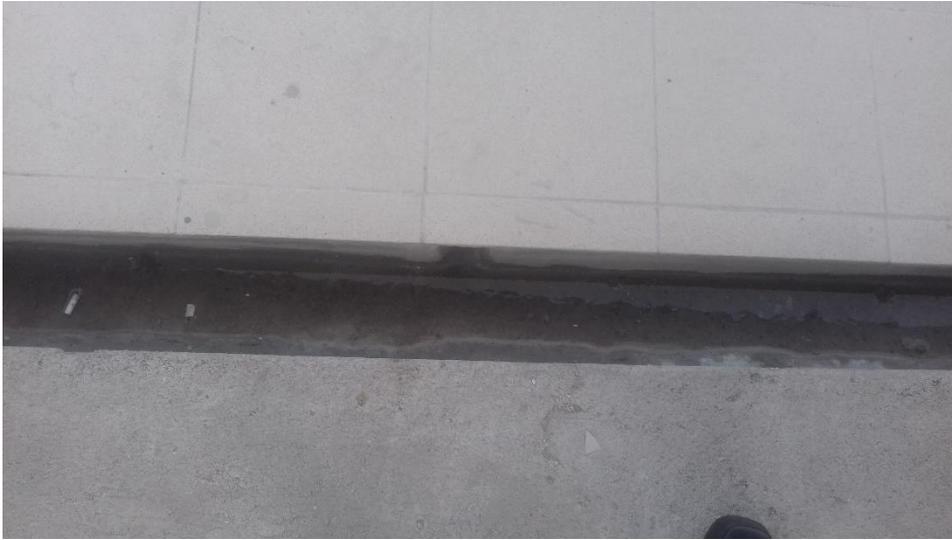
Figure 4-56: Rooftop drains into which water gets drained beneath the tile surface - 2

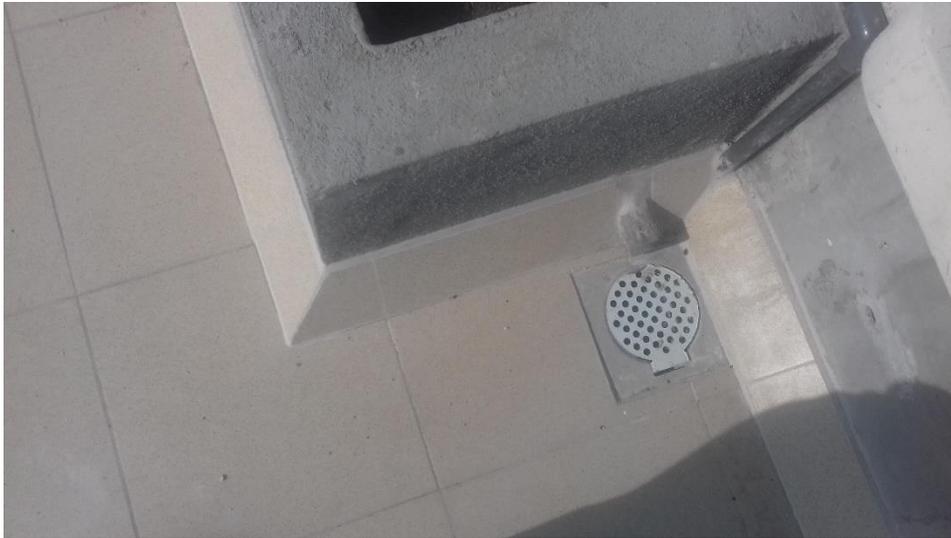
Figure 4-61: Rooftop drainpipes to facilitate proper drainage

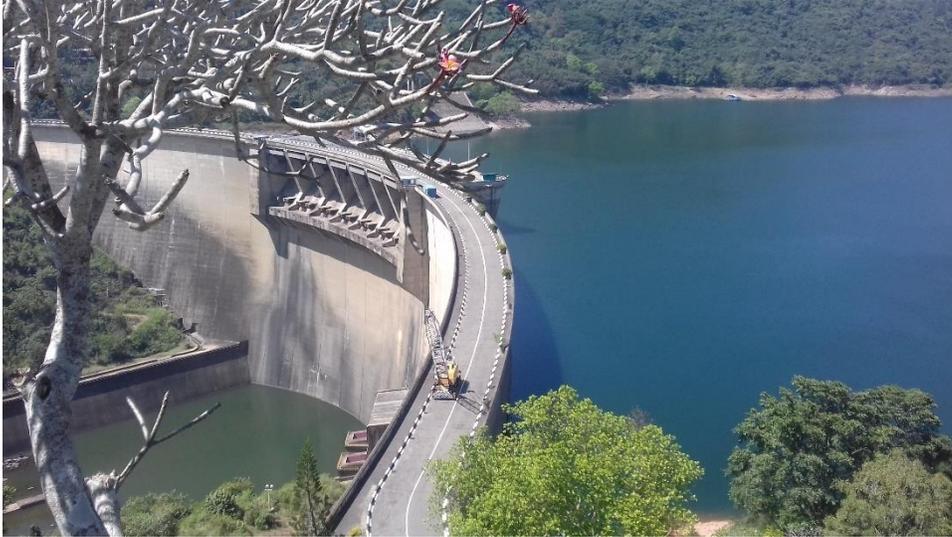
Figure 4-62: Sluice gates located at the far left were affected by waterproofing issues. The cause has been identified as a leak that sprung up due to the high pressure that the structure is being subjected to. These minor leaks were addressed by injection moulding.

the structural integrity of the sluice gates of the dam. These affected surfaces were quickly patched up with waterproofing solutions to prevent such damages from reaching the light of day.

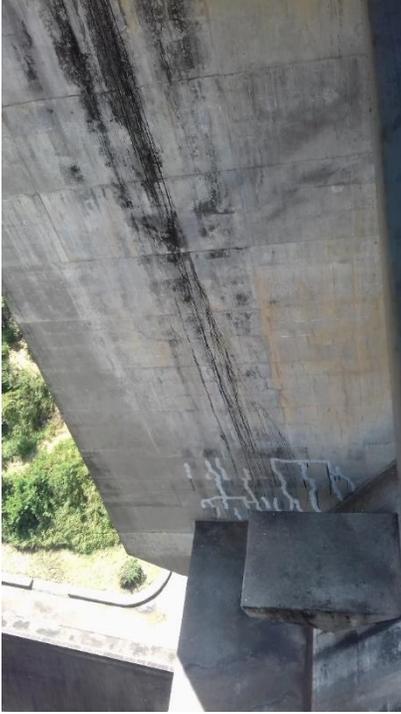
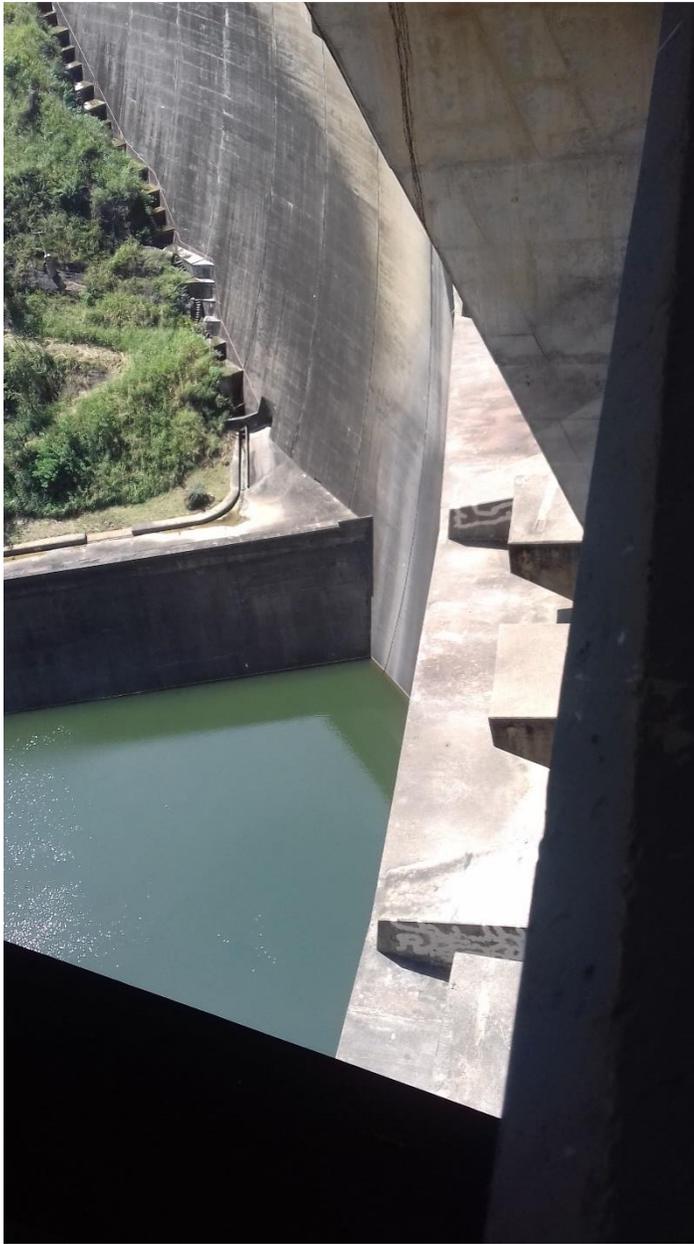
Figure 4-63: Affected surfaces were injected with waterproofing solutions - 1

Figure 4-64: Affected surfaces were injected with waterproofing solutions - 2

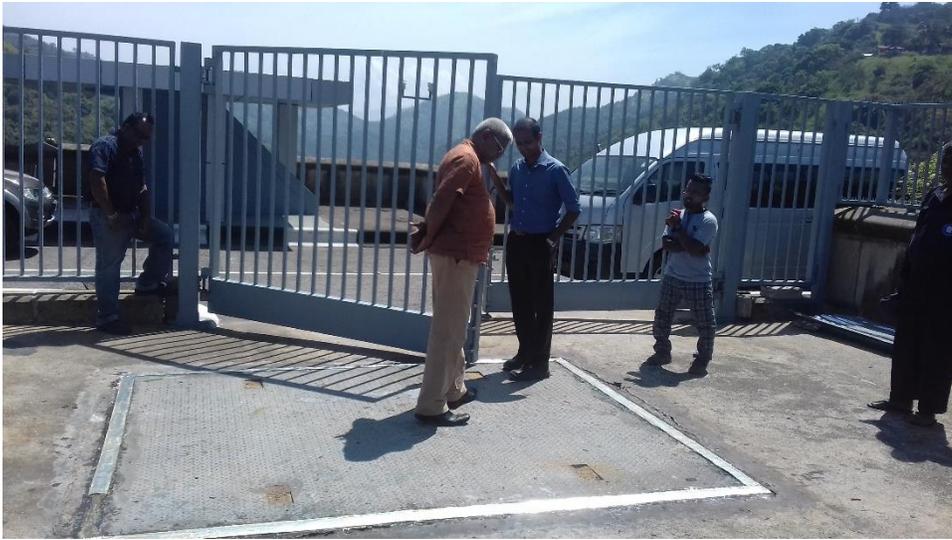
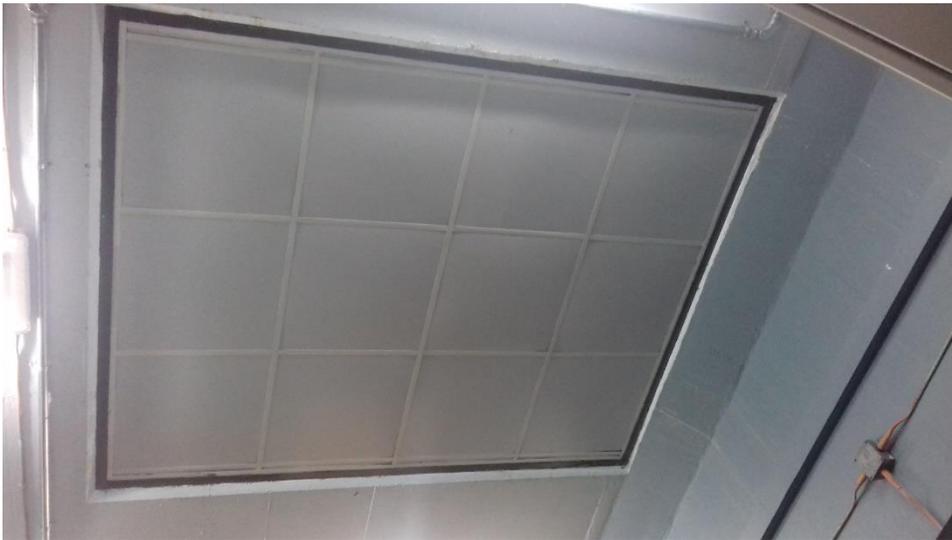
The following figure shows the surface at ground level of an underground control room located within the premises of the dam. Water seeps in from the corners of the surface into the underground control room and this required an immediate remedial measure in terms of waterproofing as well.

Figure 4-65: Top surface of the underground control room from which water leaks in

Figure 4-66: Bottom surface through which water leaks in
