**CRITICAL EVALUATION ON WATERPROOFING  
PRACTICES IN THE INDUSTRY**

Department of Mechanical Engineering

University of Moratuwa

Thesis/Dissertation submitted in partial fulfillment of the requirements for  
the degree of Master of Science in Building Services Engineering

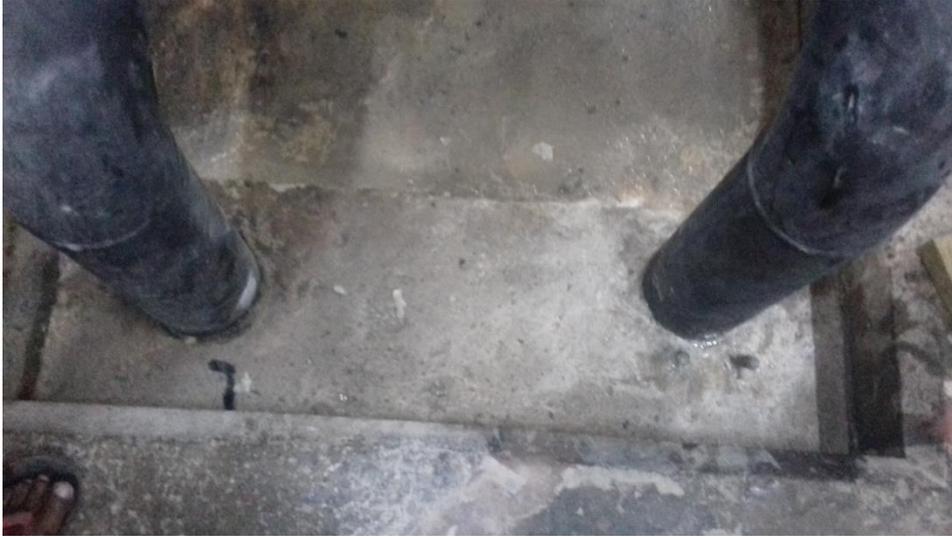
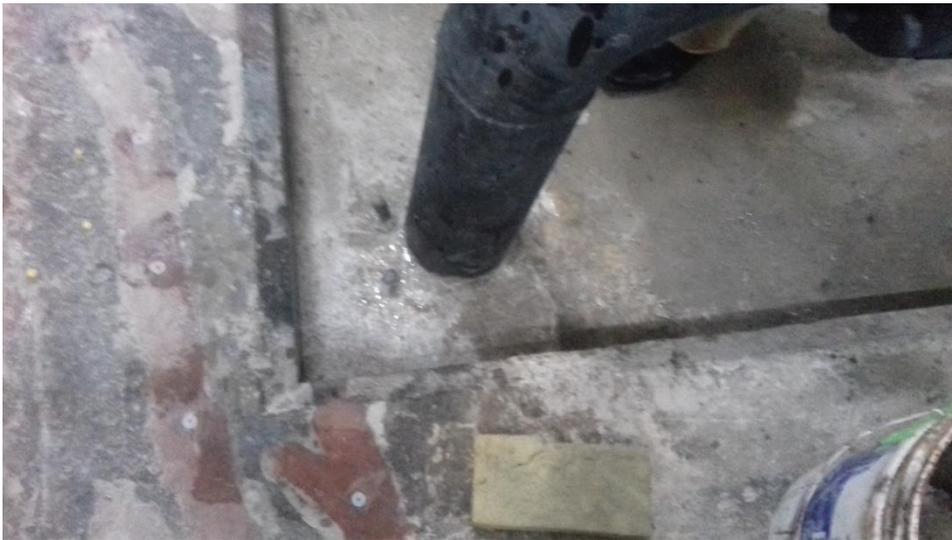
Several locations of the machine rooms with water leaks and waterproofing issues were also noted and are mentioned below. The location has not been decided with proper consideration for water drainage at ground level which is above the control room. The regulation of the slope for water drainage will help address the issue of leaking through the joints.

Figure 4-67: Water seeping in from puddle collar - 1

Figure 4-68: Water seeping in from puddle collar - 2

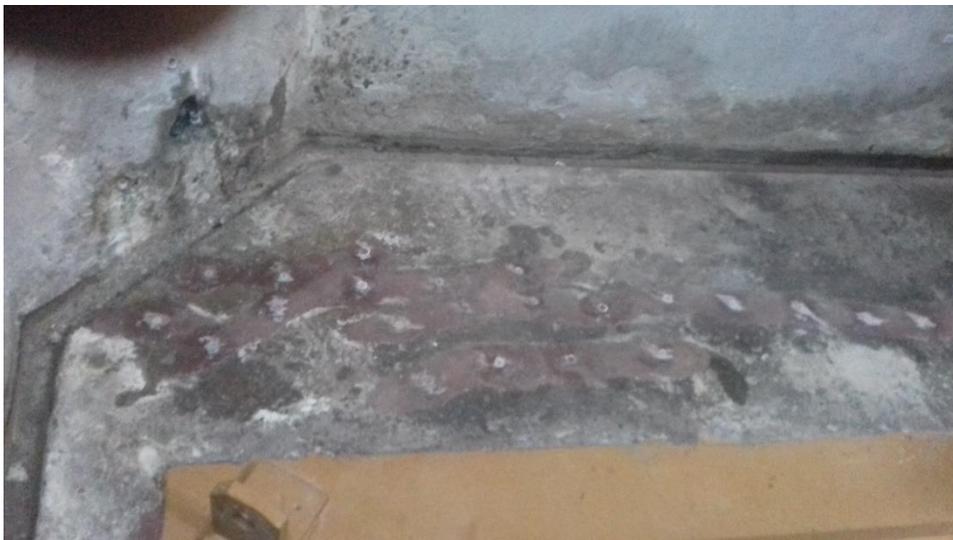
Figure 4-70: Surface injected with waterproofing solutions - 2

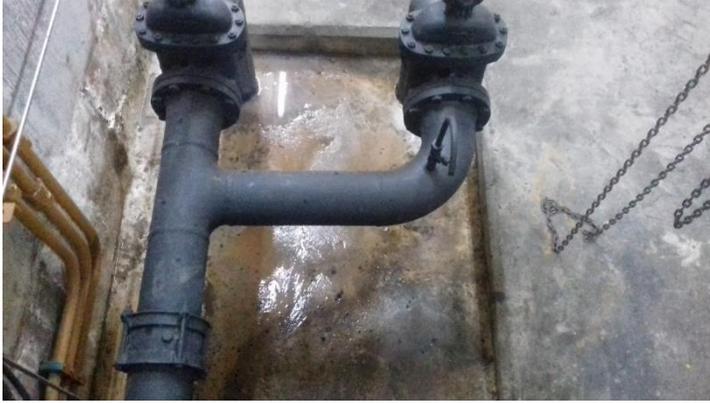
Figure 4-73: Water leaks to be injected with waterproofing solutions

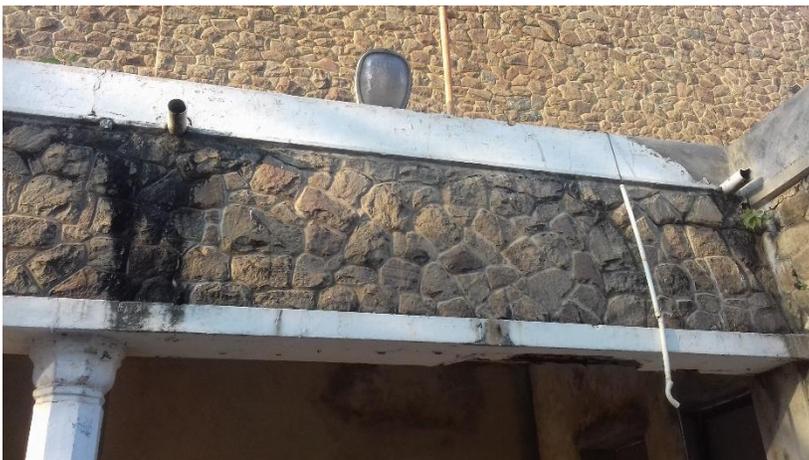
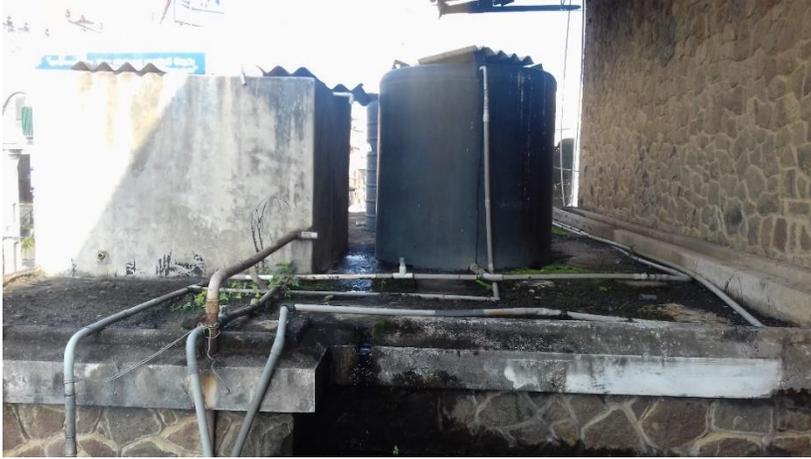
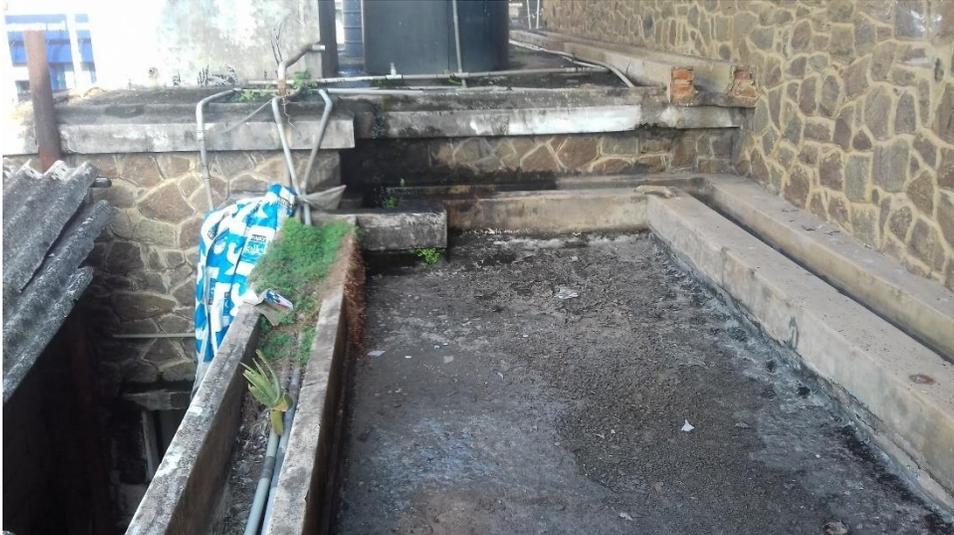
The Galle Town Hall was selected for the sixth case study. Due to its coastal location and owing to the age of the building, this site proved to be truly challenging. Being part of the Dutch Fort which was built nearly 423 years ago, the building itself requires more frequent maintenance and renovation activities to be carried out. Apart from that several locations were noted with leaks and requiring waterproofing solutions and other remedial actions. Also, structural deterioration was also noted as part of lack of waterproofing.

Figure 4-74: Water leaks in the front wall of the Galle Town Hall

Figure 4-75: Water leaks - 2

Figure 4-76: Water leaks - 3

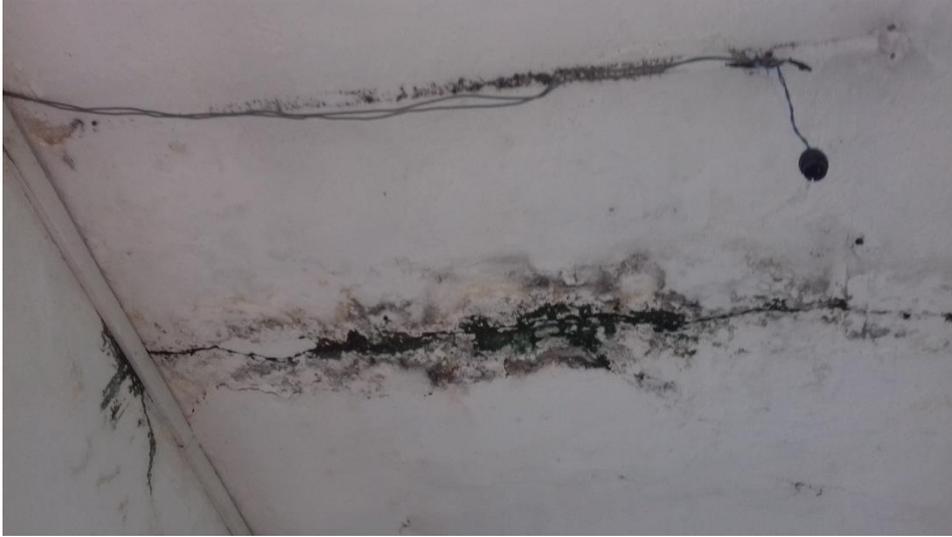
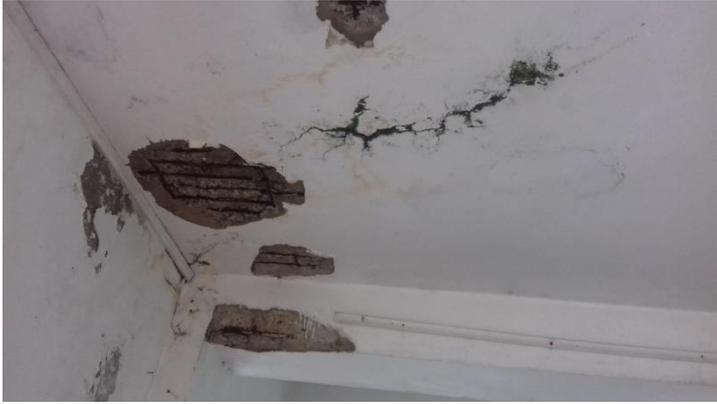
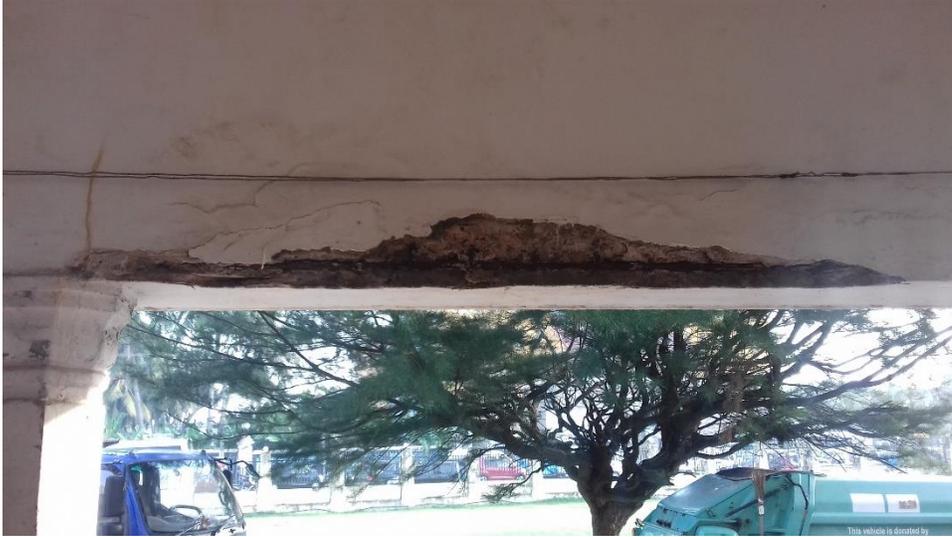
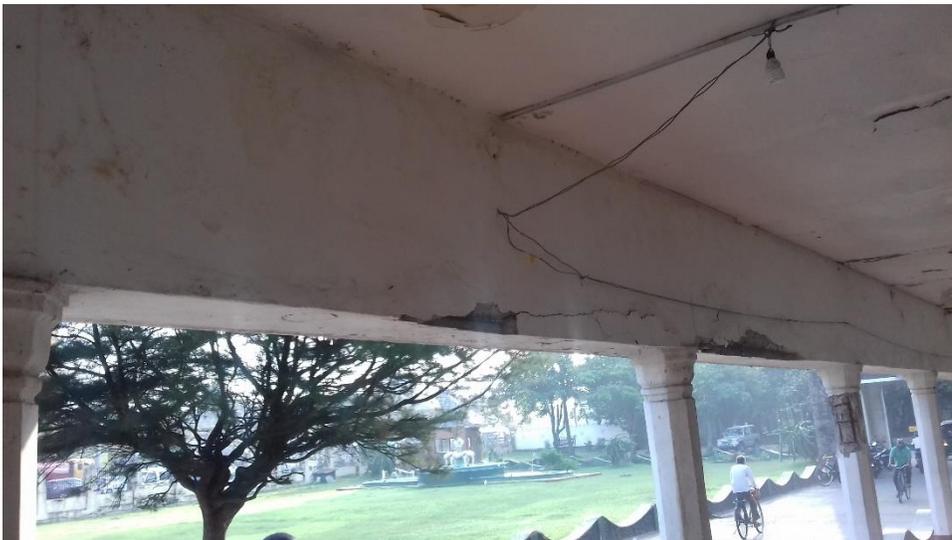
Figure 4-77: Structural deterioration of ground floor slab level due to lack of waterproofing - 1

Figure 4-78: Structural deterioration of ground floor slab level due to lack of waterproofing - 2

Figure 4-79: Structural deterioration of ground floor slab level due to lack of waterproofing - 3

Figure 4-80: Structural deterioration of ground floor slab level due to lack of waterproofing – 4
