PRESERVATION OF PRIVATE HOUSES IN FORT OF GALLE, SRI LANKA: A CASE STUDY

Samitha Manawadu*

Department of Architecture, University of Moratuwa, Sri Lanka

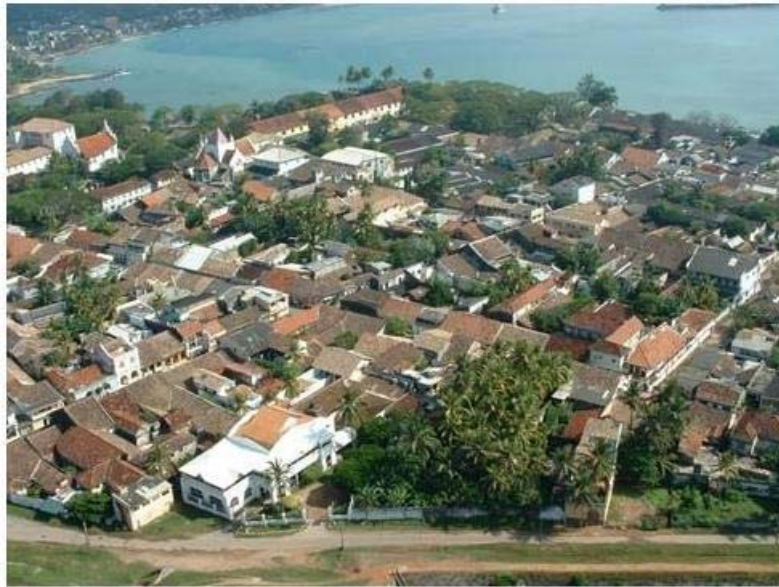
Figure 2: Houses with Diverse Characteristics

The southern sector of the historic fort of Galle is congested private housing with extremely high density, providing accommodation for more than 400 families. The cursory examination reveals a group building, in poor status of maintenance, with some hidden order in their architecture (Figure 2). 60 houses for refurbishment have been selected from this neighbourhood.

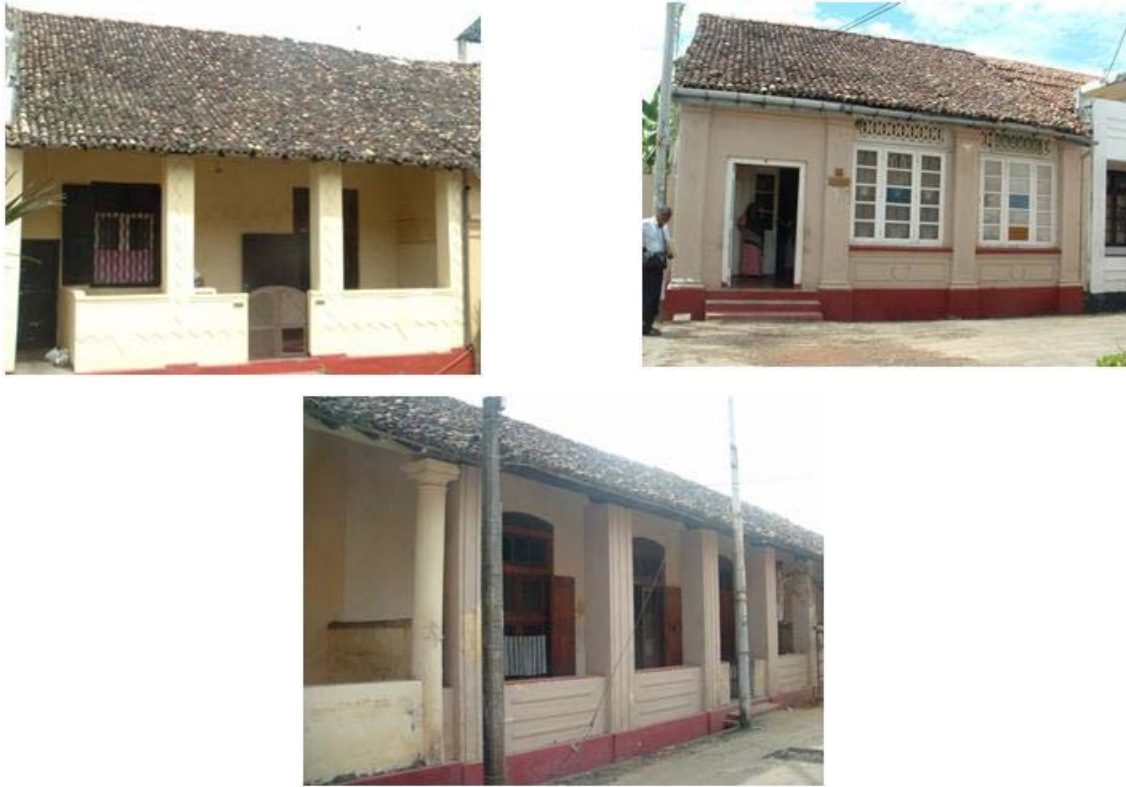
Figure 3: Diverse Building Forms

The large majority of houses that have been studied for refurbishment revealed that they had been either constructed or subjected to major repairs during latter part of British and Early Post-independence Periods. Very few houses could be antedated, but repetitive repairs also have affected their authentic characteristics over the years. None of the houses could be dated to Dutch origin, or early British Period, though they possess some generic characteristics sympathetic to buildings of those periods (Figure 3).
