**OPTIMUM RETROFITTING METHODS FOR  
LOW RISE MASONRY STRUCTURES IN SRI LANKA**

Department of Civil Engineering

University of Moratuwa

Thesis submitted in partial fulfilment of the requirements for the Degree of Master of  
Science in Civil Engineering

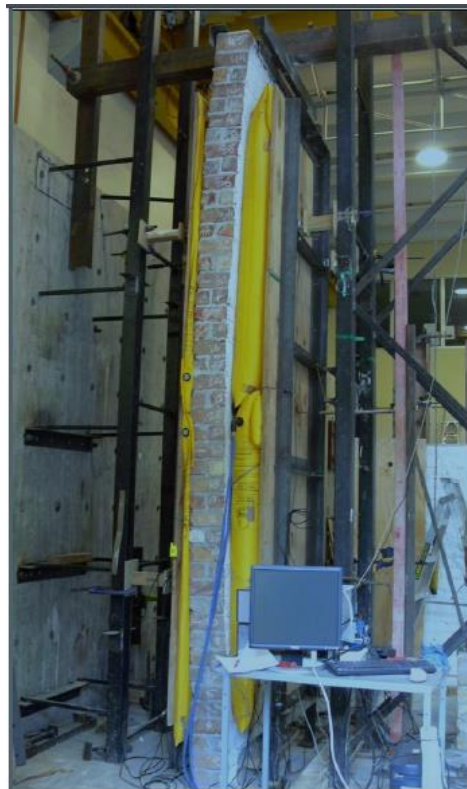
*Figure 2. 2: Arrangement for the testing*

In the aforementioned study that was done by Dizzhur et al., (2014), nine masonry beams and five full scale masonry walls were cast and tested which consist a mortar mix of 1:2:6 (Ordinary Portland Cement, Hydrated Lime, Sand) and 1:2:9 respectively. The walls were built with a thickness of two and three leaves and a bed joint thickness in between 10mm to 15mm. These walls were cured for 28 days before applying the bonded CFRP strips. Figure 2.2 presents the arrangement of necessary equipment and the test specimen which was used during the experiment.

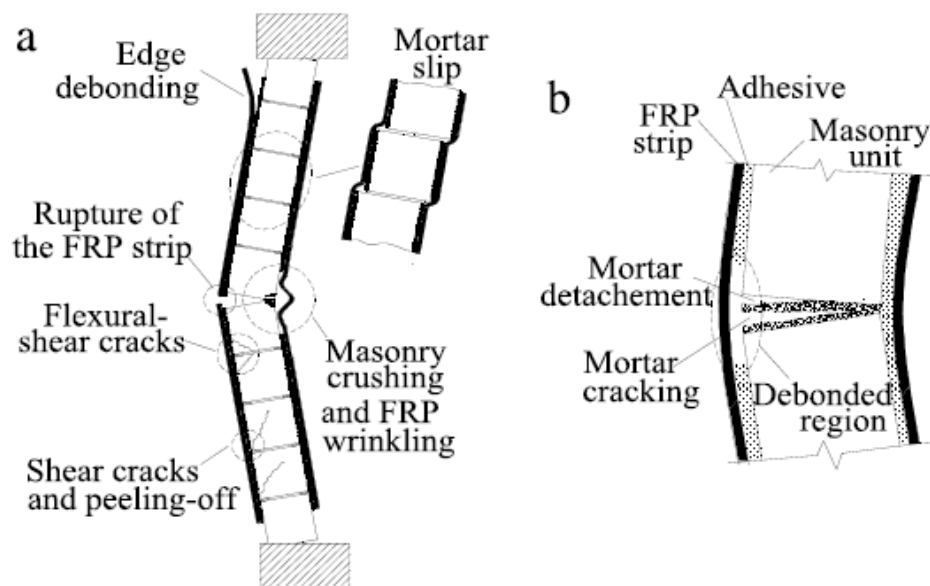
*Figure 2. 3: Structural functioning of reinforced masonry wall subjected to loading (out-of-plane)*

Hamed and Rabinovitch (2010) executed an experimental program to identify the failure characteristics of Fiber Reinforced Polymer (FRP) strengthened masonry walls under out of plane loading. Two full scale walls (a control specimen and a wall reinforced with FRP strips) were built and loaded up to failure. Figure 2.3 expresses the structural performance of stiffened masonry wall with FRP which is subjected to out of plane loading.

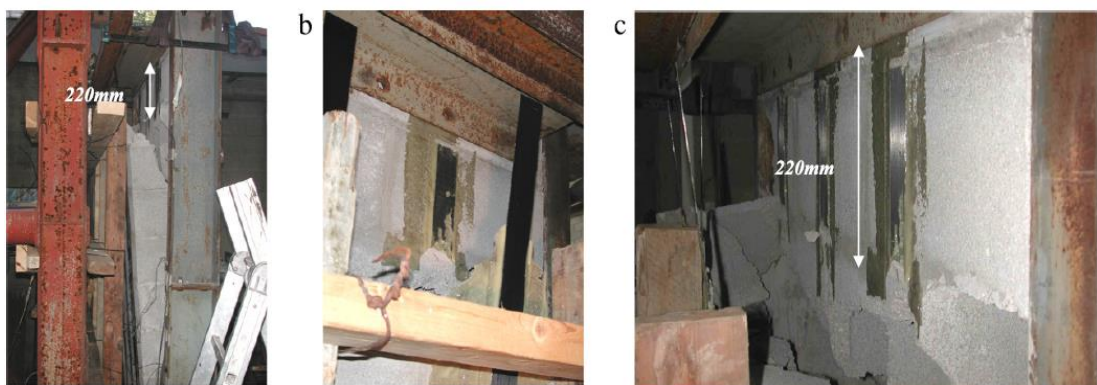
*Figure 2. 4: Failure of the reinforced wall due to shear*

parameters used in the experimental program. Furthermore, producer's data sheet was utilized to obtain some material properties. A full-size masonry wall reinforced with surface glued composite CFRP strips and an unreinforced control wall were subjected to out of plane forces as the second phase. The control wall was failed with observations such as fragile and sudden while the failure of the reinforced wall was occurred as a consequence of shear failure in masonry units related with de bonding of the CFRP. However, it was observed that the strengthening process prevents the integrity and stability of the wall at failure. Figure 2.4 displays failure of the wall panel retrofitted with CFRP.

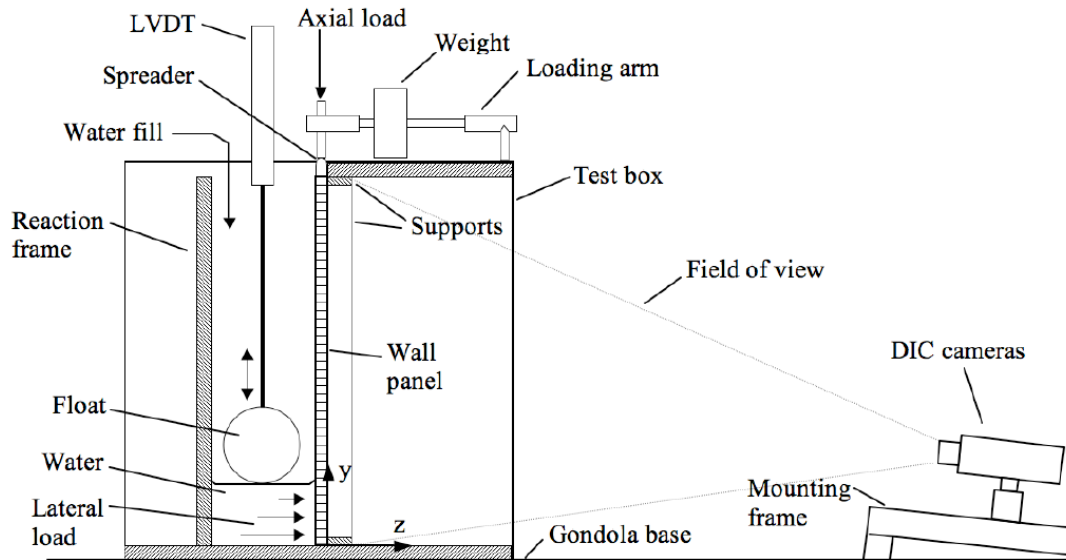
*Figure 2. 5: Testing arrangement of the wall panels*

failure happened. As stated by the authors, scaled down modelling of masonry has been utilized well by numerous researches and it permits testing to be accomplished cost effectively and cautiously. Testing arrangement of the wall panels is shown in Figure 2.5.

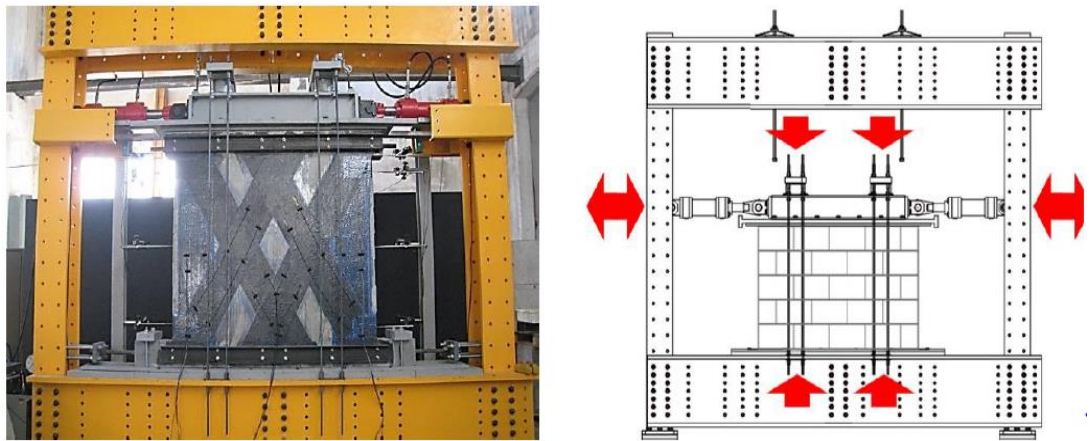
Figure 2. 8: Arrangement for the experimental program

Specimen No	Retrofit Configuration
1	Reference wall (No retrofitting)
2	Carbon mesh strips that was applied vertically (2 Nos)
3	Two Carbon mesh strips applied vertically and diagonally (45°)
4	Two and four, applied carbon mesh strips vertically and diagonally (45°) respectively
5	Two and four, applied carbon mesh strips vertically and diagonally (60°) respectively

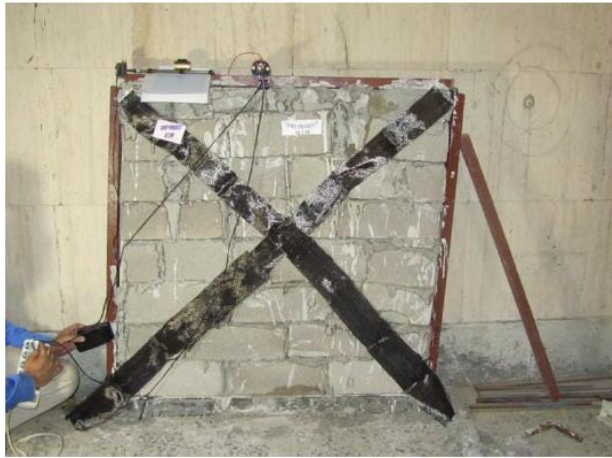
*Figure 2. 9: Test apparatus with CFRP applied to wall*

was suggested as a potential retrofitting material than CFRP. Figure 2.9 exhibits the test apparatus with CFRP applied to wall.

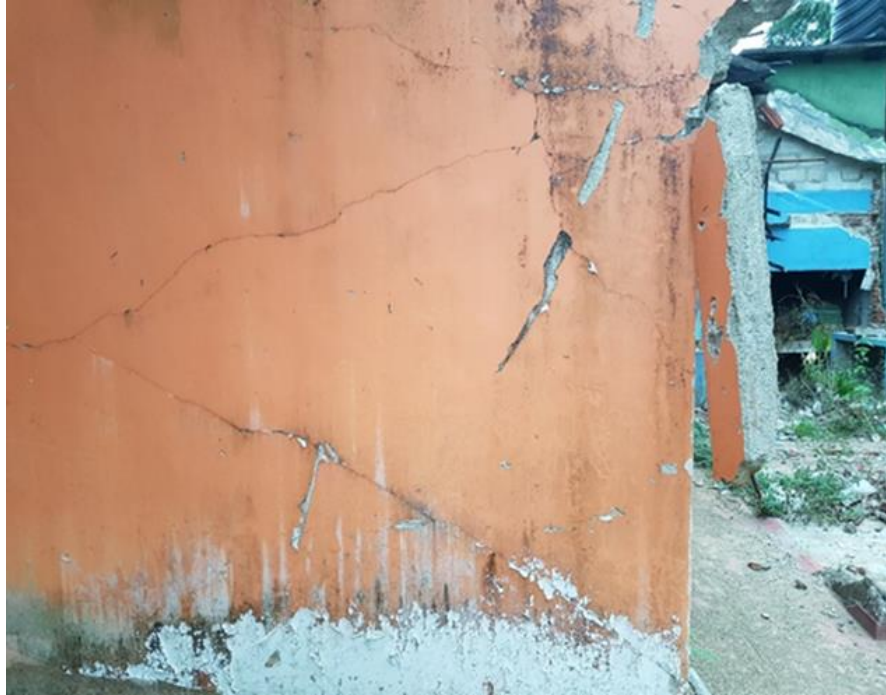
*Figure 3. 18: Wall failed in flexure parallel to bed joint*

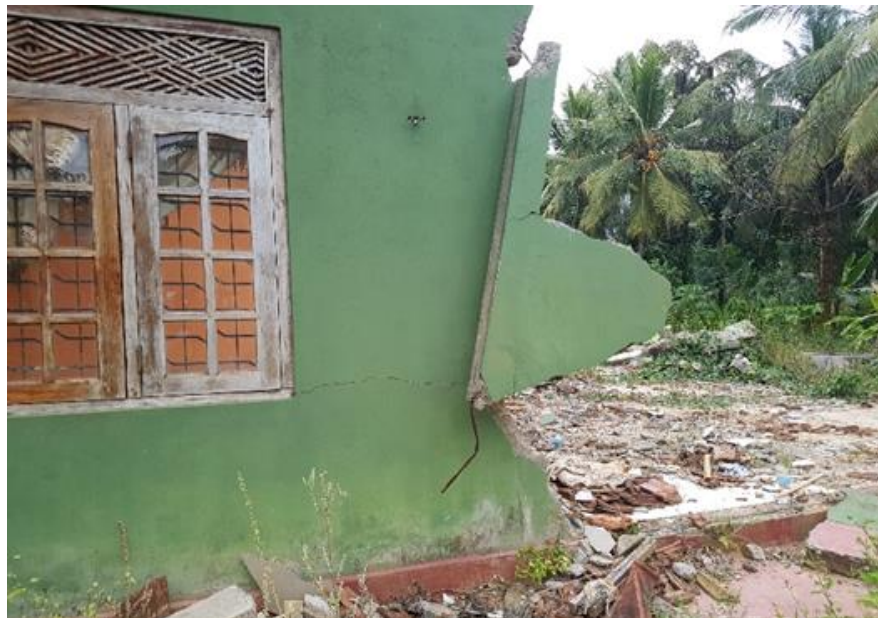
*Figure 3. 19: A collapsed and cracked wall*

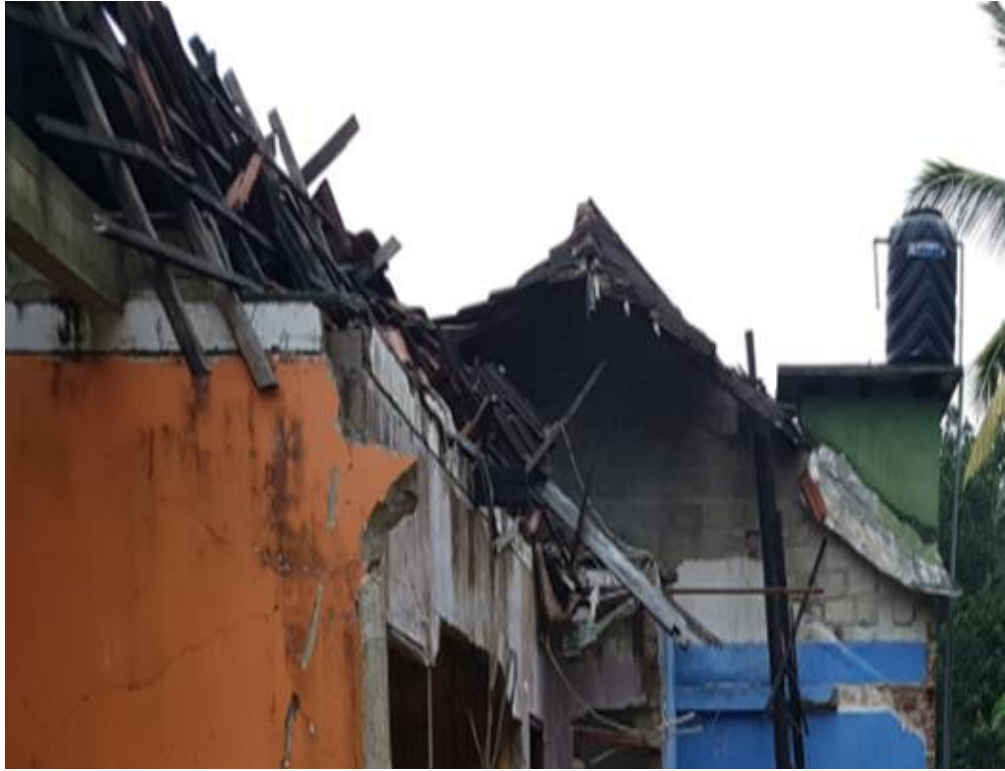
*Figure 3. 20: Damages took place in the roof*

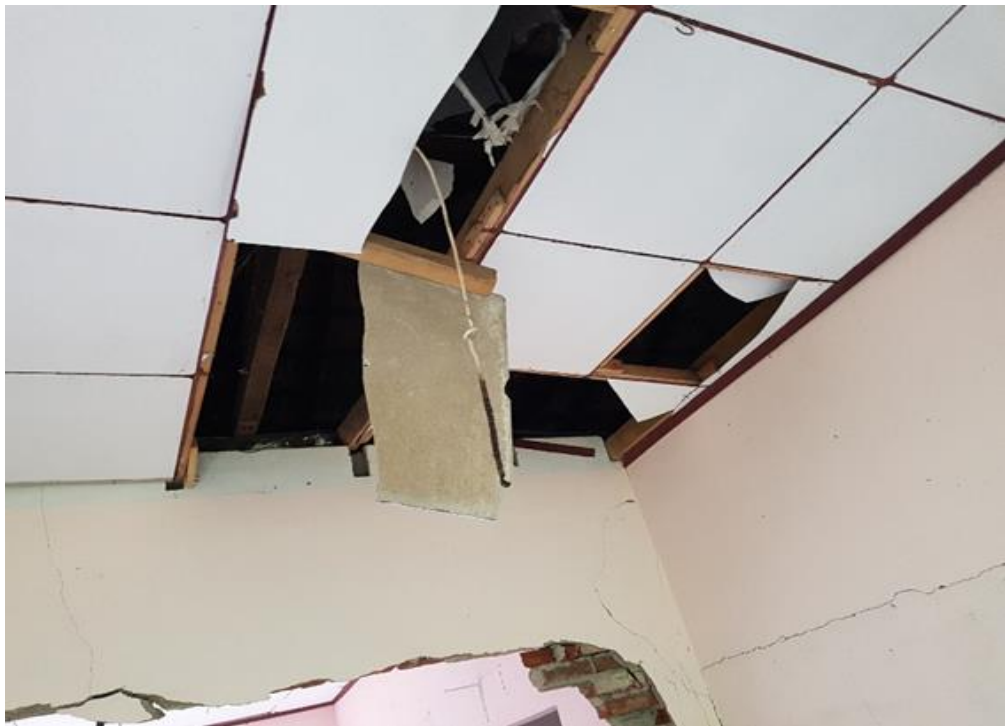
*Figure 3. 21: Damages occurred to the plaster board ceilings*

also been damaged due to the collapsing of the walls and the roof onto the floor. Damages to the floor can be visible in Figure 3.22. As demonstrated by Figure 3.23 plasterboard ceilings were also damaged by water, weakening the lining and increasing its weight and by pressure from trapped air below the ceiling.

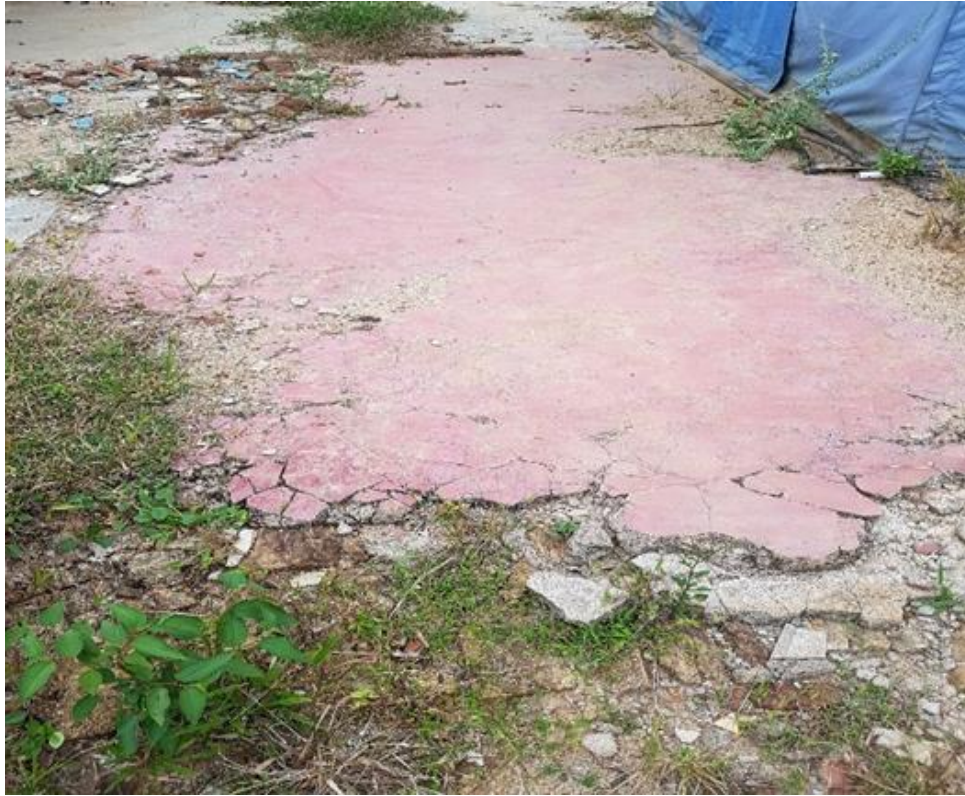
*Figure 3. 22: Damages emerged to the floor*

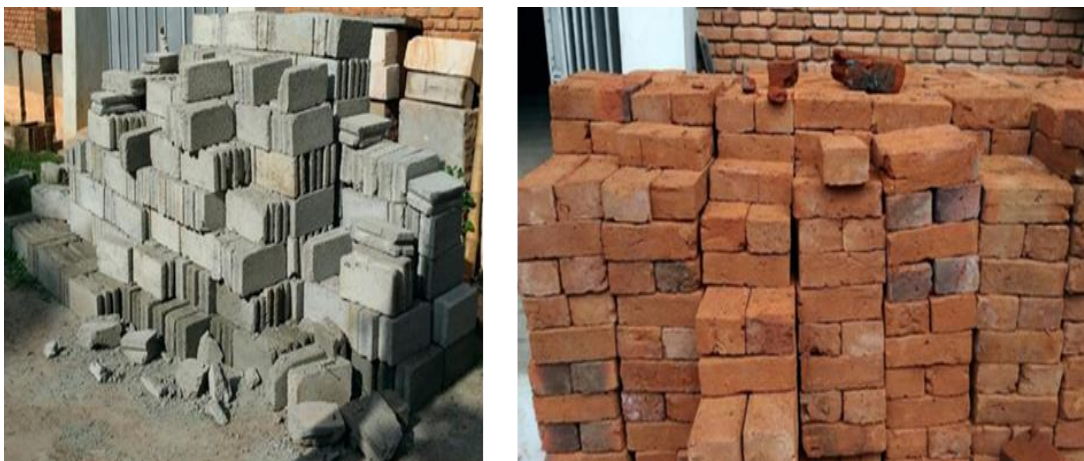
*Figure 4. 1: Masonry Units*

FCB and CB that are regularly used as walling materials in low-income houses were used for the entire experimental program. In order to reflect the practical scenario in Sri Lanka, both these unit types were purchased from a local manufacturer. The solid FCBs were acquired with nominal dimensions of 190 mm (length) x 90 mm (width) x 50 mm (height). The solid CBs were frogged on one bed face and both vertical edges with dimensions of 338 mm (length) x 94 mm (width) x 172 mm (height). The FCB and CB used are shown in Figure 4.1.

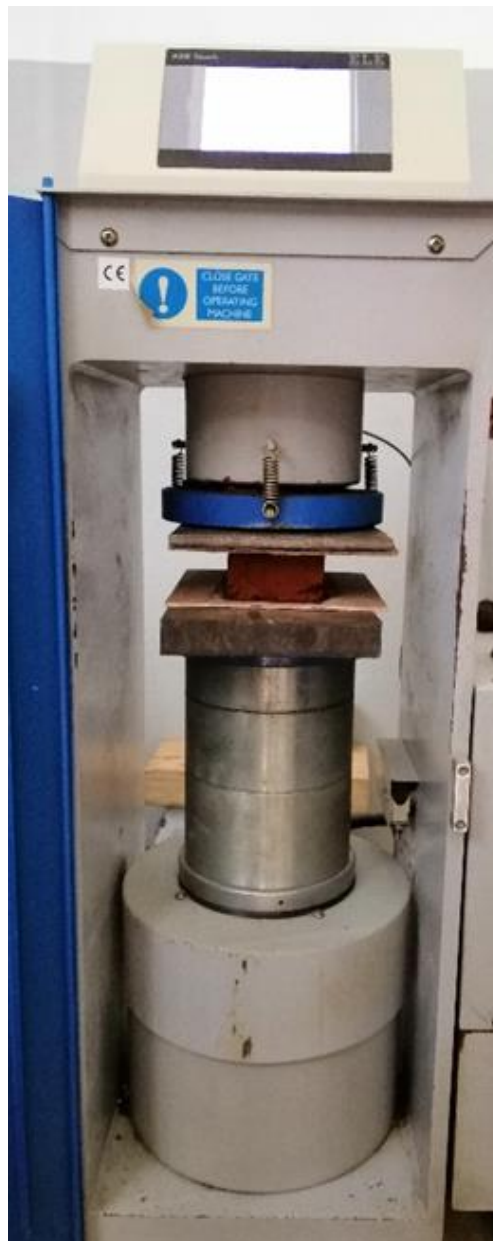
*Figure 4. 2:* Testing the compressive strength of masonry units

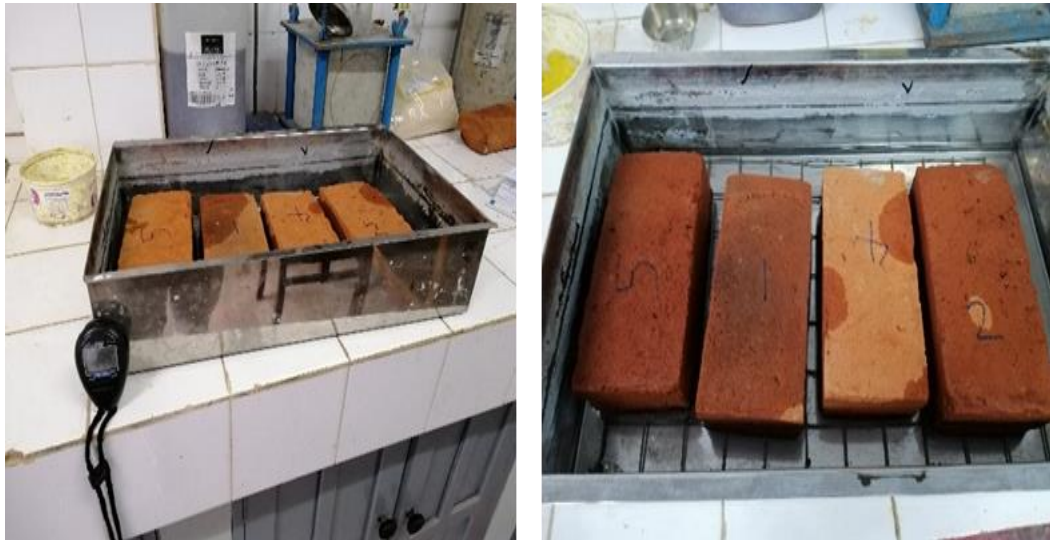
Figure 4. 3: Determination of initial rate of water absorption for FCB units

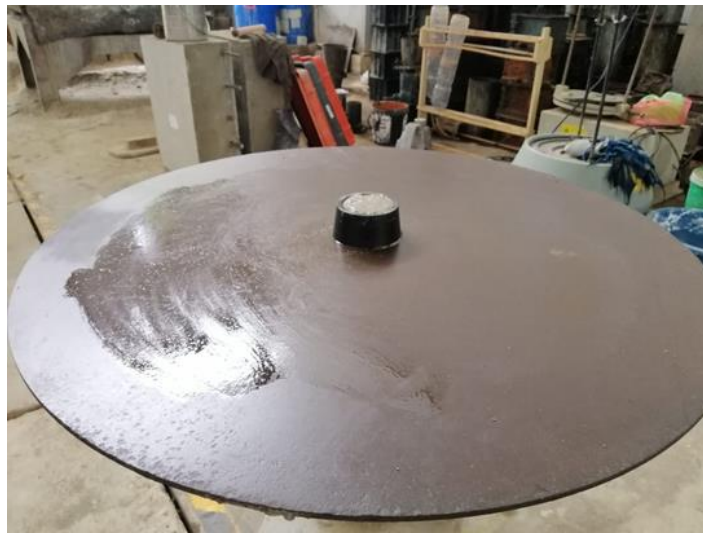
*Figure 4. 4: Compacted mortar in the mold*

filled with mortar after compaction. Excess mortar and water were removed and cautiously cleaned the free area of the disc. After 15 seconds the mold was raised vertically and Figure 4.5 demonstrates the mortar after removing the mold. The flow table was jolted 15 times at a constant frequency of approximately one per second to spread out the mortar on the disc. Figure 4.6 shows the expanded mortar after jolting. Finally, the diameters of the mortar in two directions at right angles were obtained in order to find the consistency of fresh mortar. Table 4.10 and 4.11 present the flow values of mortar used to cast and render with different types for FCB and CB wall panels respectively.

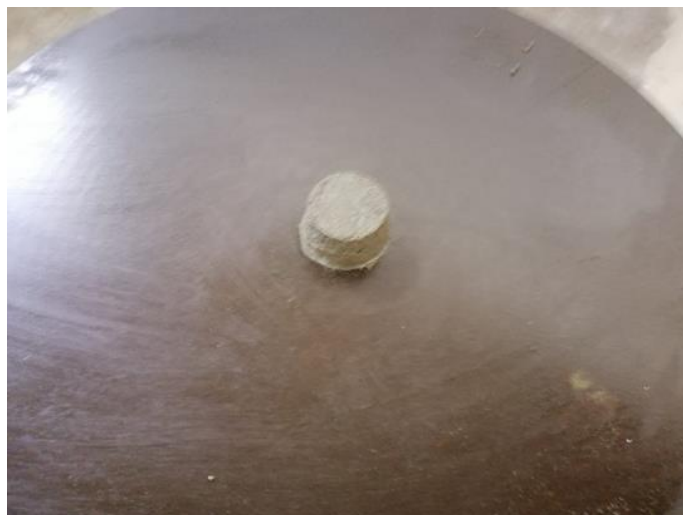
*Figure 4. 5: Condition of the mortar after removing the mold*

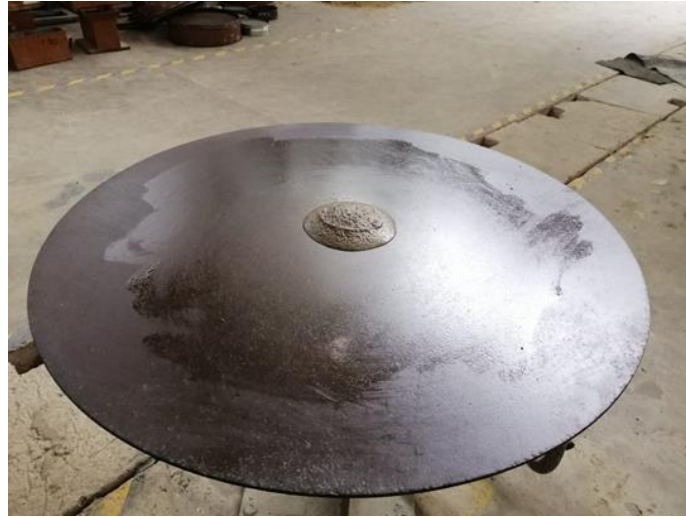
*Figure 4. 6: Mortar after jolting for 15 seconds*

All the average diameters were deviated from their initial individual diameters by less than 10%. Hence the flow value of each batch of mortar can be considered as an average diameter of the spread mortar in each respective batch.

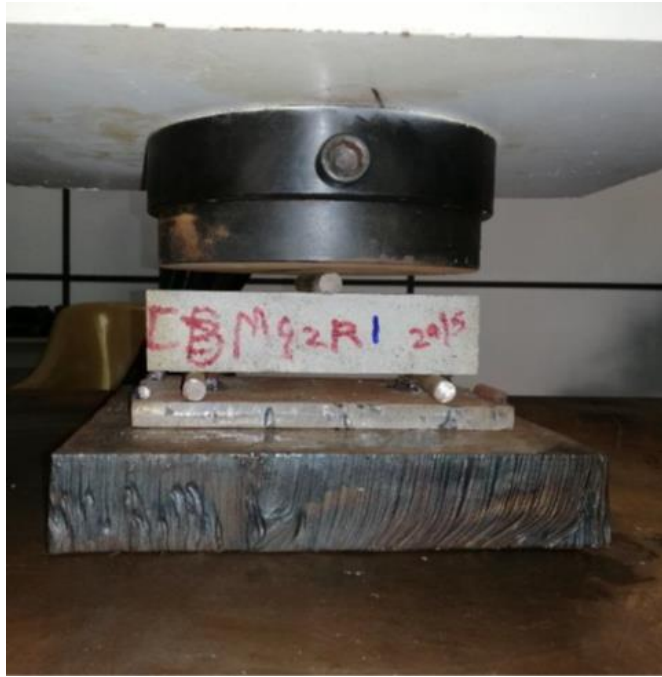
*Figure 4. 7: Flexural Testing of a mortar prism*

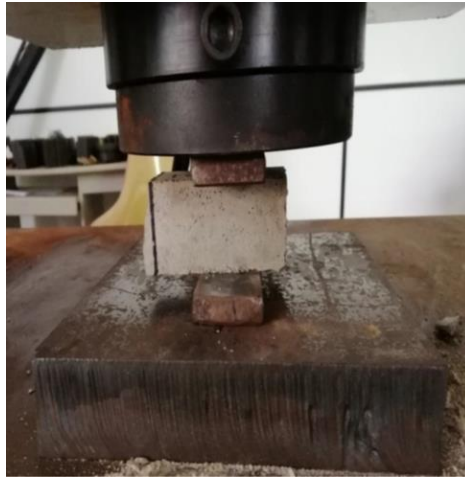
*Figure 4. 8:* Compression testing of a mortar prism

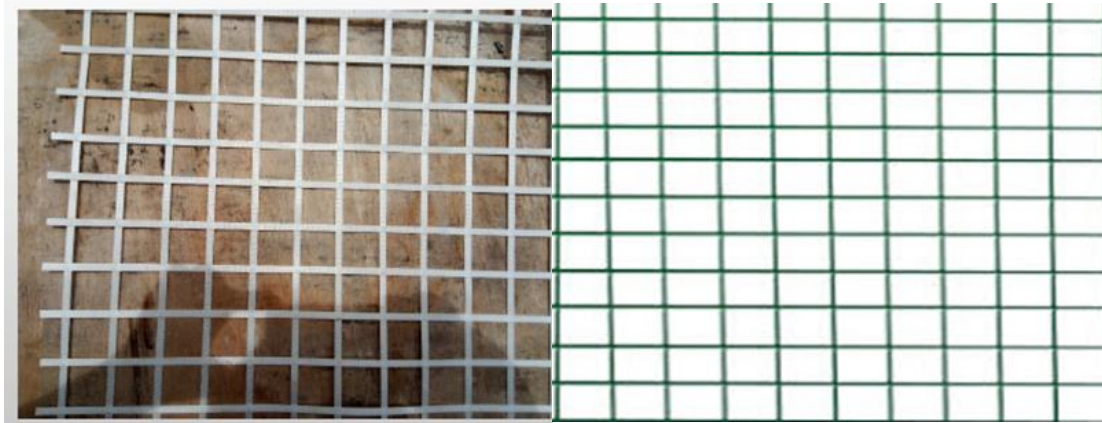
Figure 4. 10: Geogrid

welded junctions was used as one retrofitting material in the research. The other type of retrofitting material was the polyvinyl chloride (PVC) coated wire mesh which is welded and coated with a protective layer of zinc on steel fabric and PVC fuse bonded to the wire. Figures 4.10 and 4.11 illustrate the geogrid and wire mesh which were applied in the study. Further, the material properties of the retrofitting types are indicated in Table 4.14.

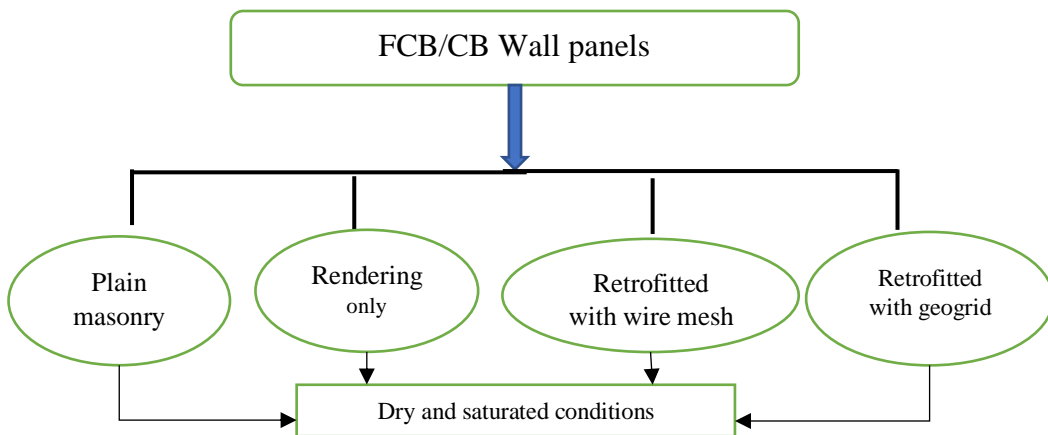
Figure 4. 12: Different variables introduced for wall panel construction

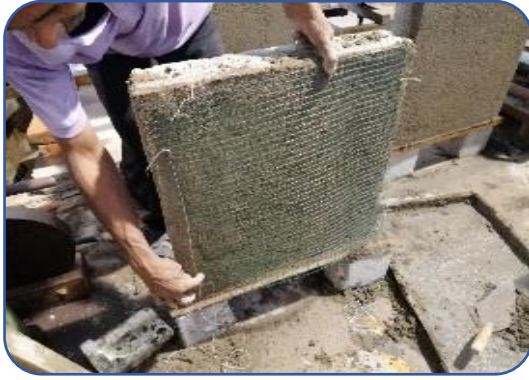
**Step 5: Applying the wire mesh and rendering up to 17.5 mm thickness after 14 days of curing**

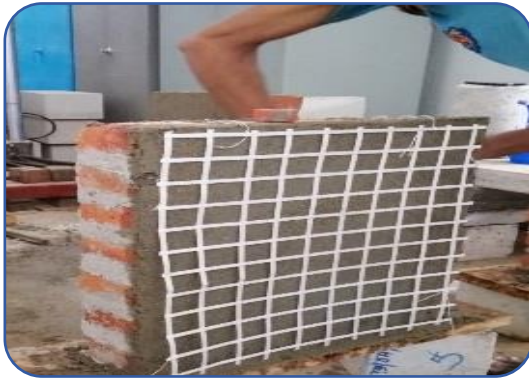
**Step 6: Applying the geogrid and rendering up to 17.5 mm thickness after 14 days of curing**

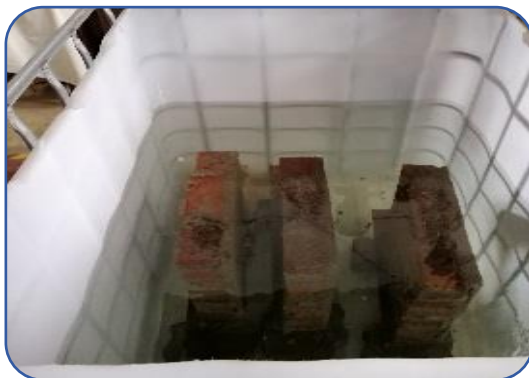
**Step 7: Saturation of specimen for 24 hours after 28 days of retrofitting (applicable for saturated condition)**

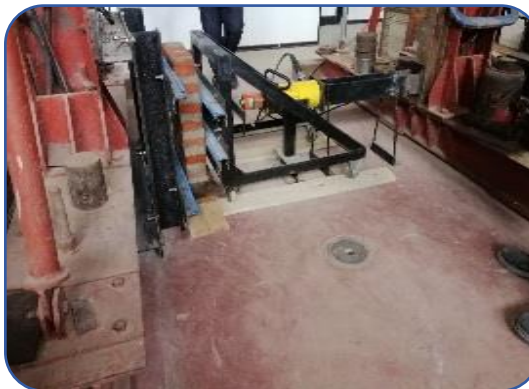
**Step 8: Testing arrangement for FCB wall panels**

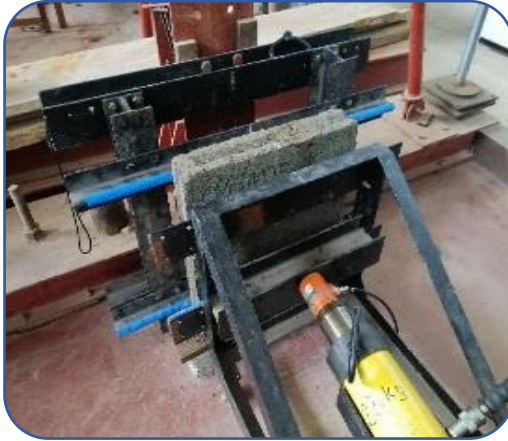
**Step 9: Testing arrangement for CB wall panels**

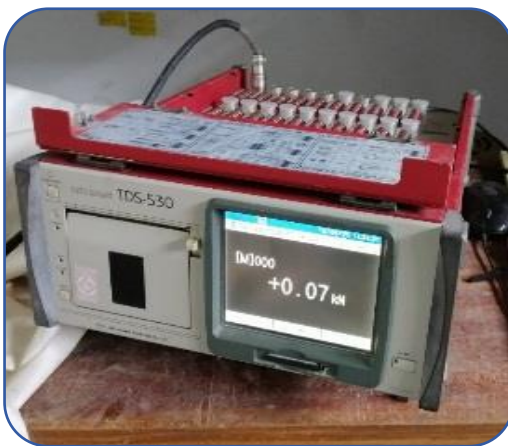
**Step 10: Recording the ultimate loads**

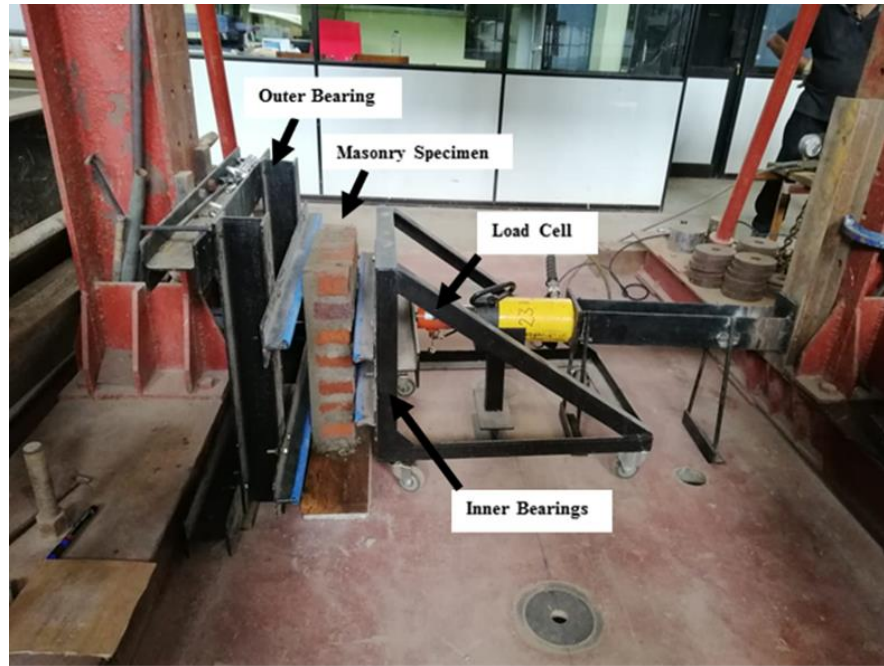
Figure 4. 14: Experimental Setup

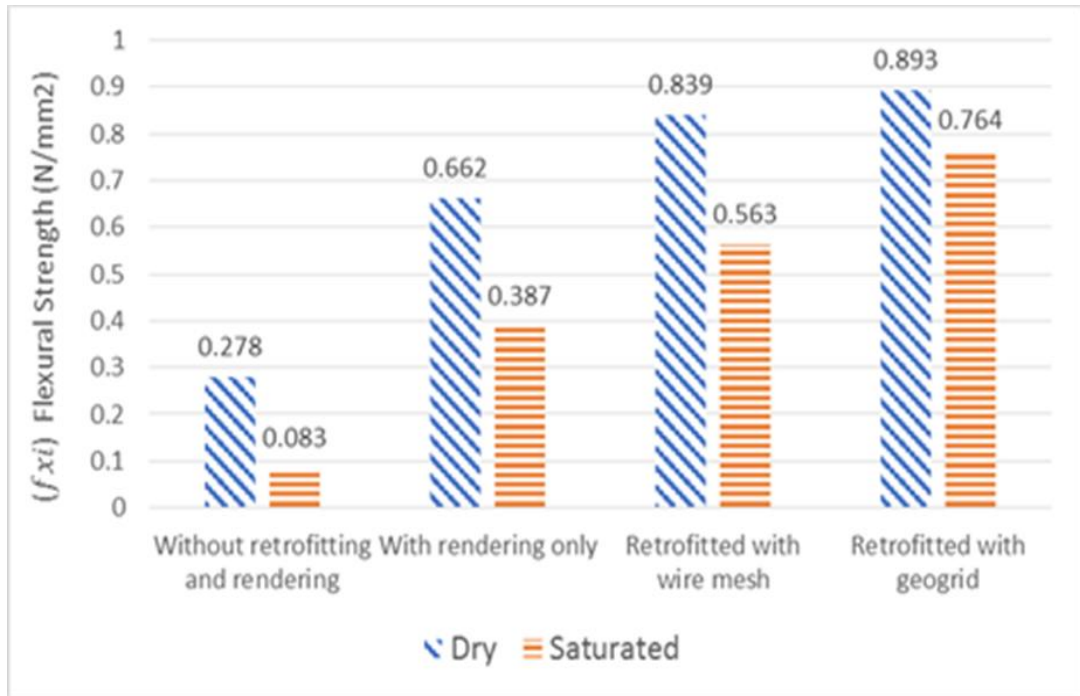
*Figure 4. 15:* Variation of flexural strength parallel to bed joint for FCB wall panels. The results are displayed for both dry and saturated conditions. It is recognizable that the flexural strength in saturated condition was discovered to be less than that of the dry condition for the FCB wall panels. Maximum flexural strength was obtained for the dry FCB wall panel retrofitted with geogrid and the minimum was recorded for the saturated FCB wall panel without retrofitting and rendering.

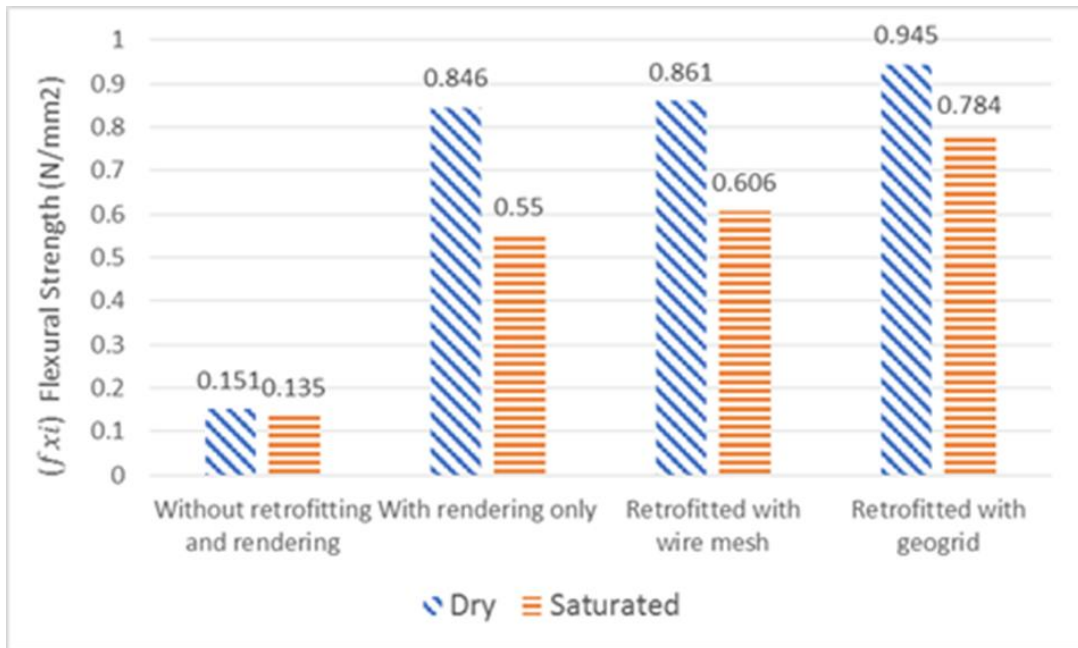
Figure 4. 16: Variation of flexural strength parallel to bed joint for CB wall panels

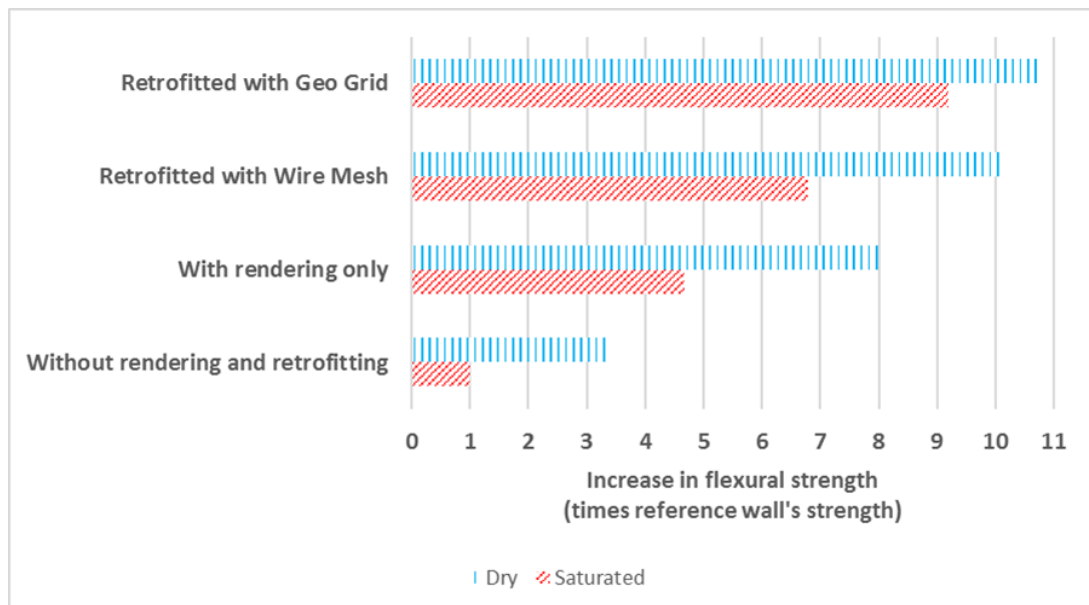
Figure 4. 17: Flexural strength increase in parallel to bed joint of retrofitted FCB wall panels

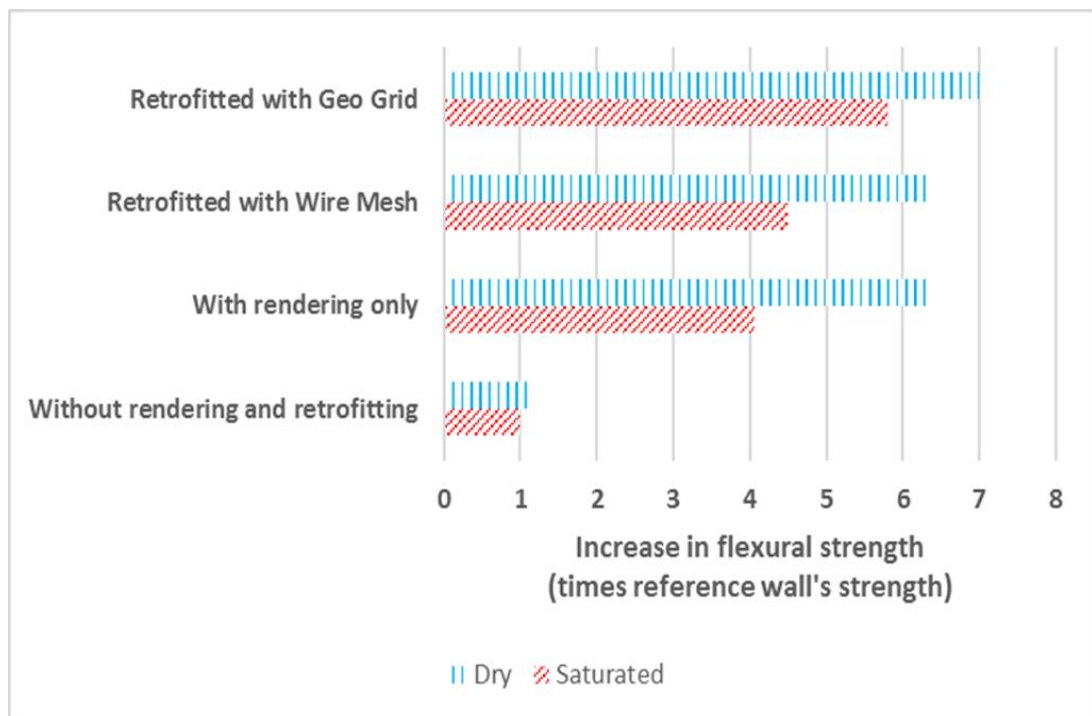
*Figure 4. 18:* Increase in flexural strength parallel to bed joint of retrofitted CB wall panels

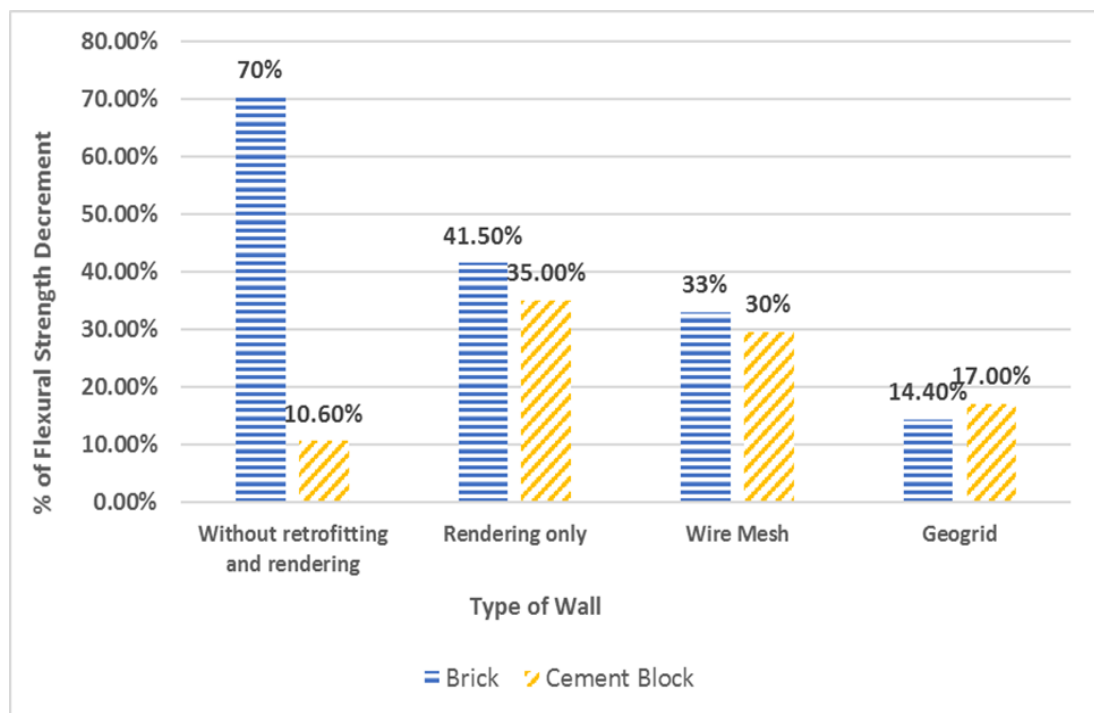
Figure 4. 19: Percentage reduction of flexural strength of masonry wall panels from dry condition to saturated condition

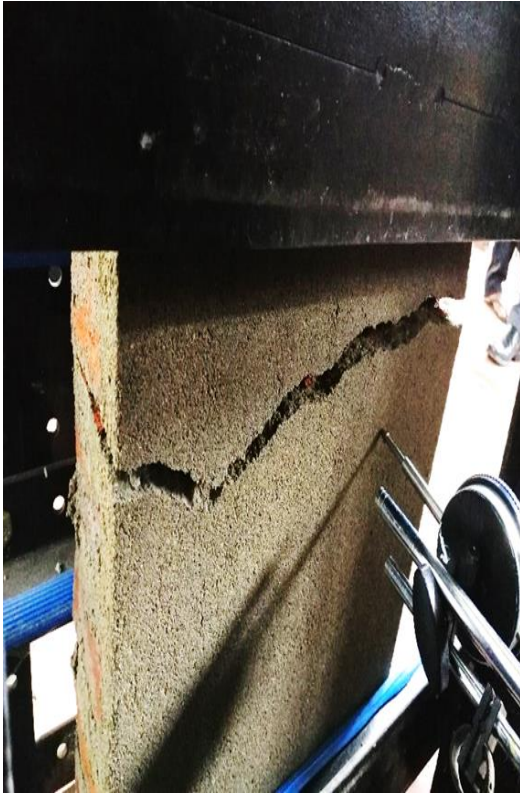
Horizontal flexural crack

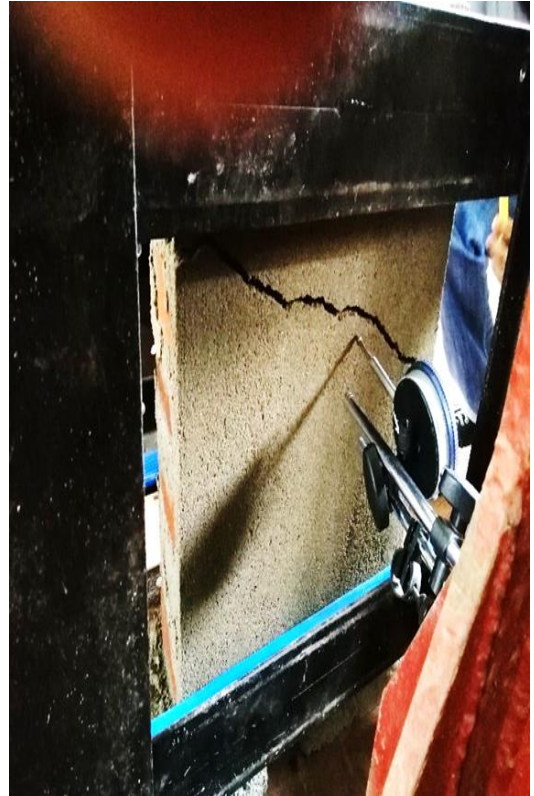
Diagonal crack

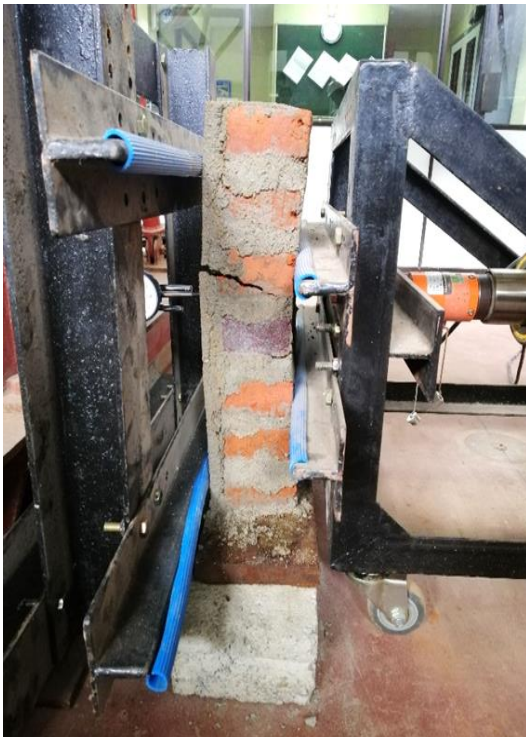
Brittle failure

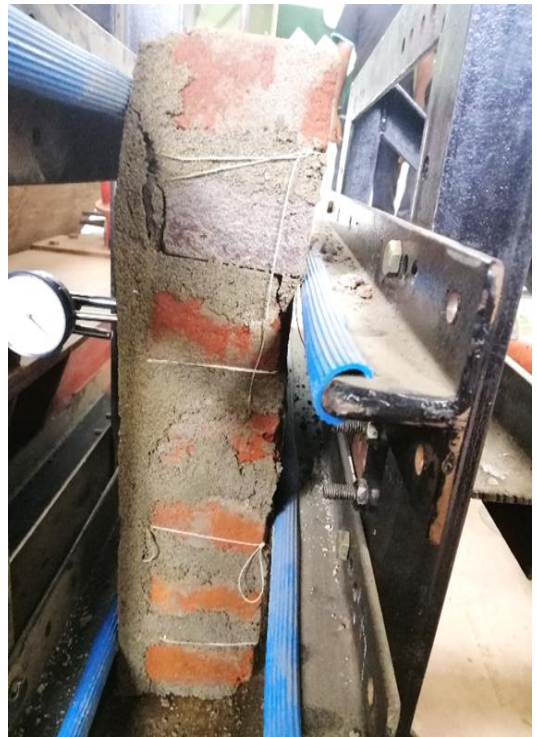
Shear failure

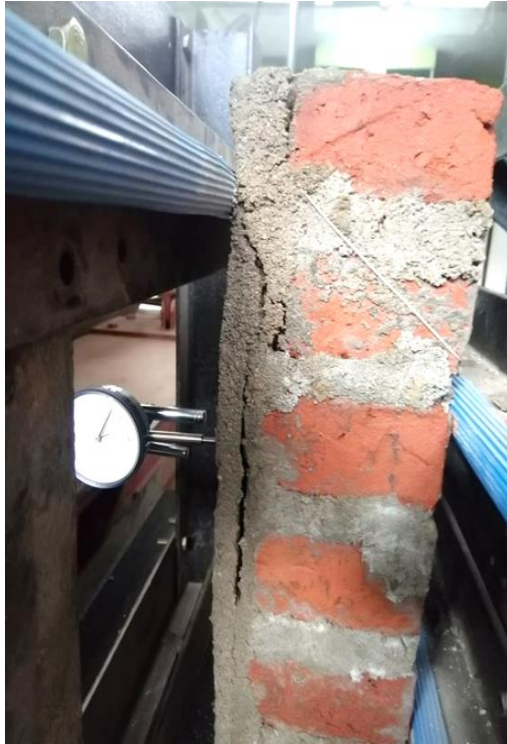
Separation of retrofitting material and external plaster

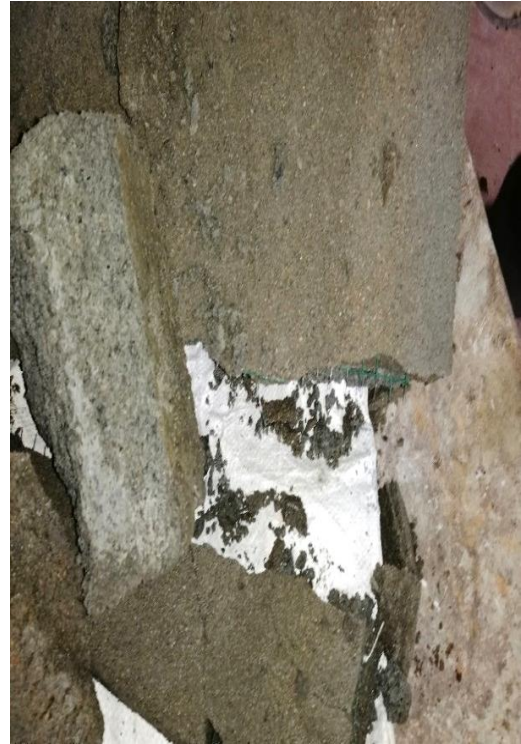
Wire mesh was broken

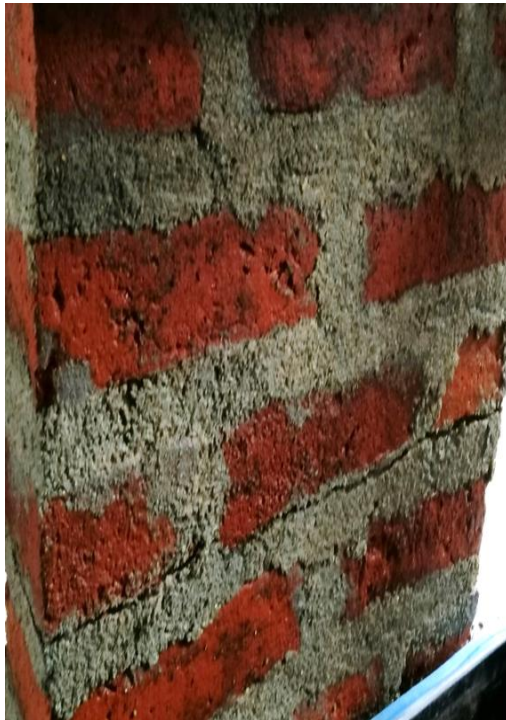
Crack along the bed joint

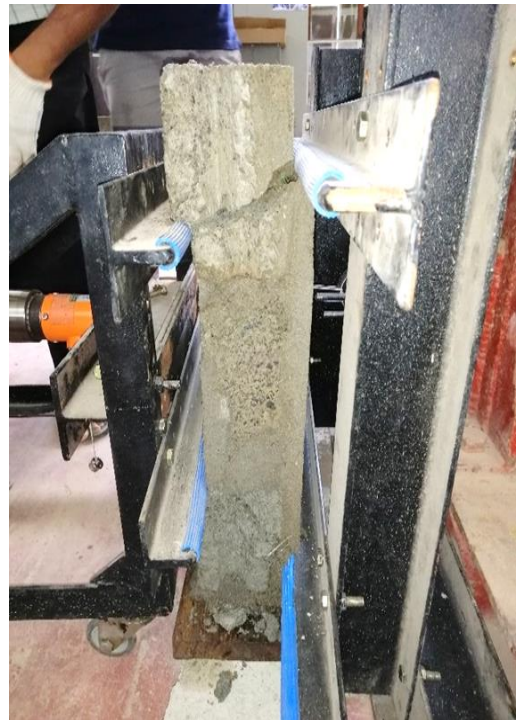
Crack in the masonry unit

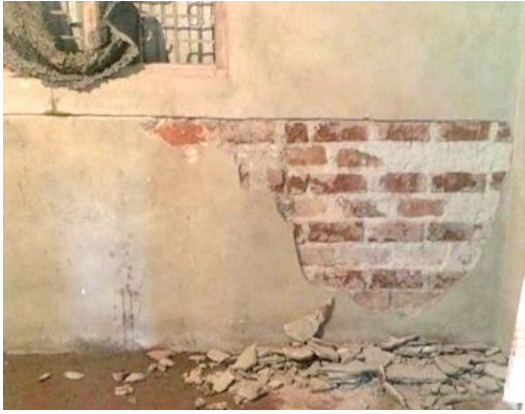
(a) Removal of existing plaster

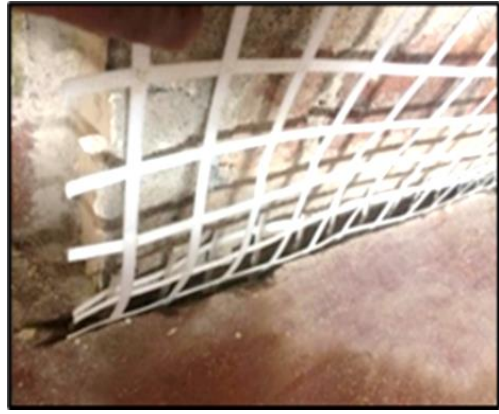
(b) Epoxy the geogrid in place

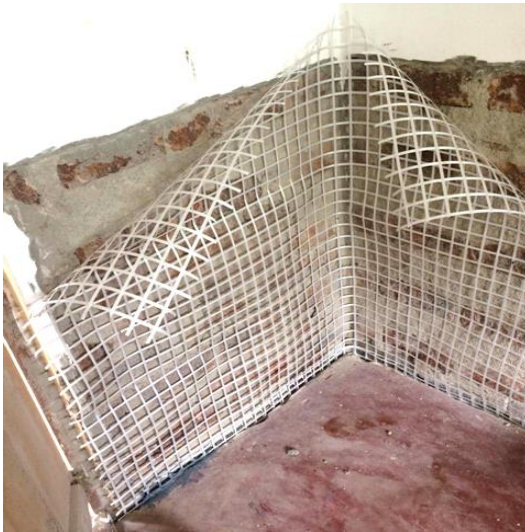
(c) Curing of epoxy

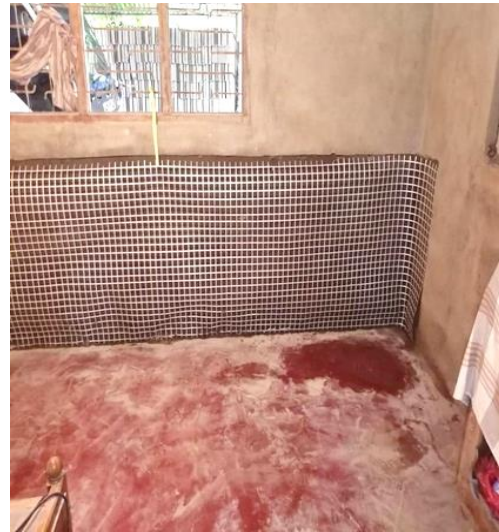
(d) Application of scratch coat and epoxied geogrid

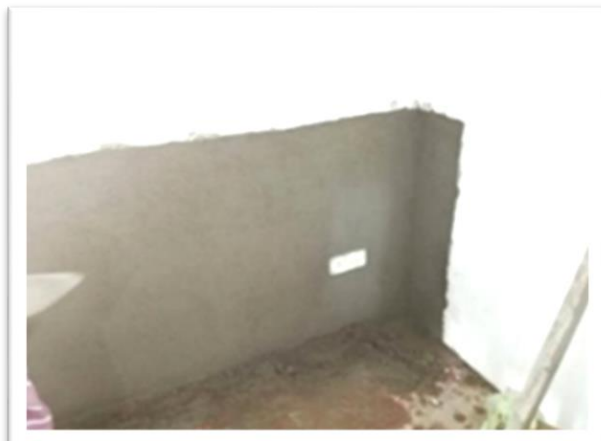
(e) Final coat of rendering after embedding the geogrid
