# **Long Term Coastal Erosion and Shoreline Positions of Sri Lanka**

Department of Earth Resources Engineering, University of Moratuwa

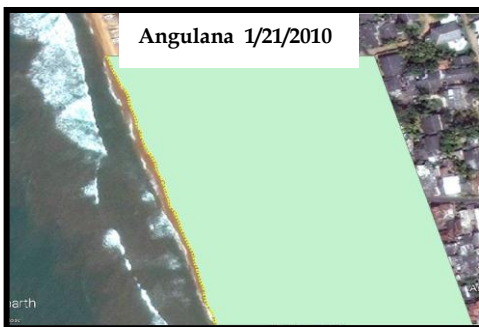
Figure 1: Polygon drawn by taking dry wet boundary as one edge

considered for the study. Images used for long term changes had at least five year gap and taken at nearby months from the particular year to minimize seasonal variations due to monsoon. Image processing and analysis were performed by means of ArcGis software, and polygons were drawn on all images for a particular location, as per the Figure 1, by demarcating the wet - dry boundary as the shoreline [4].

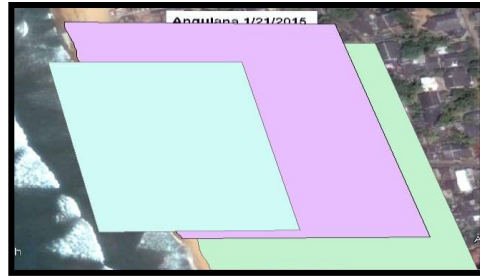
Figure 2: Common polygons

A common polygon was drawn as per Figure 2 and combined it with other two polygons that were drawn in the images belong to two different time periods in the same location. Attribute tables of combined polygons were edited and a new grid code was defined by assigning 0 for water and 1 for land. Then, those polygons were converted into raster format, and raster calculations were performed. Final Raster maps are given in Figure 3. For seasonal change, two images were selected within two seasons representing south-western and south-eastern monsoon periods and the images were compared using above GIS method.

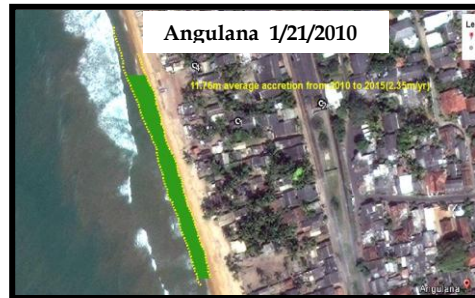
Figure3: Final output of accreted or eroded area

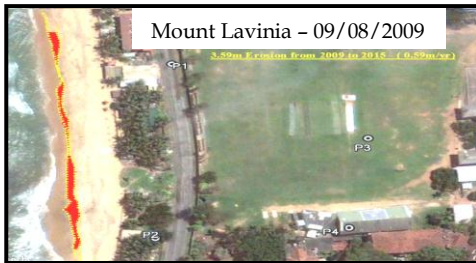
Figure 5: Mount Lavinia - long term erosion

Selected all locations along the southwest coast, including Dehiwala, Mount Lavinia, Wellawatta, Wadduwa, Rathmalana and Hikkaduwa, show severe seasonal erosion, mainly during the southwest monsoon. As figure 4 and 5 shows, this erosion observed along the most parts of the south west coast is not a permanent feature. They vary only seasonally and accreted with the onset of fair weather north eastern monsoon.

| Location | Beach condition | Quantity (m/yr) |
|---|---|---|
| Mount lavinia | Erosion | 0.59 |
