GEO-ENVIRONMENTAL ASSESMENT ALONG SOUTHERN AND WESTERN COASTAL BELT OF SRI LANKA AFTER THE INDIAN OCEAN MEGA TSUNAMI

Abstract

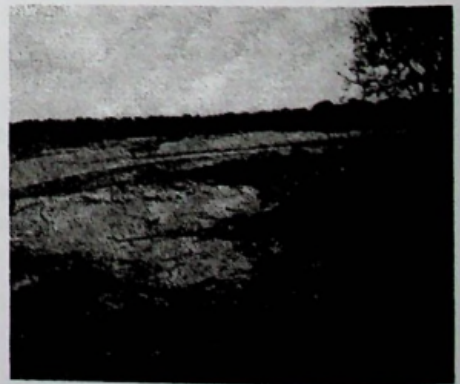
Tsunami waves could either deposit or erode sediments in coastal land area. Present studies show, that many areas in southwestern coasts are dominated by erosion rather than deposition. Most of the beach areas show at least 300m of erosional zone while deposition predominated afterwards. Deposition of tsunami sediments were observed even at 1 km distance (about 1-2 cm) in areas at Yala near Mahasilawewa. These erosional and the depositional pattern of tsunami sediment can be used to reconstruct tsunami wave properties (Minoura et al., 1997). Considerable amount of sediments have eroded from this 300m zone as you can see from the fig. 1

Fig. 1: Extensive erosion of beach sediments at Yala national park

Immediate actions have to be taken to study these areas in detail especially to understand changes of beach profile and to demarcate an area for possible flooding by storm events (which is usually more frequent than tsunami events). Re-excavated coral pits should refill, immediately. Relationship between soil salinity and crop damages has to be studied. Long term study on water quality of coastal aquifer (considerable amount of Sri Lankan population depends on this coastal aquifer) has to be started soon. Based on such detailed studies, Sri Lankan government must get the leadership to build an effective disaster management program not only for future tsunamis but also for other disasters such as floods, storms, earthquakes and landslides.

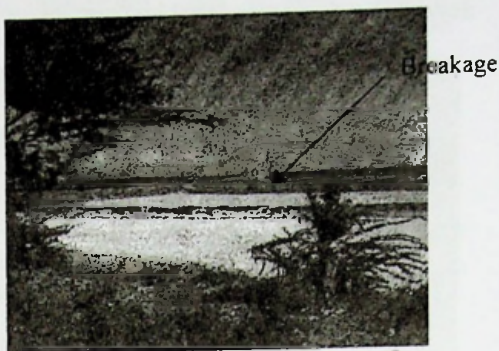
Hambanthota and Bundala are two of the major salton which produces rock salts and gypsum to the requirement of country. Tsunami has severely impacted on both these saltons destroying infrastructure including roads, and water ways, those bring sea water into the salton. Heavy deposition of sand has filled most of salton fields causing massive capital expenditure to renovate them. Tsunami waves have broken part of the sand bar (Fig. 3) which separated salton and the sea bringing large amount turbulent water causing wide spread damage including (Fig. 4) death to many people. Since most of the death bodies were recovered from the salt domes people are still reluctant use such salts for their food requirements even though necessary cleaning has done, putting much pressure on the saltons to recover from this economic disaster.

Fig.3: Sea water has intruded into the salton breaking part of the sand bar that separated sea and the salton

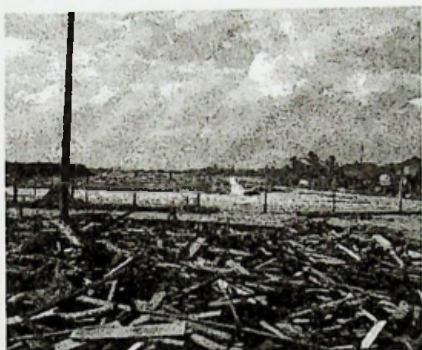
Fig.4: Severe infrastructure damage to the salton

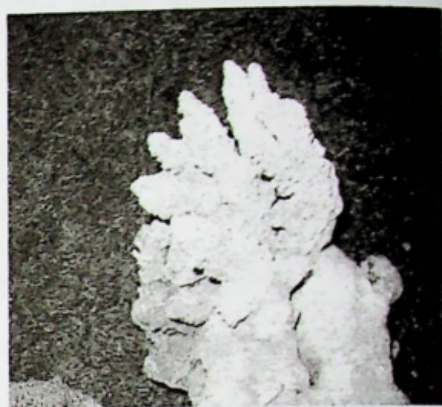
There is considerable number of coral debris scatter (Fig. 5) around the western and southern coastal area.

Fig. 5: Scattered coral fragments in Ussangoda area

Particularly in Ussangoda area there were large amount of scatted unbleached (which indicates the freshly broken coral from a live reef) fragments. However, there was not any significant damage to the Ussangoda serpentinite deposit by tsunami, understandably since this deposit forms very positive relief even though located in coastal zone.

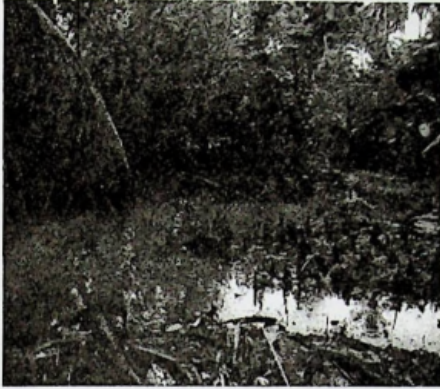
Southern and western coastal belt also characterized by large inland coral reefs running parallel to the coast. These corals were probably resulted during Holocene maximum sea level condition. During the recent past unauthorized as well as authorized coral mining was widespread in this region. There were large number excavated pits in these areas which were mostly or partially filled. Tsunami has re-excavated (Fig. 6) these partially filled pits and filled them with contaminated water causing epidemic threat,

including mosquito problems. In addition, most of the tsunami debris was dumped into these pits turning these pits further deteriorating them.

Fig.6: Inland coral pits were re-excavated by tsunami
