**APPLICATION OF CFRP COMPOSITE FOR
SUSTAINABLE SOLUTION OF CORRODED SLAB
SYSTEM DUE TO LOW NOMINAL COVER
CASE STUDY ON NERD SLAB SYSTEM**

Degree of Master of Science

Department of Civil Engineering

University of Moratuwa

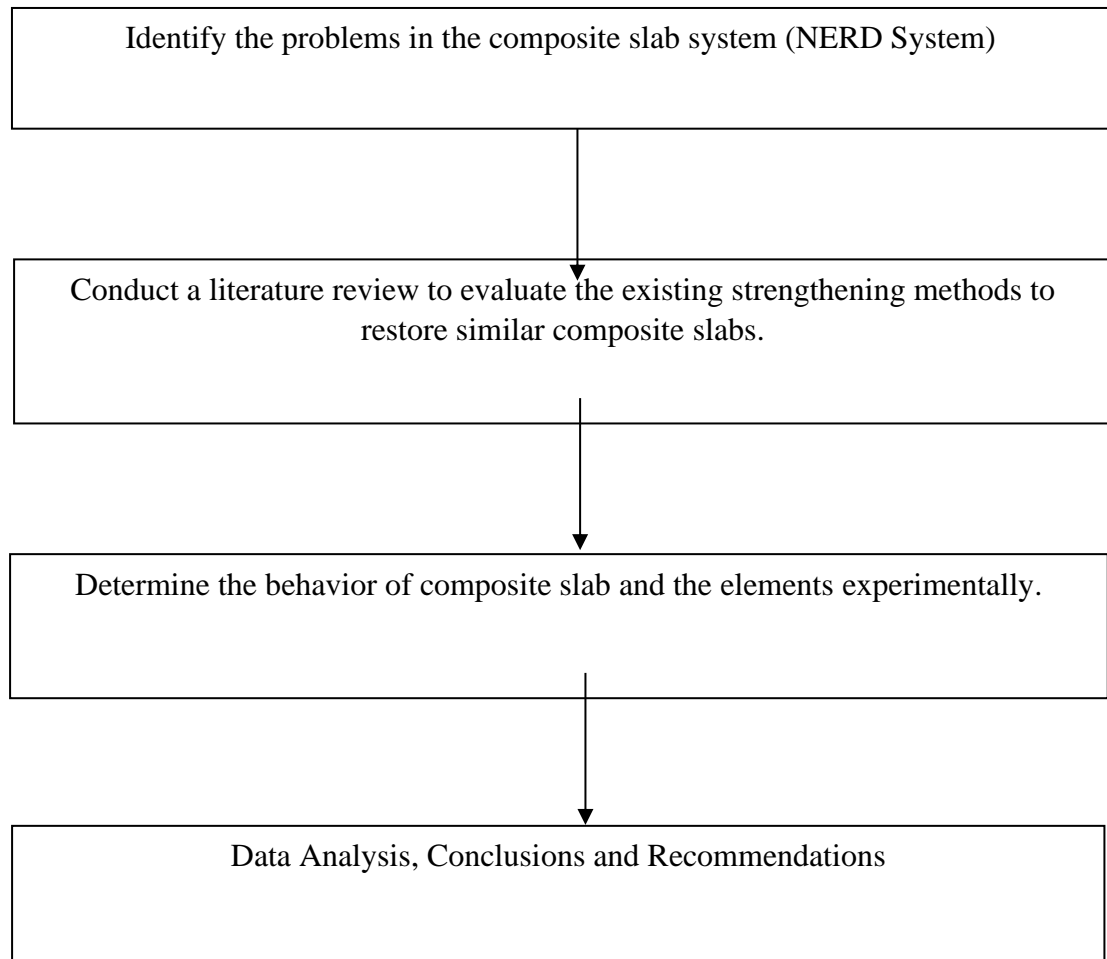
Figure 1.2: Summary of methodology

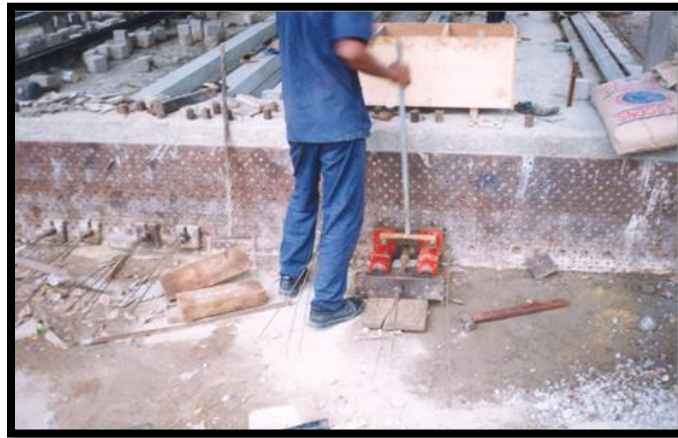
Figure 2.5: Stressing wires using special jacking arrangement.

30 m long pre-stressed wires are typically used to manufacture pre-stressed concrete beams. To stress the wires, wires are fixed at one end, and jacking is done as per the special jacking arrangement introduced by Dr. ANS Kulasinghe at the other end, as shown in Figure 2.5. The wires, which have a tensile strength of 1670 kN/mm^2 , are kept straight as much as possible by using intermediate supports before jacking. For pre-stressing, normal relaxation indented type wires of 5 mm diameter are used, and for the holding purposes of the wires, an anchor cone and an anchor pin are used at the end.

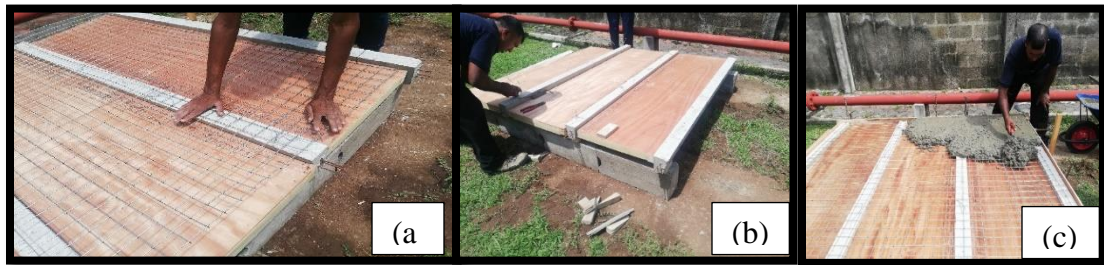
Figure 2.9: Casting the composite slab panel (a) Hang the plywood shutter (b) keeping the welded mesh at the center (c) Making the in-situ topping.

Binding wires are used to hang the plywood shutter on pre-stressed beams, and a portion of the pre-stressed beam is inserted into the concrete, as shown in Figure 2.9. 50mm in-situ topping is cast utilizing the nominal mix of grade 30 (1:1 ½: 3, ¾") concrete whereas keeping the gauge 10, 50 mm x 50 mm welded mesh at the middle of the in-situ topping.

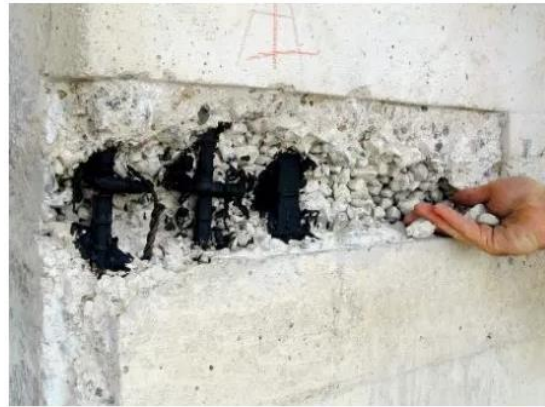
Figure 2.10: Remove damaged concrete, cut spalling concrete, brush steel bars, and coat steel bars (the constructor)

bond failure in two-course construction due to shrinkage differences between the topping and foundation courses can all cause concrete spalling. Furthermore, according to numerous researchers, the best technique to avoid spalling is to apply a repair material mixture after cleaning and coating the corroded steel bars.

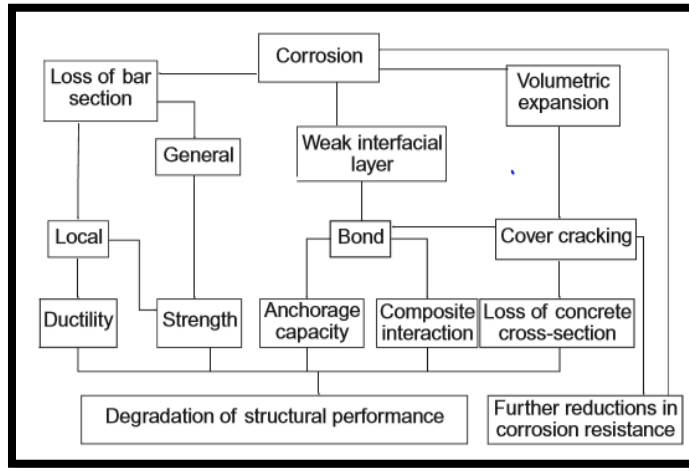
Figure 2.13: Corrosion effect of reinforcement on residual structural capacity (Cairns J. et al., 2008)

al.,1999; Fernandez et al., 2018; Craig Tahershamsi, 2016). The interrelationship of corrosion effect in deterioration is summarized in Figure 2.13.

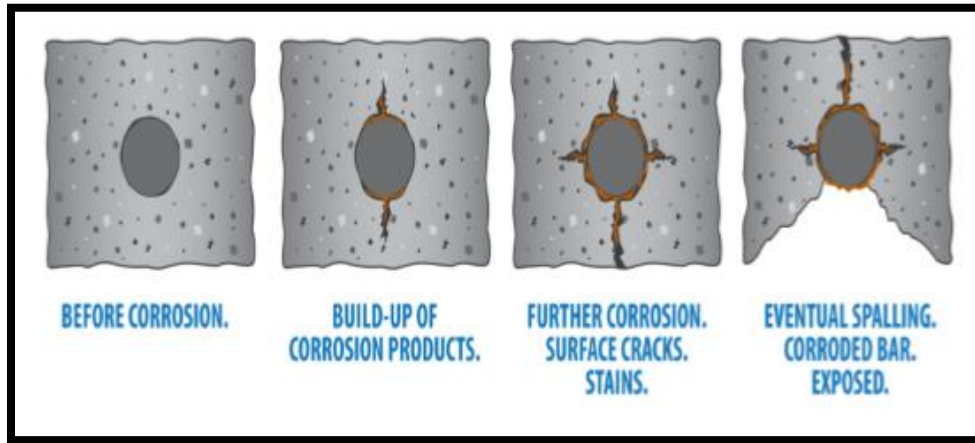
Figure 2.17: Progress of corrosion in concrete and eventual spalling (Dhawan et al., 2014)

spalling of concrete may happen, as given in Figure 2.17. Further, the loss of concrete cover significantly reduces the load-bearing capacity of the structure. (Dhawan et al., 2014)

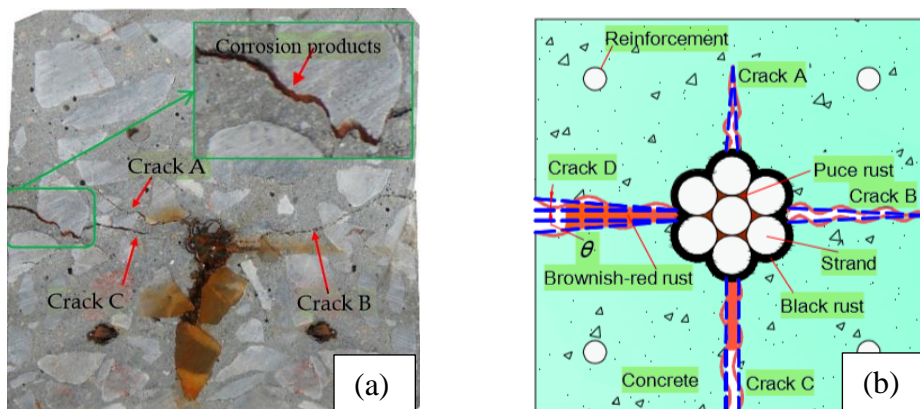
Figure 2.18: Schematic diagrams (a) Crack distribution (b) Simplified crack propagation (Wang et al., (2016))

In their work of "Concrete cracking prediction considering the filling proportion of strand corrosion products," Wang et al. (2016) has found that the crack widths have varied depending on the degree of corrosion. The triangle, rectangle, and trapezoidal stages of cracks are depicted schematically in Figure 2.18. The crack (crack A) inside concrete seems to be a triangle before cover cracking. Crack propagation (crack B) enters the surface as corrosion progresses. Cracks in the concrete surface occur, with a rectangle-shaped crack (crack C). When the fracture widens in the radial direction, it takes the shape of a trapezoid, as depicted in crack D.

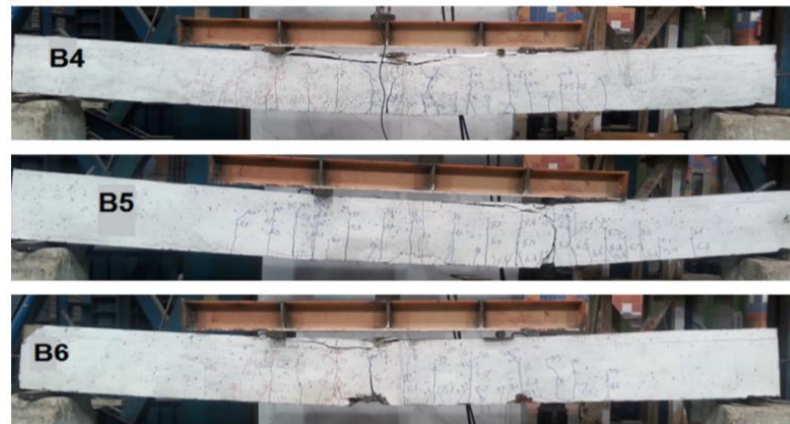
Figure 2.27: Crack pattern at the controlled specimens

The failure of all parts of the pre-stressed specimens begins with the yield of the lower main reinforcement and then the fracture of the top concrete. The cracking pattern of the partially pre-stressed beams has appeared as irregular cracks at the concrete cover with varying thicknesses as illustrated in Figure 2.27. The crack pattern of the partially pre-stressed beams has scattered along their entire length.

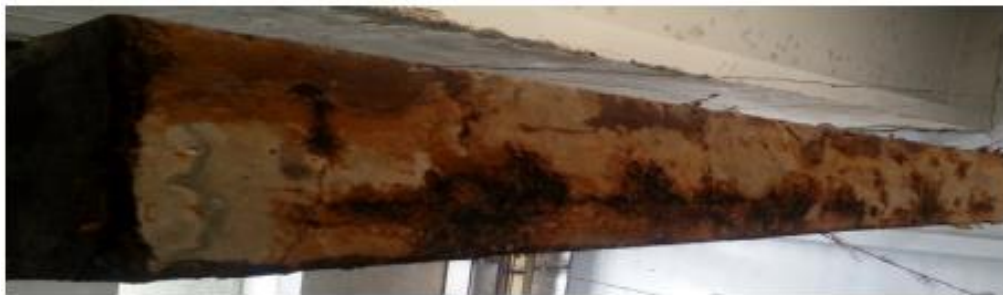
Figure 2.28: the crack pattern of corroded concrete specimen

Furthermore, they tested several samples which were partially exposed to corrosion. Consequently, they observed that a smaller amount of variance in behavior and also ultimate loading capacity and propagation of cracks along the beam. Figure 2.28 gives a clear image of cracks due to excessive stresses of corrosion.

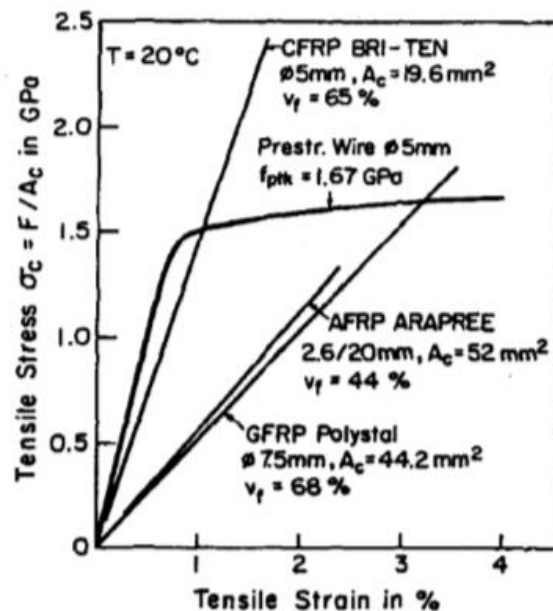
Figure 2.20: Material characteristics of CFRP, GFRP, AFRP, and Steel pre-stressing tendons (Erki et al.,1993)

In addition to that, Figure 2.20 shows material characteristics of CFRP, GFRP, AFRP, and steel pre-stressing tendons. The figure shows that CFRP, AFRP and GFRP give linear behavior of tensile stress vs tensile strain graph. Pre-stressing wires behave like steel when subjected to the tensile forces as usual. After certain point, pre-stressing wires cannot receive higher loads.

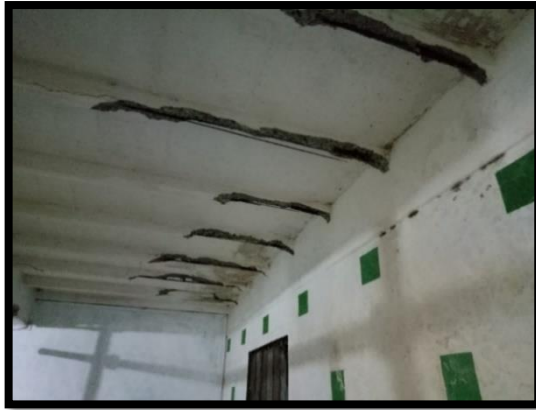
Figure 3.10: Deterioration of NERD slab system

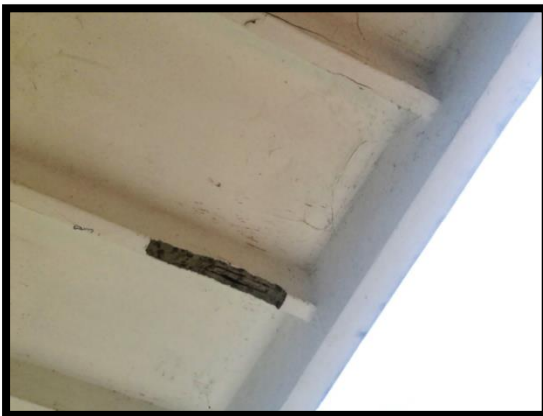
Figure 3.12: Deterioration of Pre-stressed NERD slab purlins in house located in Ekala

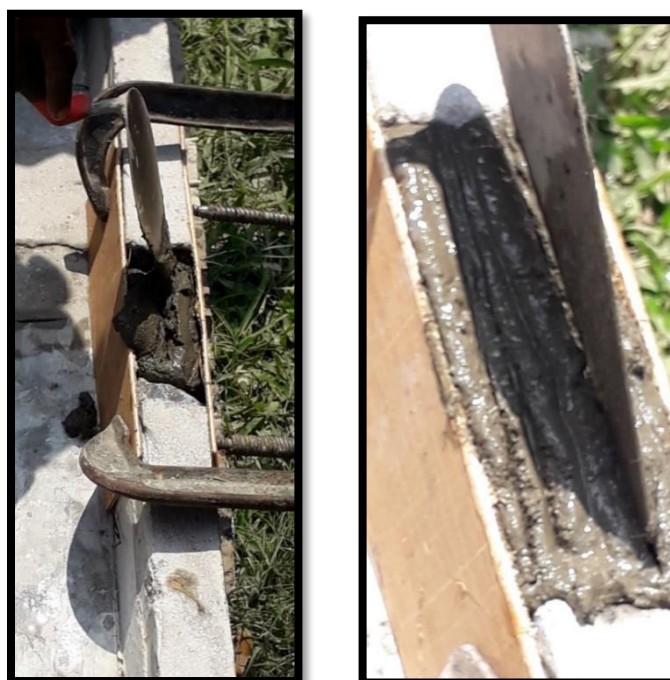
Figure 4.6: Repairing of cracks using structural repair mortar

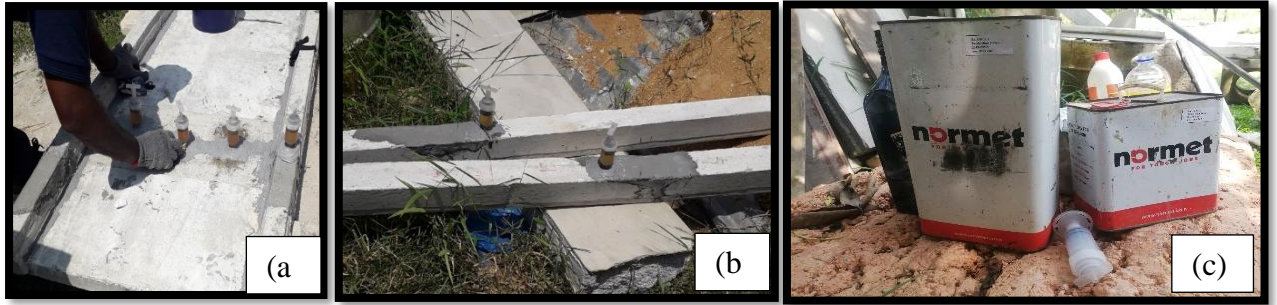
Figure 4.7: Inject epoxy resin (a) for composite panels (b) for pre-stressed beams (c) low viscosity long pot life epoxy injection resin, TamRez 220 TG

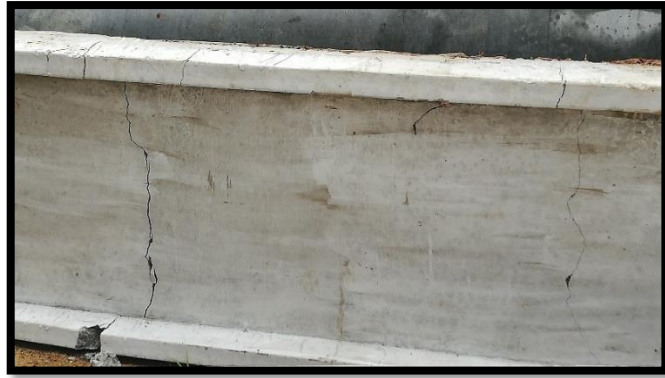
Figure 5.2: Slab failure at two supports

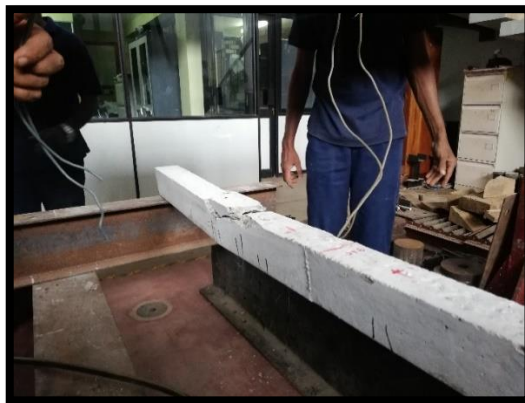
Figure 5.3: Cracking on pre-stressed beams

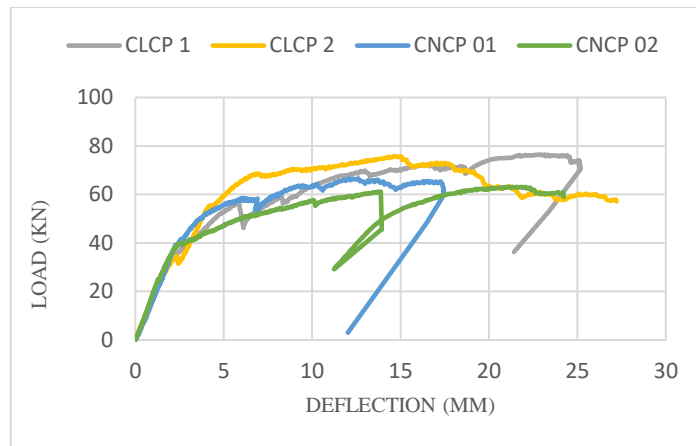
Figure 5.4: Variation of load vs deflection of composite slabs

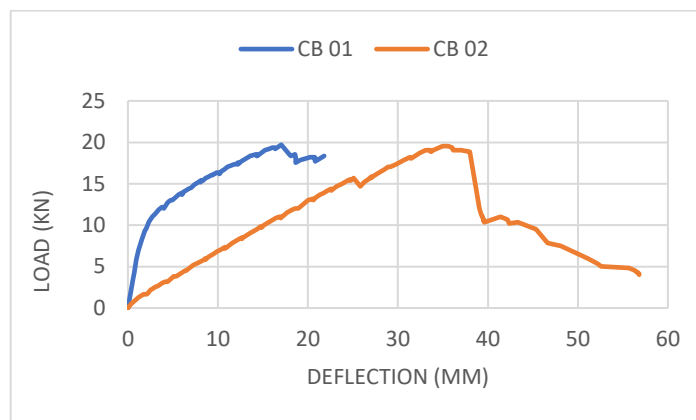
Figure 5.5: Variation of load vs deflection of pre-stressed beams

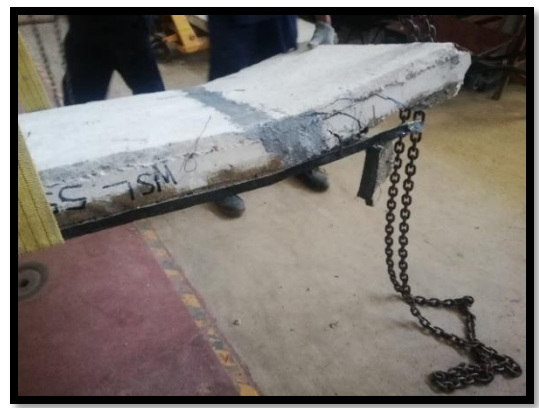
Figure 5.7: Shear cracks near CFRP wrappings

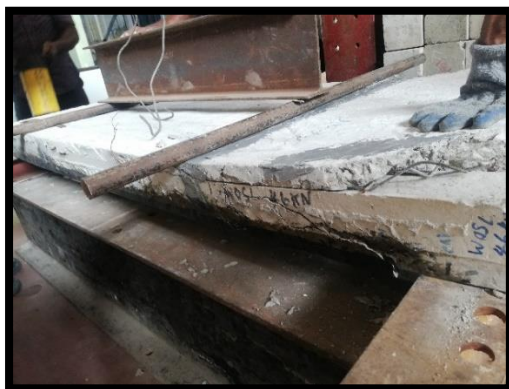
Figure 5.8: Models failed by de-bonding of CFRP

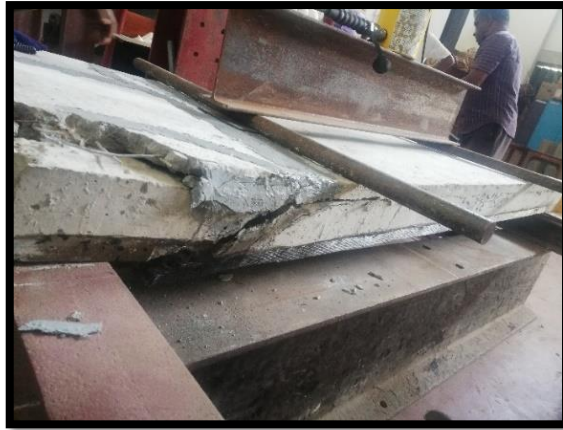
Figure 5.9: Loosening of strength between in-situ concrete and pre-stressed beam.

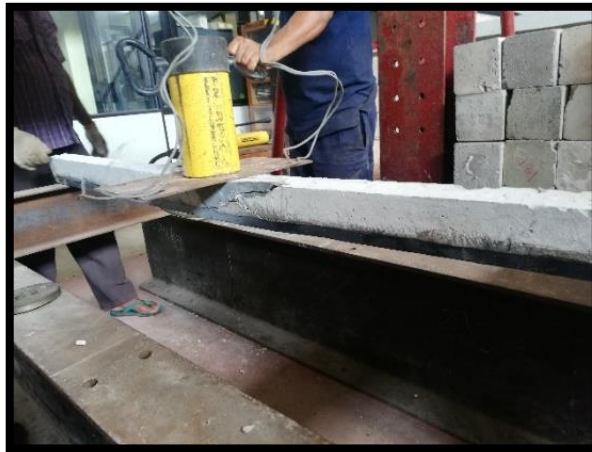
Figure 5.10: Pre-stressed beams failed due to crushing and propagation of flexural cracks.

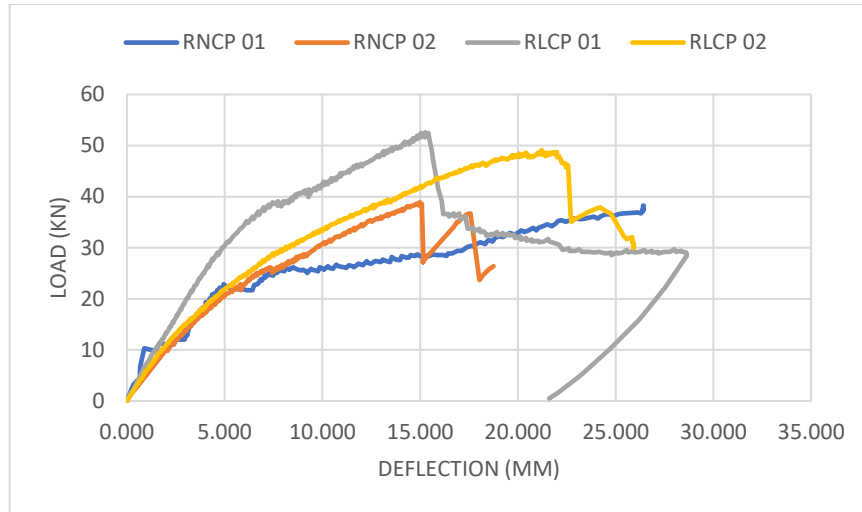
Figure 5.11: Variation of load vs deflection of composite slabs

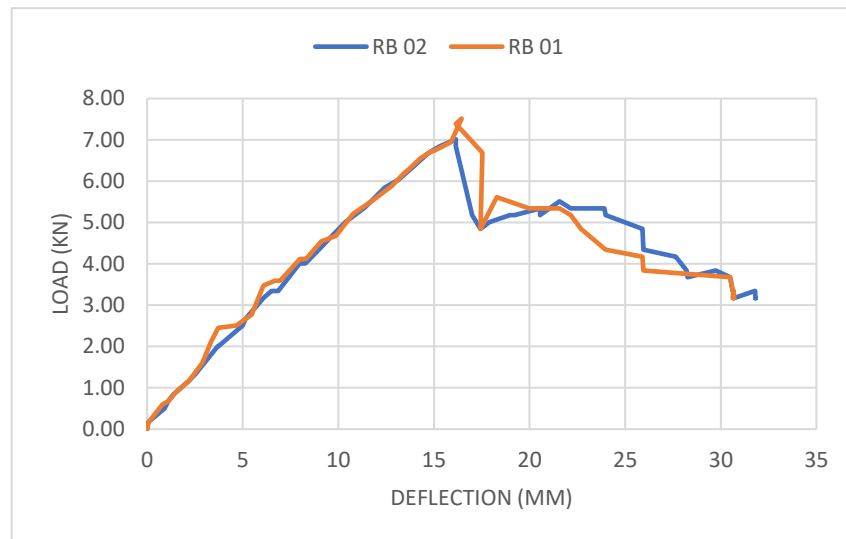
Figure 5.12: Variation of load vs deflection of pre-stressed beams

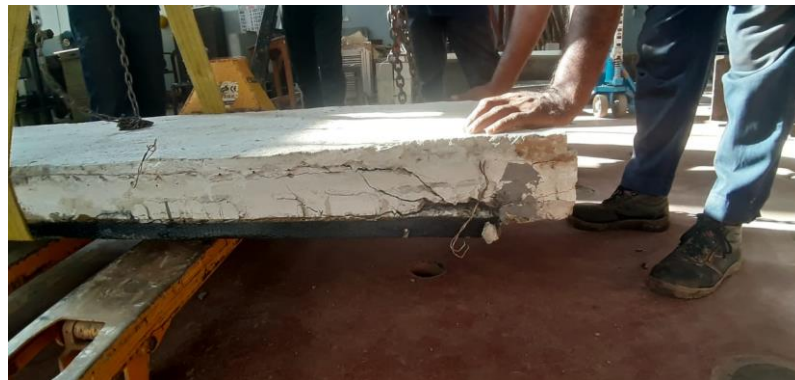
Figure 5.13: Shear and flexural cracking on strengthened models with FRP.

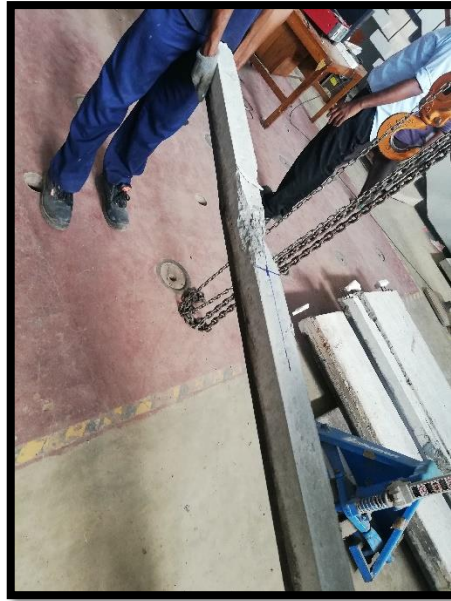
Figure 5.14: Strengthened Pre-stressed beams failed due to crushing & propagation of flexural cracks.
