Learning From the Vanishing Built Heritage of Colonial Architecture (A case of Abbottabad-Pakistan)

Undertaking Historic Conservation for the protection of vanishing built heritage

Frontier House and Commissioner House Abbottabad

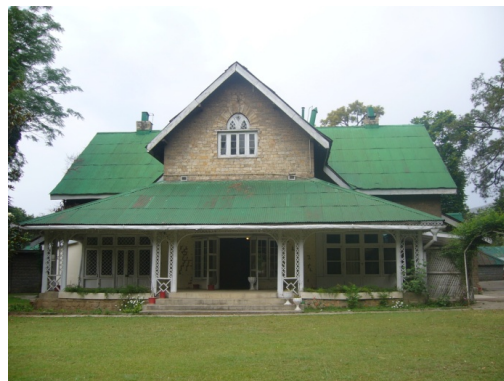
Fig. 1: Frontier House Abbottabad
Source: Author

Frontier House and commissioner House was among top priority in the list of built heritage to be conserved after the great earthquake 2005, As a result of prilimery visual survey, lot of cracks and material decay were identified, and Frontier house and commissioner house are the unique examples of British Era Architecture. (Figure. 1 & 2)

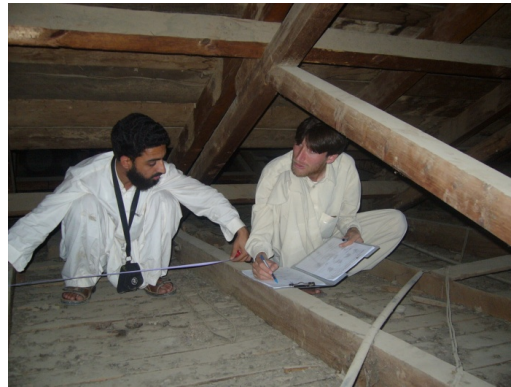
The visual survey of twin buildings is all done through the help of Heritage Architects. Each and every technical aspect of the buildings was checked during the condition survey to ensure the safety and authenticity of built heritage. The buildings were examined in details. The Architectural and Archeological features were identified by Archeologists during the condition survey. Plans and sectional details, elevation, and roof details were documented during the survey as well as primary and secondary elements and technical aspects were studied to sort out treatment. (Figure. 3)

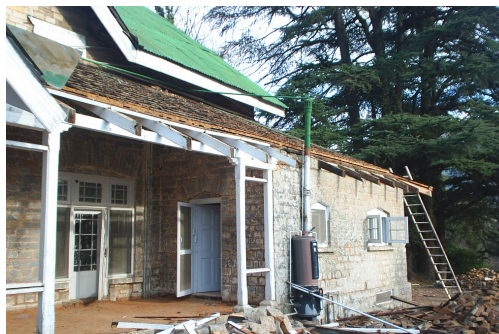
Fig. 4: Frontier House Back Side View
Source: Author

The next crucial step in conservation was to open the roof in order to identify the voids which later on might be become a serious problem in storm water management. In frontier house the access were difficult to roof due to very worse condition of the roof because of dampness in wooden materials as the structure is surrounded by heavy tall trees around the buildings. The roof was repaired in its original condition through the help of expertise. (Figure. 4)

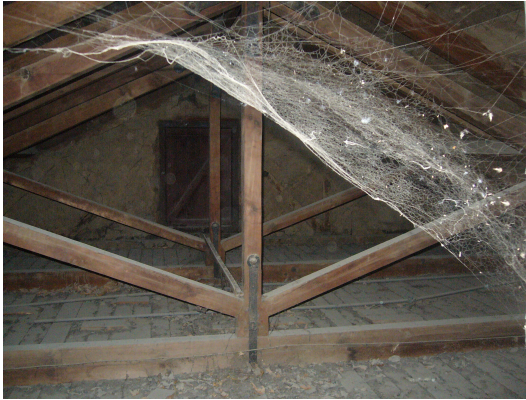
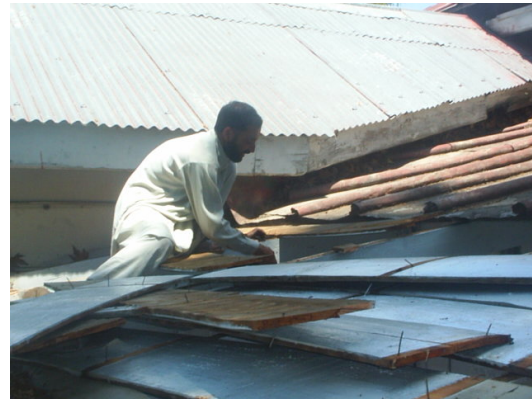
Fig. 5: Commissioner House Roof Inside
Source: Author

The assessment for the roof of these buildings was being made in order to identify the nature of damaged occurred due to the earthquake and weather condition. It was consider to accessing the roof details of the historical building and to sort out the possible solution for retaining its originality without taking any risk. (Figure. 5 & 6)

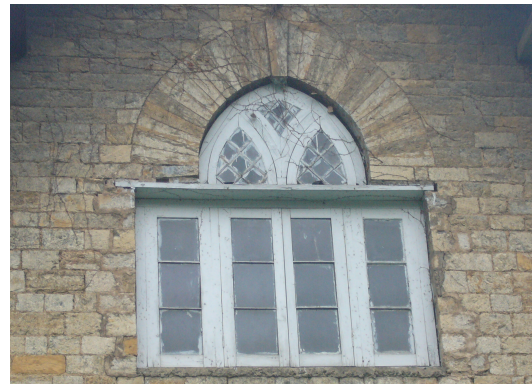
Fig. 7: Frontier House Window
Source: Author

For proper investigation of built heritage which is at stake, we were supposed to remove the herbs/sherbs on the walls and on its roof very carefully according to the experts' opinions and advice. While removing the finishing from the walls, proper consideration needs to be taken. In given figure (7) the window shown was completely damaged and due to the vegetation on the wall surface, unnecessary plants were removed from the whole building to clean and secured from the further seepage and keep the originality of the buildings maintained. (Figure. 7)

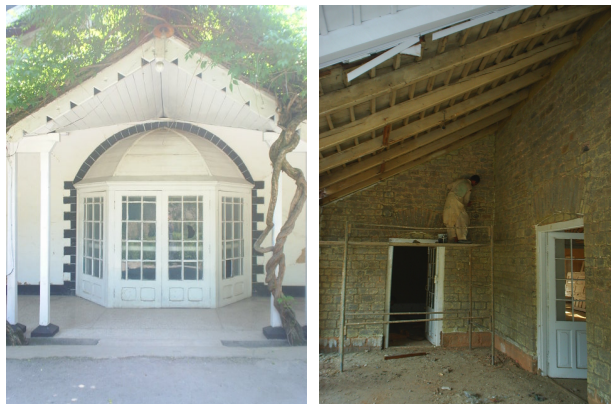
Fig. 10 & 11: Commissioner House Front and Back Entrance. Source: Author

Precautionary measures in the conservation work are of prime importance and before undergone through the conservation of Historic buildings that have been not in use for some time and are in condition of highly deteriorated state. It is important to use all safety tools, equipments and methodology before enter into the building. (Figure. 10 & 11)

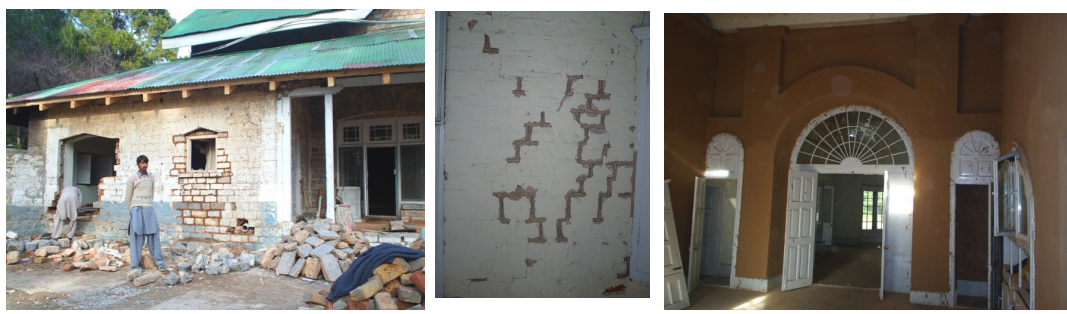
Fig. 12, 13 & 14: Frontier House Inside and Outside View during and after work. Source: Author

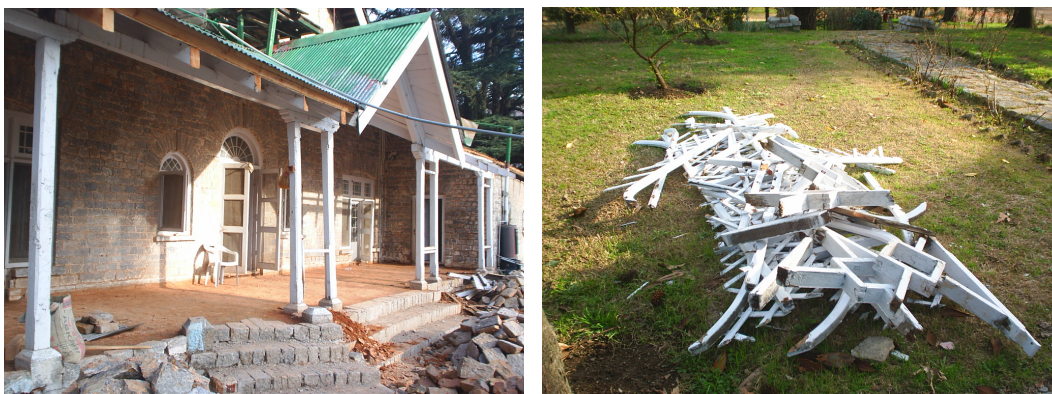
Fig. 15 & 16: Frontier House Back Side View and damaged wooden handrail
Source: Author
