**INVESTIGATING THE PERFORMANCE OF
LAMINATED GLASS PANELS UNDER WINDBORNE
DEBRIS IMPACT**

Master of Science (Major Component of Research)

Department of Civil Engineering
Faculty of Engineering

University of Moratuwa
Sri Lanka

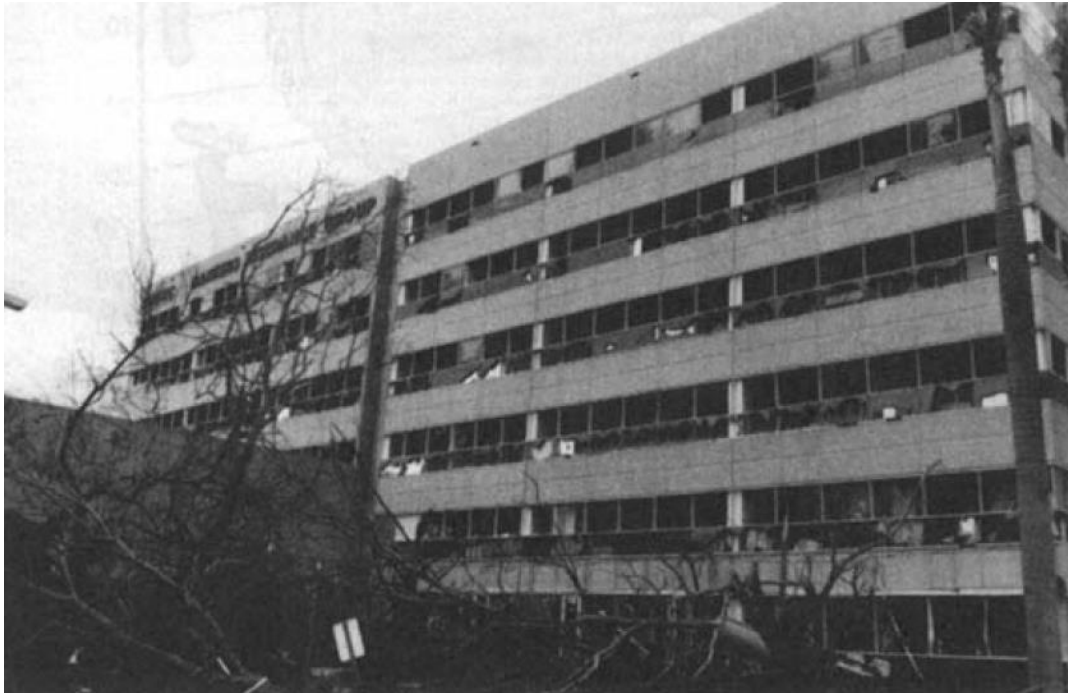
Figure 2.13 - Extensively damaged glass panels of the American Bankers Insurance Group Building, Cutler Ridge, Florida (Behr & Minor, 1994)

the broken glass pieces of the glass panels Behr and Minor (1994) reported that 6 mm thick annealed or heat-strengthened glass had been used in the spandrel glass. They found that 6 mm thick fully tempered monolithic glass had been used in the vision glass and structural silicone sealant was used along the supporting frame of the glass panel (Behr & Minor, 1994). Roof gravels and segments of failed roof structures were identified as the common debris types that made severe impacts on that building.

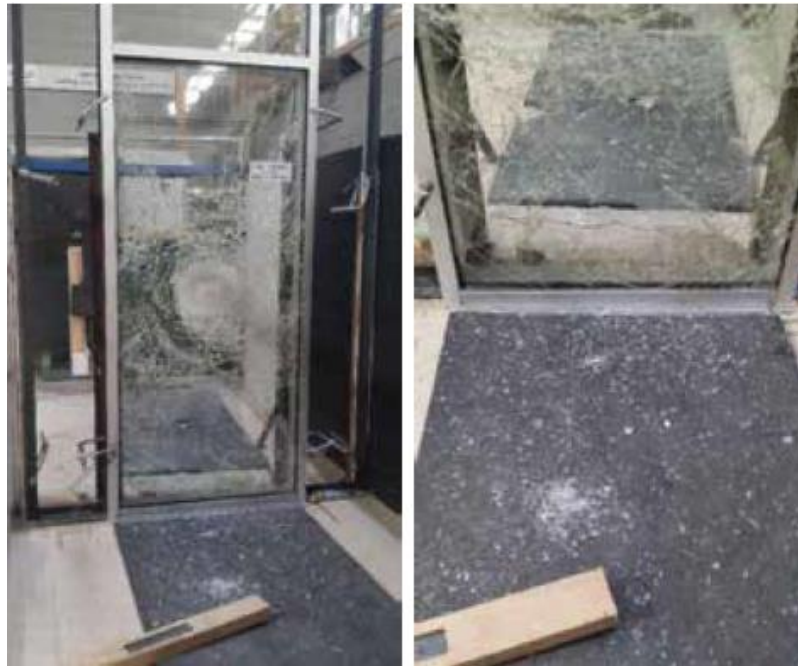
Figure 2.21 - Tested window panel (Mejorin et al., 2019)

The purpose of having an argon-filled air gap is to provide the required thermal comfort to the building. The glass window panels were tested at the Azuma Lab following the standard specifications given in the Australian Standards. Figure 2.21 shows a tested glass panel that was impacted by a standard timber missile at 40 ms^{-1} impact speed. In addition, a standard steel ball bearing test was also conducted on windows panels. After conducting standard tests, engineers identified that the selected typical window panel satisfied the impact-resisting requirements, and neither the standard timber missile nor steel balls penetrated the glass panel (Mejorin et al., 2019). Furthermore, as it was suggested by the experts, an additional impact test was conducted by impacting the timber missile at the corner of the panel. It was observed that the glass panel deformed out of the window frame and failed. Although the cyclic loading phenomenon was not tested during this testing procedure, it can also lead to tearing the glass panes from the sealant joints due to the possible movements in the outward and inward directions. However, the tested panels satisfied the minimum required performance for the podium façade system. For cyclone testing, the fracture of the inner glass pane was not considered as a failure.

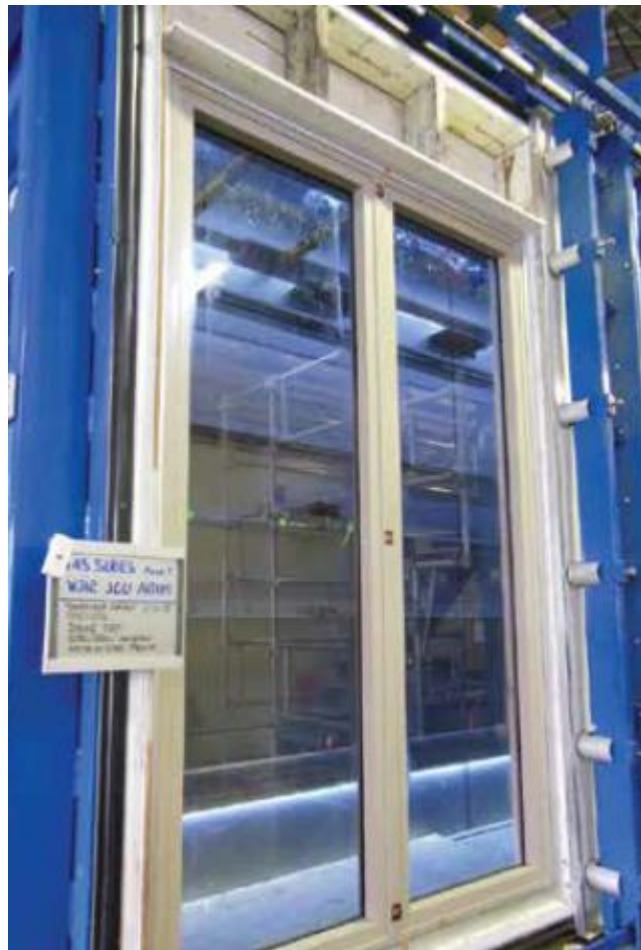
Figure 2.23 - Fixed glass window used in mock-up test (Mejorin et al., 2019)

window panels have been used in this building which can provide better weather resistance. Additionally, an extra aluminium adapter frame has been attached to the traditional window frame to improve its debris impact resistance. For debris impact-resistant glazing, an 18.84 mm thick heat-strengthened LG has been used. The window panels were tested at an impact speed of 37 ms^{-1} . After conducting these tests, it was found that the selected window panels satisfy the desired impact-resisting requirements.

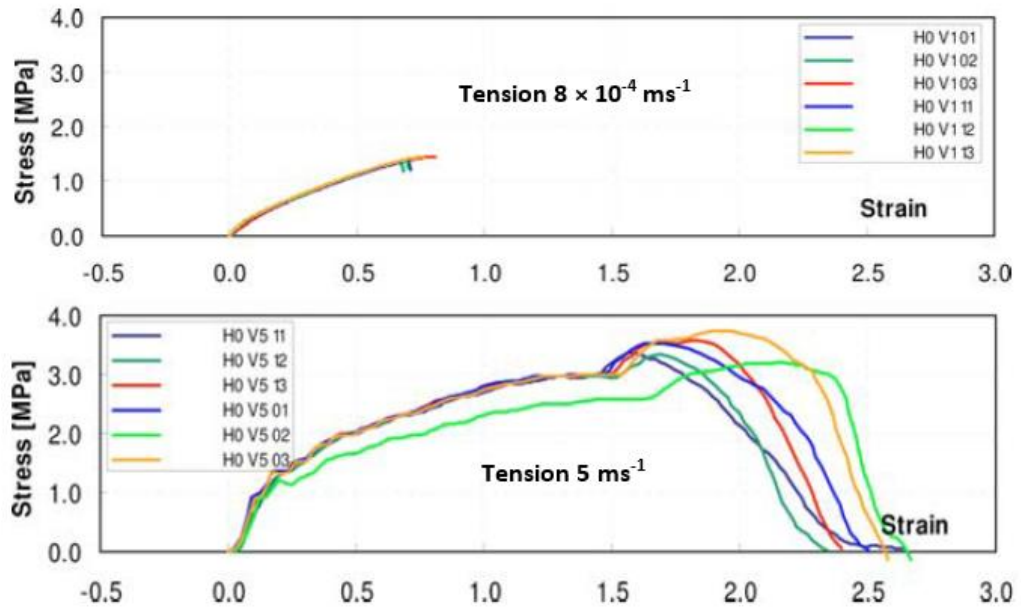
Figure 2.24 - Stress-strain curves of a typical silicon sealant specimen in tension at different movement rates (Yarosh et al., 2008)

ms^{-1} (Yarosh et al., 2008). Figure 2.24 demonstrates that silicon sealant exhibits elastoplastic characteristics when it undergoes high strain rates. Furthermore, it was found that some improvements can be seen in the strength parameters of silicon sealant as the strain rate gets higher (Hidallana-Gamage, 2015).

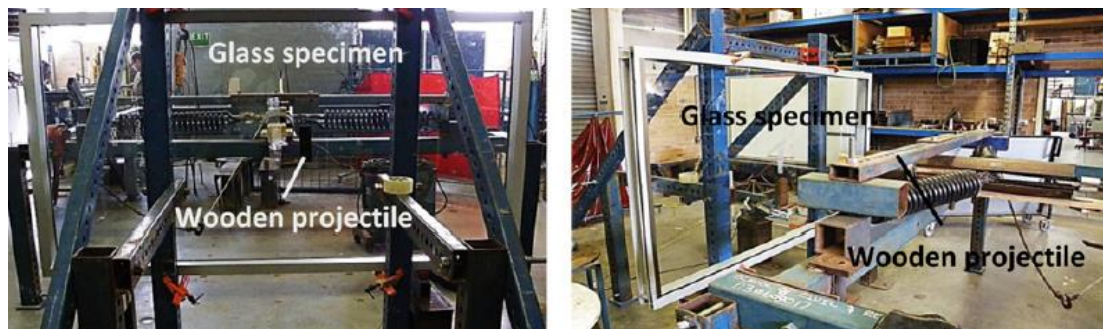
Figure 2.26 - Impact testing apparatus with a two-spring catapult system (Zhang et al., 2013)

Zhang et al. (2013) conducted a combined experimental and numerical study to investigate the response of LG window panels subjected to windborne debris impact. A standard timber block missile with a cross-section of 100 mm × 50 mm was considered in their study. The study was carried out at different impact speeds, ranging from 9 ms⁻¹ to 35 ms⁻¹, and for different debris masses: 2 kg; 4 kg; and 8 kg. Two typical panel sizes, 2000 mm × 1100 mm and 1200 mm × 600 mm were also considered in the study to examine the effect of panel size on impact performance. A testing apparatus with a two-spring actuated catapult system and a high-speed camera was used in their laboratory experiments. Laboratory tests were conducted on four different specimens at an impact speed of 15 ms⁻¹. These test specimens had different configurations with varying interlayer and glass thicknesses. Figure 2.26 shows the impact testing apparatus that was used during their tests. After conducting the experimental program, they used those laboratory test results to validate their numerical models before using those numerical models in their parametric study. It was found that the developed numerical models could approximately predict the glass cracking, maximum dynamic deflection, penetration status, and maximum strain of the back glass pane.

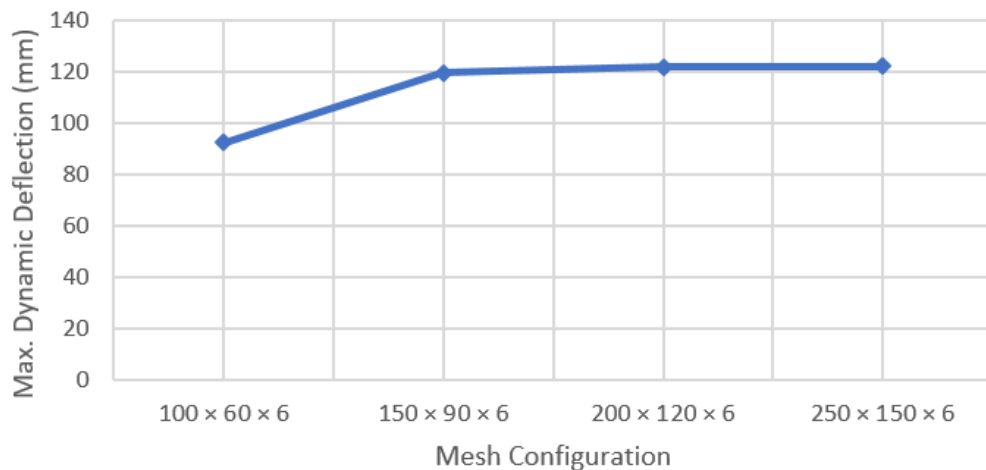
Figure 4.1 - Maximum dynamic deflection for varying in-plane mesh configurations

Therefore, the arrangement with $200 \times 120 \times 6$ elements was selected as an appropriate mesh arrangement in this study.

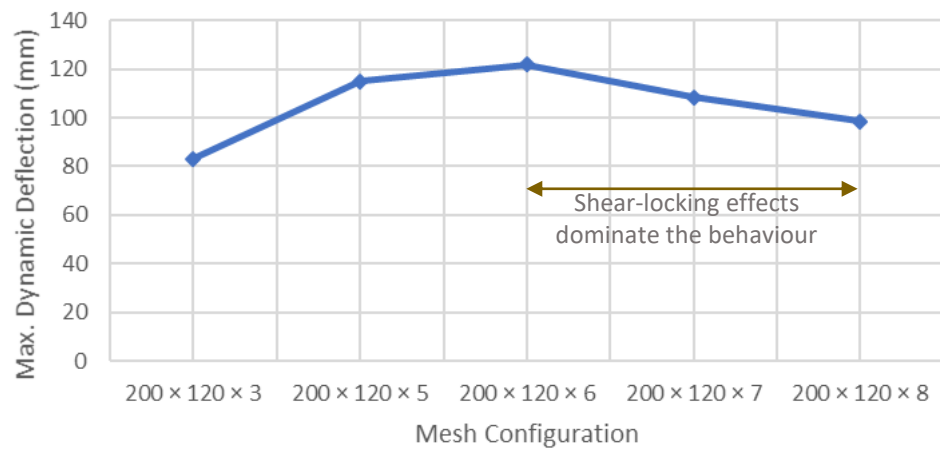
Figure 4.2 - Maximum dynamic deflection for varying through-thickness mesh configurations

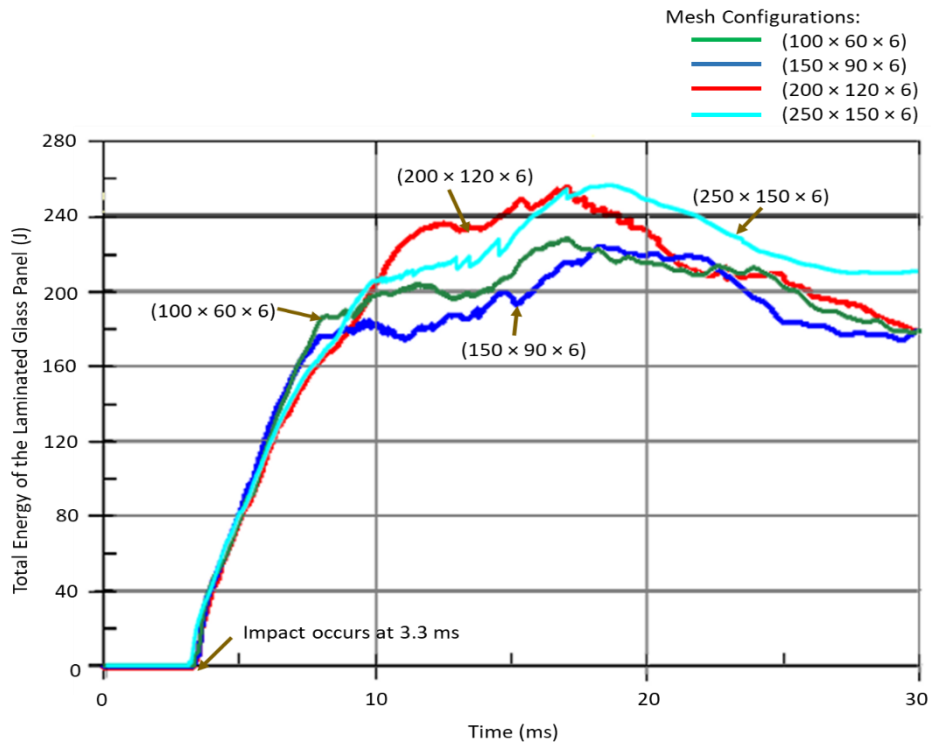
Figure 4.3 - Variation of the total energy of the LG panel for varying mesh configurations

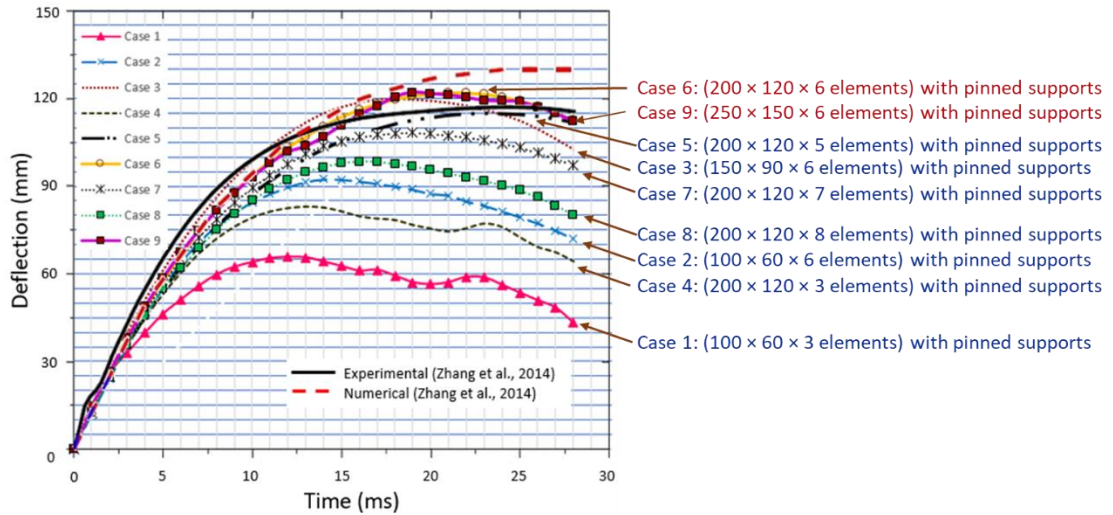
Figure 4.5 - Deflection-time history curves at the centre of the back glass pane of the LG panel subjected to mid-impact

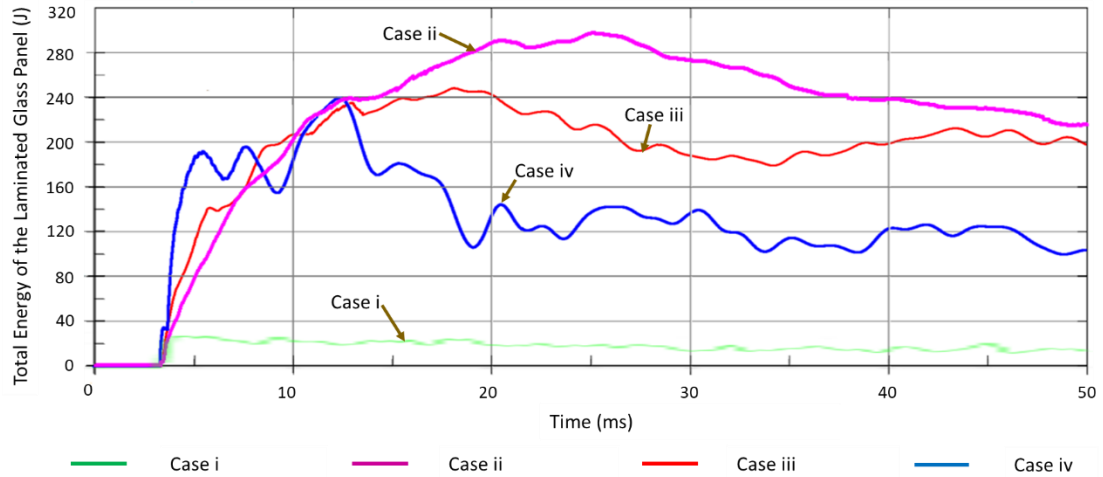
Figure 5.16 – Variation of total energy of the LG panel

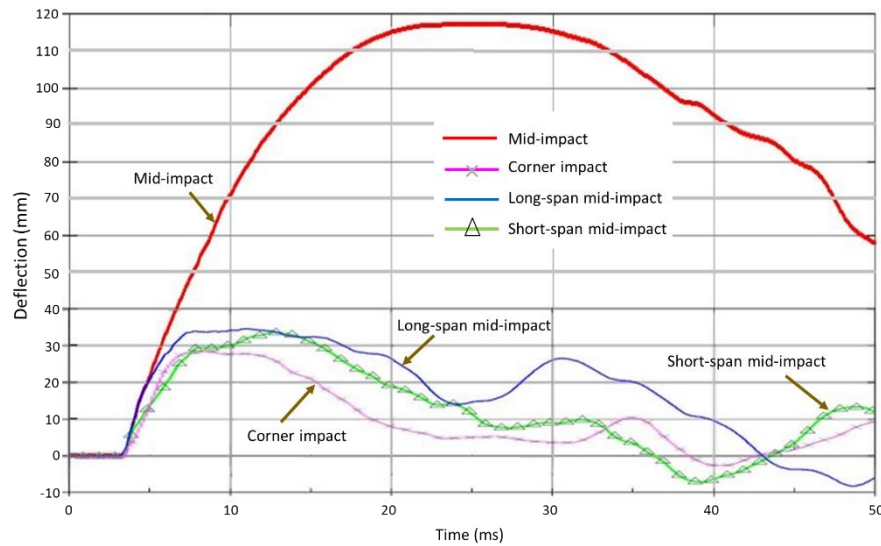
Figure 6.11 - Variation of maximum dynamic deflection of the back glass pane
