Session 2 – A

A Study of Groundwater Recovery Following Tunnel Construction in the Upper Highland Complex – A Case Study on the Ranwediya Tunnel

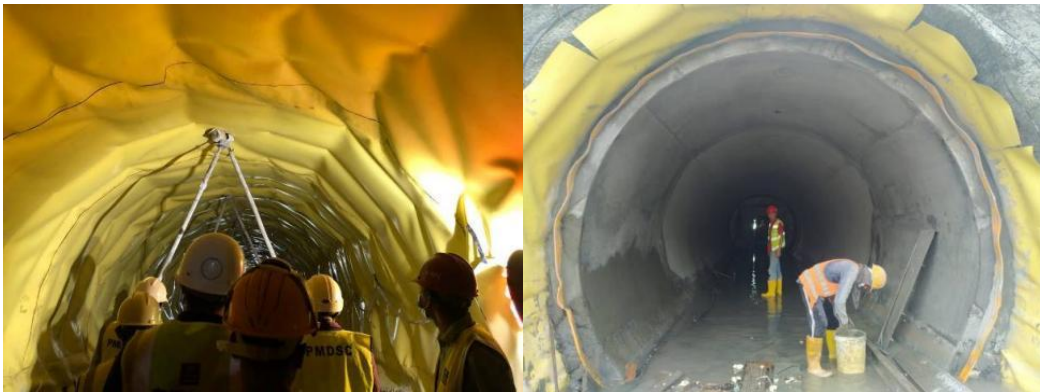
Figure 5: Applying of tunnel waterproofing

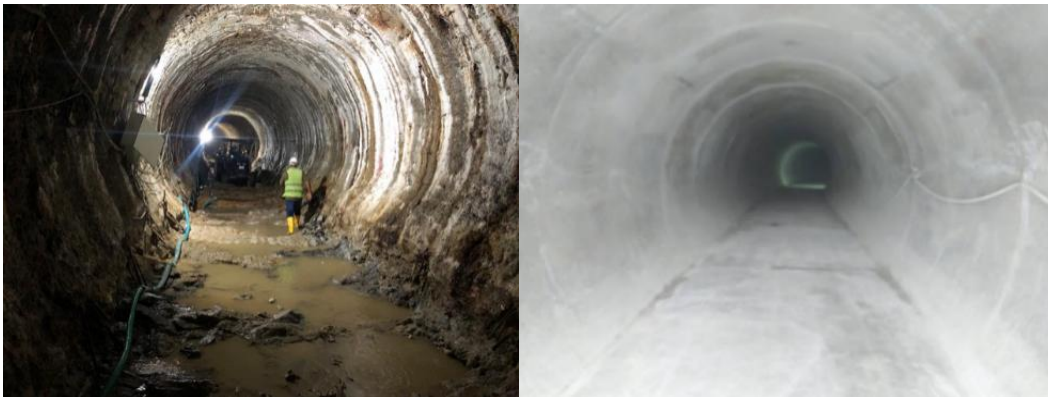
Figure 6: Comparison Before and After Application of Tunnel Waterproofing

The transition from highly weathered rock to hard fresh rock required changes in rock support and the excavation process to ensure structural integrity and stability. Monitoring systems were installed to continuously assess ground movements, facilitating real-time adjustments to construction methodologies with the application of rock reinforcement measures such as rock bolting and shotcrete in accordance with NATM principles. On completion of the excavation a waterproof lining was installed. This involved the installation of a PVC membrane and a cast in-situ concrete lining as shown in Figure 5. Application of a waterproofing membrane and lining concrete commenced in August 2022 and was completed by May 2023 and this is seen in Figure 6.

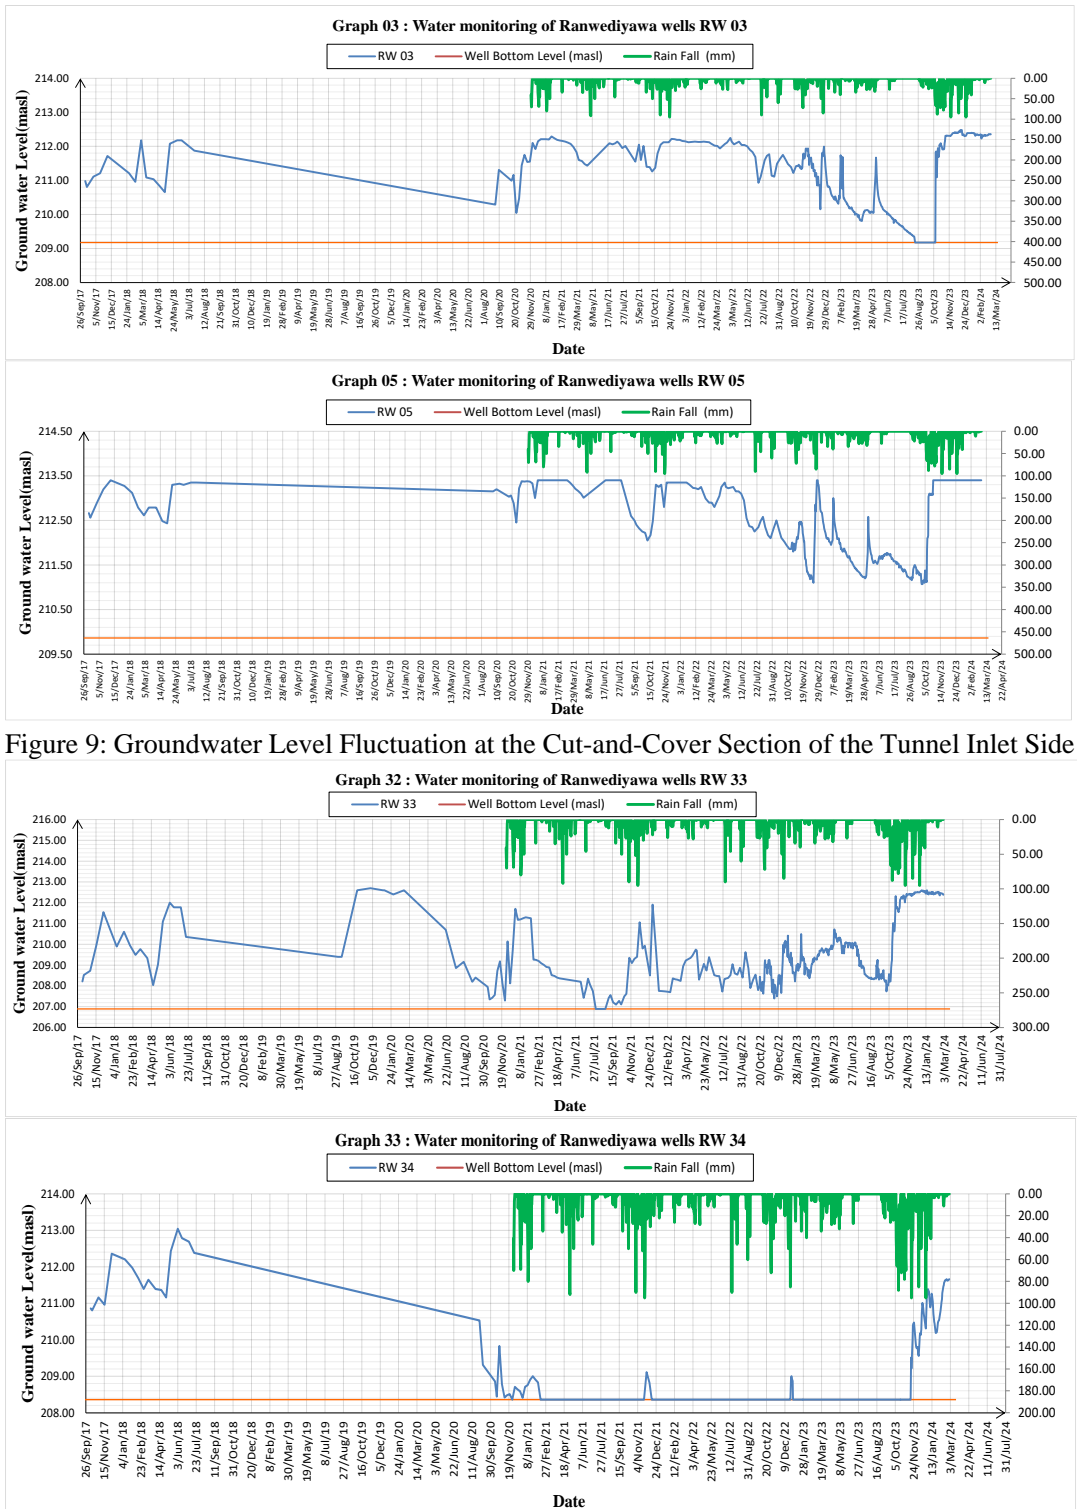
Figure 9: Groundwater Level Fluctuation at the Cut-and-Cover Section of the Tunnel Inlet Side

Analysis of groundwater level trends reveals a discernible decline in groundwater levels (GWL) concurrent with tunnel excavation activities, together with a corresponding escalation in tunnel water ingress as excavation progresses. Noteworthy is the transient increase in well water levels during rainy periods, indicative of the sensitivity of this aquifer to precipitation and groundwater recharge. However, this rise is ephemeral in nature.

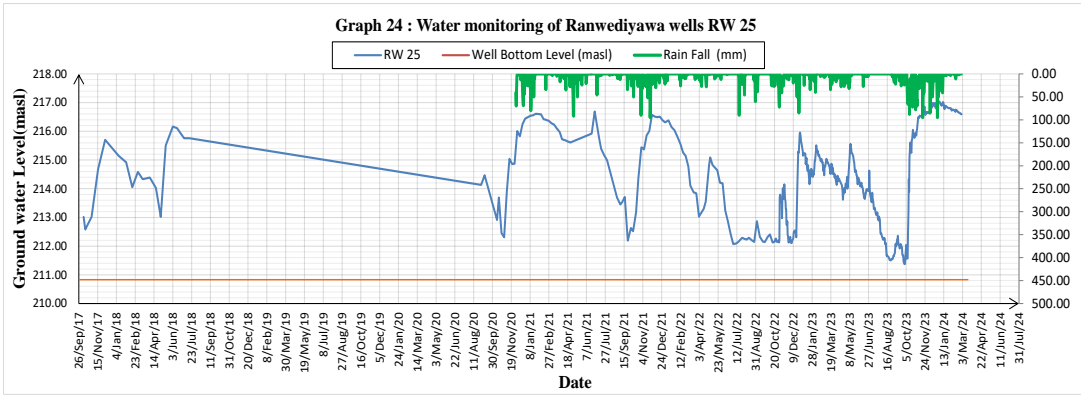
Figure 12: Groundwater Level Fluctuation during Tunnel Excavation and After Completion of the Tunnel Waterproofing System at the Center Section of the Tunnel Trace.

The wells situated in proximity to the tunnel trace experienced significant adverse effects during the excavation phase, with some wells even drying out completely. However, following the completion of tunnel waterproofing measures, a recovery trend was observed in all monitored wells. At present, all wells within the vicinity have fully regained their water levels as shown in Figures 11 and 12.
