Structural Assessment and Rehabilitation Option for YudaganawaDagoba in Buttala

Abstract

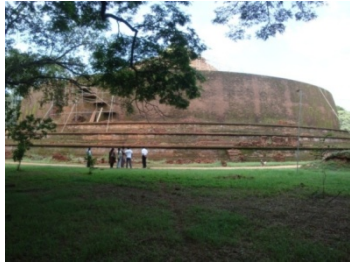
Figure2: Present view of Yudaganawadagoba

After the stupa was found in completely ruined over thousands of years (Fig.1), the first conservation and restoration works on the stupa were initiated in 1970s. After 13 years, in 1990s again some restoration works had been done on the stupa. Finally, in 2003 the conservation and restoration work on the stupa was continued by the archeological department. After all these efforts to conserve the stupa, now it is standing not to its full height but slightly above its basal rings (PesaWalalu) as shown in Fig.2.
