# STRENGTHENING LOAD BEARING MASONRY WALL PANELS USING LOCALLY AVAILABLE MATERIALS

## Abstract

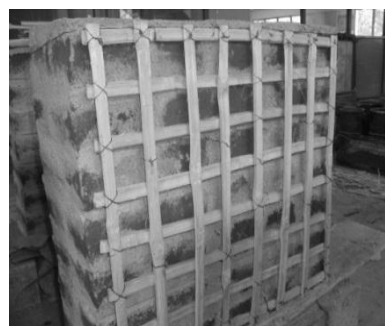
Two meshes were prepared with 20 mm wide bamboo strips and the strips were placed in 50 mm intervals (Figure 2(a)). The strips of mesh were connected at their intersecting points using binding wires. After construction of clay brick wall, this bamboo meshes were installed on both side of the wall. The meshes were easily attached to the wall surface using steel wire inserted through straws kept at pre-requisite places within the wall during its construction as shown in Figure 2(b). Then the both sides of the wall were plastered.

*Figure 2: Installation of bamboo mesh on the wall surface*

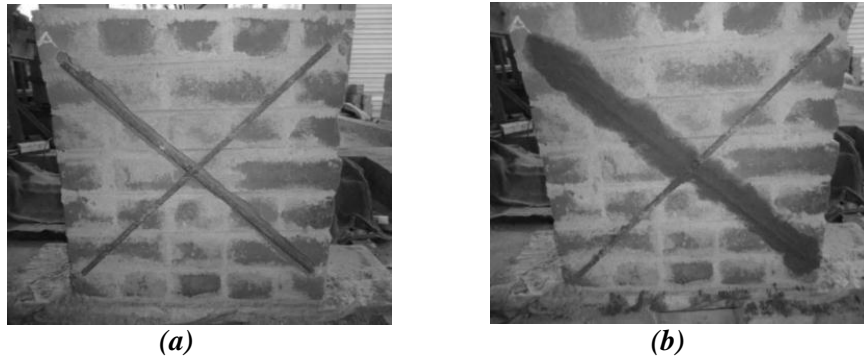
In this method, diagonally arranged two twisted steel bars, with 12 mm diameter, were installed on both sides of the wall by inserting them into grooves made on wall surface (Figure 3). The grooves were cut along the diagonal directions and then cleaned and dust was removed using an air blower. The cutting grooves were 16 mm deep and 20 mm wide. An approximately 10 mm thick grout bed was injected into grooves before placing the steel bars. Then twisted steel bars were inserted into the grooves (Figure 3(a)) with the help of the fingers and finally grooves with

steel bars were filled with grout (Figure 3(b)) and after that, the specimen was plastered using 1:5 cement :sand mortar.

*Figure 3: Installation of steel bracings on the wall surface*

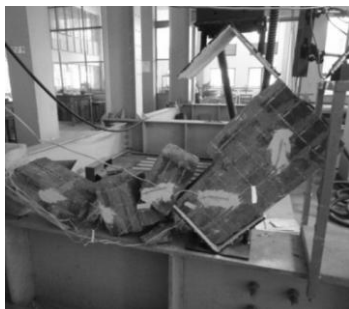
Full scaled models were used in this experimental program in order to investigate the static behavior of masonry walls. To evaluate the beneficial effects of proposed external bamboo mesh retrofitting method, steel bracing method and external PP-bands retrofitting method the diagonal compressive test was carried out on masonry wallets with and without retrofitting. Figure 7 shows the failure patterns of non-retrofitted (Figure 7 (a)) and retrofitted specimens (Figures (b), (c) and (d)). Non-retrofitted specimen displayed brittle failure and collapse where the specimens retrofitted with external bamboo mesh and PP-bands continued to maintain the structural integrity after initial cracking of the masonry plaster.

**Figure 7: (a) Non-retrofitted specimen (b) with bamboo mesh (c) with steel bracing and (d) with PP-bands at the end of the test**

Figure 8(a) shows the initial crack pattern of non-retrofitted masonry wall. It proves that, cracks were initiated through mortar joints between two rows of bricks and did not harm the bricks. Figure 8(b) shows the crack initiation on plastering layer of retrofitted wall with bamboo mesh. It could be observed that, cracks were propagated in wider area on plastering layer of retrofitted wall instead of concentration the few major cracks into specific area as in control non-retrofitted specimen. During loading, the mesh acted to maintain panel integrity allowing the load to be redistributed throughout the mesh and masonry (shown by the formation of further cracks upon continued loading) and the bricks have not been damaged at failure and bricks have been separated due to the failure of mortar joints. A similar behavior was showed by the wall retrofitted with PP-bands (Figure 8(d)) too. In case of using steel bars, few cracks were appeared near to the loading point and propagated to center area. And at the end, a brittle failure could be observed and a considerable amount of bricks have been damaged at the failure (Figure 7(c)).

Figure 10 shows the load variation with the time. The wall retrofitted with bamboo strips has failed after a considerable time period. Even after around 6.5 minutes from load application the bricks did not separate from wallet (Figure 7 (b)). The control wall failed after 50 seconds and walls retrofitted with steel bars and PP-bands failed after 4.7 minutes and 3.8 minutes, respectively.

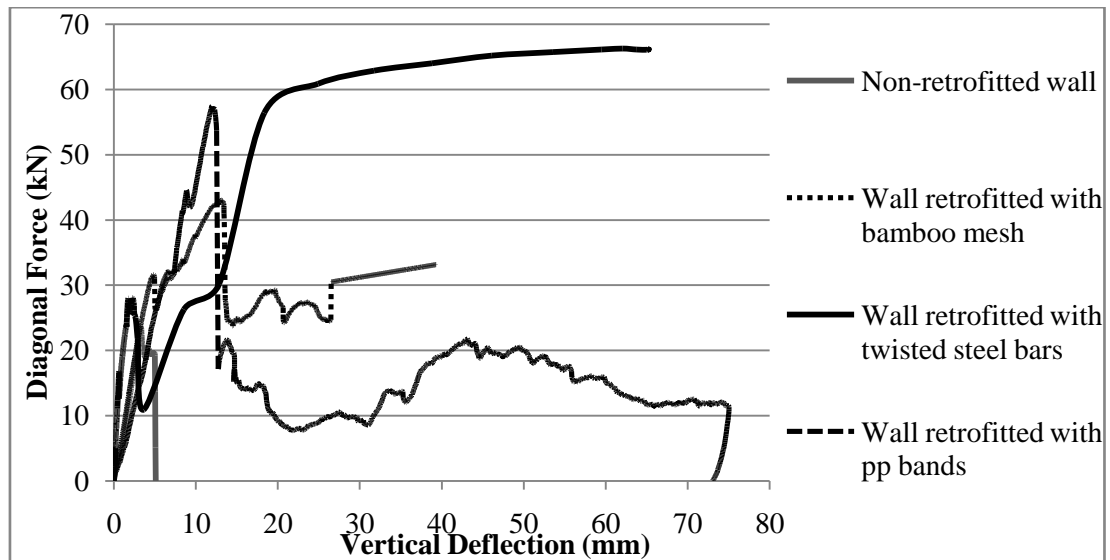
The diagonal compressive strength variations with vertical deformation for the non-retrofitted and retrofitted specimens are shown in Figure 9. The influence of bamboo mesh and PP-bands on strength can be observed even before the first cracking (Figure 9). The critical crack formation (i.e., peak strength) of non-retrofitted specimen was at 23.73 kN and 80.4% of peak strength was remained. However, there was no regaining of strength again and no residual strength left after two or three cracks appeared in non-retrofitted wallet. In retrofitted wallets with bamboo strips and PP-bands, initial cracking was followed by a sharp drop with remaining of 55.2% and 29.86% of its peak strength, respectively. After it, subsequent strength drop was quickly regained due to the elastic behavior of bamboo and PP-bands. At the end of the test regarding to both of these two techniques, the plaster layer was almost lost but the retrofitted wallets did not lose its stability.

**Figure 9: Load vs. vertical deformation for different test specimens**

When consider the test wallet retrofitted with twisted steel bars (Figure 9) it could be observed that the wallet resisted a considerably higher load than the walls retrofitted with bamboo strips and PP-bands. But there was no any strength regain after cracking and only a very few amount of cracks could be observed at peak load. The highest peak load could be observed in the wallet due to the high compressive and tensile strength of inserted steel bars.
