Reconstruction vs Retrofitting of a Bridge for Sustainability

P.B.R. Dissanayake, A.M.A.C.S. Bandara and R.M.S.U.P. Rathnayaka
Faculty of Engineering
University of Peradeniya
SRI LANKA

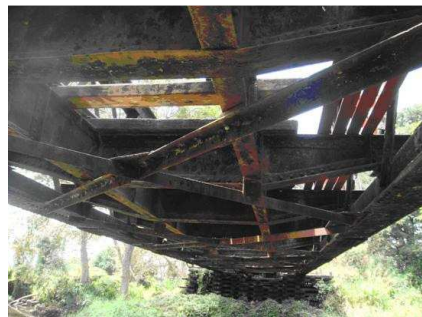
Corroded load carrying elements

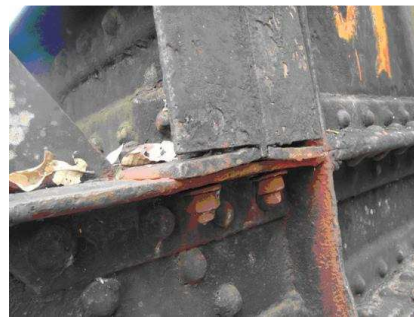
Defective connections

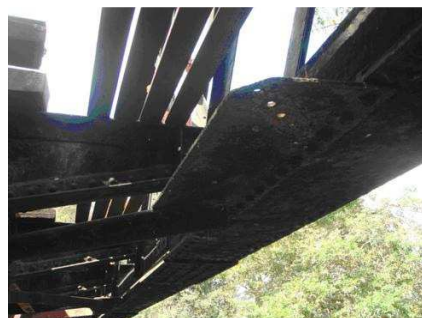
Missing elements and rivets

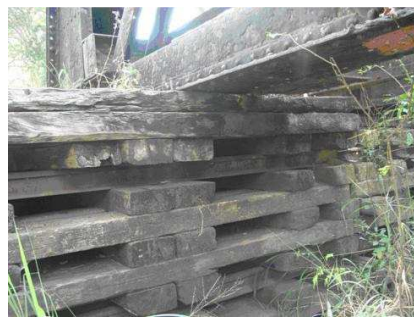
Temporary abutment

As per the assessment results, it was decided to reuse the bridge with necessary improvements. Accordingly, following improvements were recommended. (a). Placing the bridge on newly built reinforced concrete abutments, (b). Making the railway track straight near the bridge to reduce lateral stresses when the train travels on the existing curved railway track, (c). Cleaning the steel structure completely using sand blasting techniques, identifying the defective elements and replacing them (these improvements increase the fatigue life of these elements as well as the stiffness of the bridge), (d). Applying a corrosive resistant paint, (e). Placing new steel sections for missing elements and bolts for all missing rivets, (f). Aligning the railway track as smooth as possible to reduce vibration, (g). Placing sleepers at regular intervals, (h). Providing a proper river bank protection and (i). Regular maintenance. Figure 4 shows the bridge after improvement works.
