Long Term Performance Test of Low Span Low Cost Masonry Slab (without reinforcement) under Static Load, Repeated Load and Impact

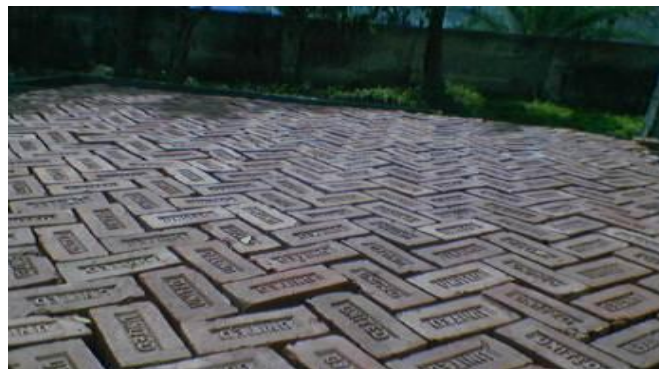
Figure 6: Photograph of Close view - showing the interspaces 12.7mm in bricks

In this study, a two panel masonry slab each of $3\text{m} \times 1.5\text{m} \times 0.075\text{m}$ are cast with brick module placed flat providing 0.075m thickness for the slab. The interspaces between the modules (12.7 mm) are sealed with mortar.

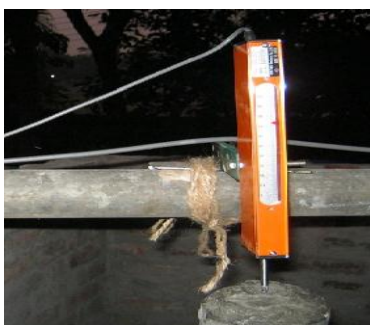
Figure 8: LVDT setup

To perform the static load test, a brick wall of height 1.2m and 125mm in thickness was constructed around the 3.65m×1.52m slab. Then water pump was used to fill the 3.65m×1.52m×1.2m chamber on the slab. Linear Voltage Displacement Transducers (LVDTs), portable data logger and computer arrangements were used for data acquisition. LVDTs were instrumented as shown in Figure 8 and connected with data logger (Figure 9).

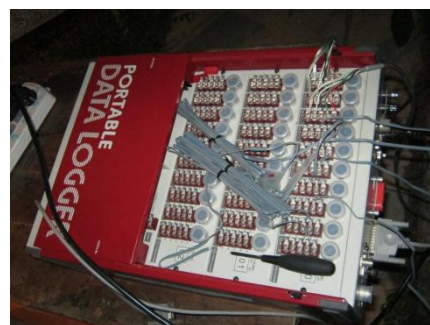
Figure 9: Portable Data Logger

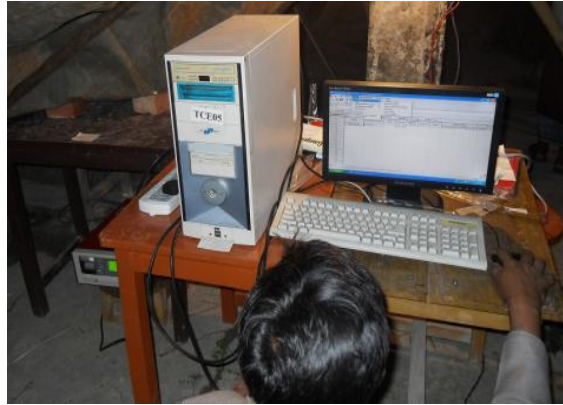
Figure 10: Data acquisition devices

To perform the repeated load test, similar instrumentation was done. In this case, the height of water was increased again decreased gradually with respect to time and the reading changes in the data acquisition devices were observed. This was repeated 10 times.

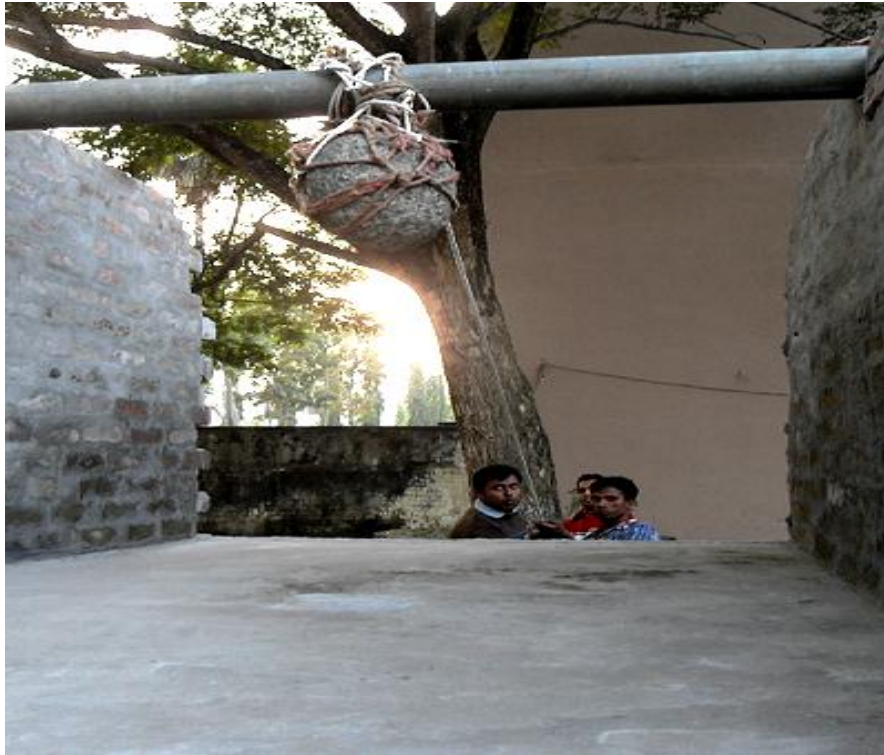
Figure 11: Impact test setup with round hammer ball, 1m free fall on slab

To perform the impact load test on the masonry slab a weight of 23 kg was set to free fall on the slab from a height of 1 m as shown in Figure 11. Figure 12 shows the indigenous arrangement for the application of impact load.

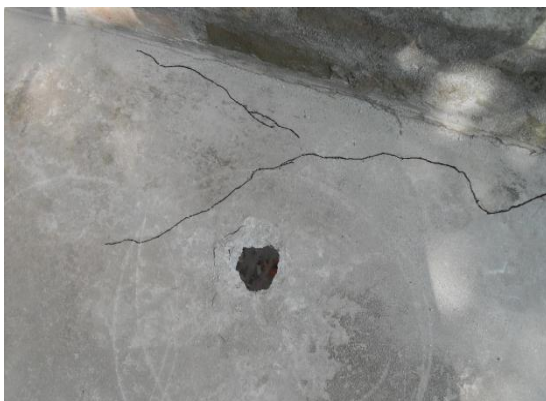
Figure 13: Crack at Point c

Table 1 shows the number of drop required for punching failure. From the test it was observed that the masonry brick slab though a brittle material, it did not failed catastrophically rather than just failed locally due to punching. In Panel A at 'b' point was tested first, but no significant crack was showed after punch of this point. On the other hand when 'c' point was tested it showed few cracks as shown in Figure 13. However significant cracks were observed when impact load were induced at points 'd' and 'e' of Panel B (Figure 14 and 15). Crack patterns showed the brick failure of the slab rather than joint failure. Hence it reveals combined action of the matrices while the structure induced to load.

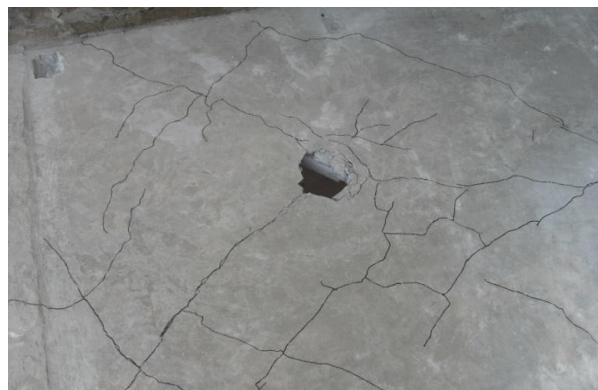
Figure 14: Crack at Point d

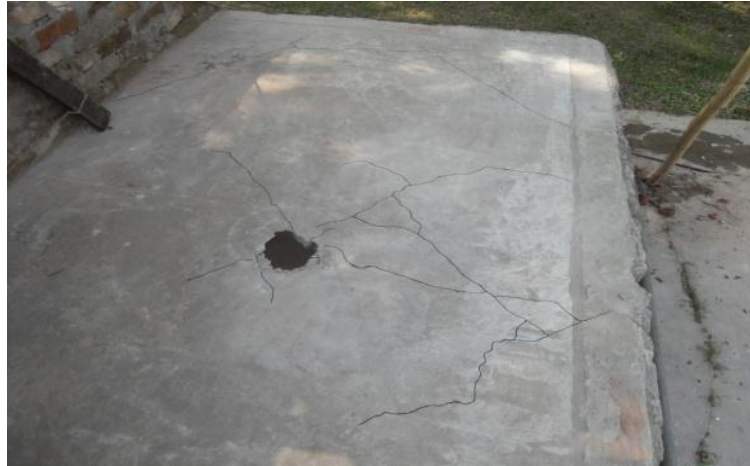
Figure 15: Crack at Point e
