# Rehabilitation of Yudaganawa Dagoba in Buttala, Sri Lanka

## Abstract

Yudaganawa dagoba in Uva province is one of the largest stupas in Sri Lanka which dates back to 2<sup>nd</sup> century BC. Presently, this colossal stupa with a diameter about 91.2 m and reaching a height of 13 m is undergoing several issues which necessitate it to be rehabilitated. The stupa was found in ruins and grown with vegetation until it has been preserved by subsequent restoration efforts in the recent past. However, it is not standing at its original height well-matched with the circumference at its base. Further, existing formation of the structure, existing foundation and ground condition are unknown. This paper presents structural assessment of existing stupa and proposal for rehabilitation in order to build the stupa to its full height.

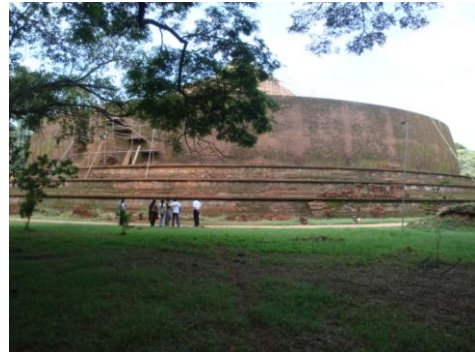
Figure 2: After conservation of the stupa

After the stupa was found in completely ruined over thousands of years (Fig.1), the first conservation and restoration works on the stupa were initiated in 1970s. After 13 years, in 1990s again some restoration works had been done on the stupa. Finally, in 2003 the conservation and restoration work on the stupa was continued by the archeological department. After all these efforts to conserve the stupa, now it is standing not to its full height but slightly above its basal rings (Pesa Walalu) as shown in Fig.2.

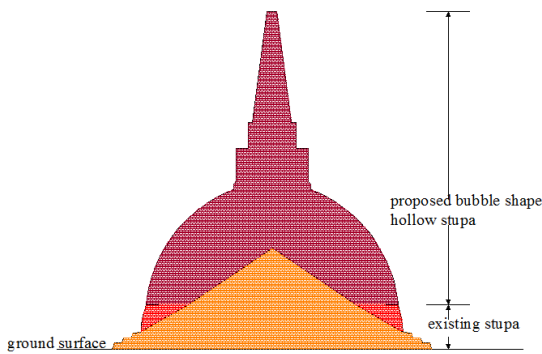
Figure 4: Alternative 1  
Bubble shape solid brick stupa

Several alternative models were developed considering the shape as bubble and heap of paddy and then considering the method of construction as hollow concrete structure and solid brick structure. The proposed alternatives are as follows:

An axisymmetric model was used in the analyses as shown in the above fig. 4.4, 4.5 and 4.6 respectively where Asolid element incorporated in SAP 2000 was used. The Asolid is a three- or four-node element for modeling axisymmetric structures under axisymmetric loading. It is based upon an isoparametric formulation that includes four optional incompatible bending modes. The element models a representative two-dimensional cross section of the three-dimensional axisymmetric solid. The axis of symmetry may be located arbitrarily in the model. Each element lies fully in a plane containing the axis of symmetry.

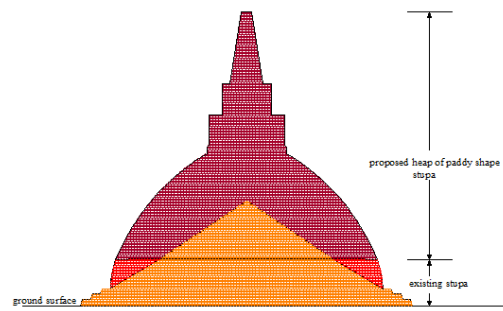
Figure 5: Alternative 2  
Heap of Paddy shape solid brick stupa

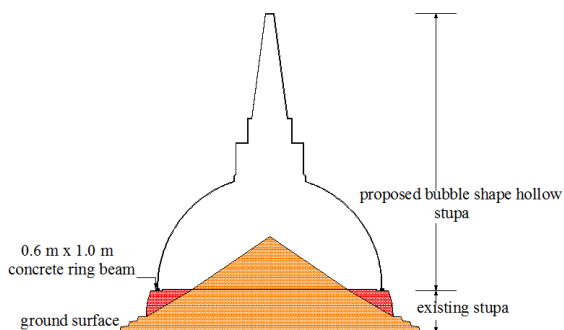
Figure 6: Alternative 3(1)  
Bubble shape hollow stupa

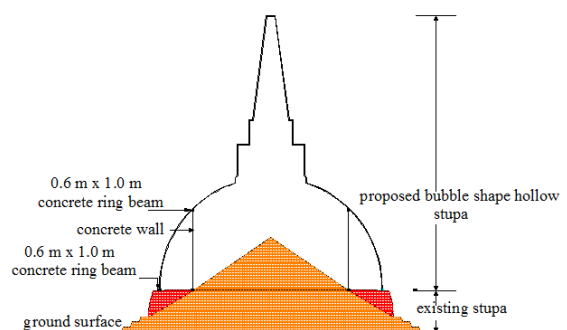
Figure 7: Alternative 3(3)  
Bubble shape hollow stupa

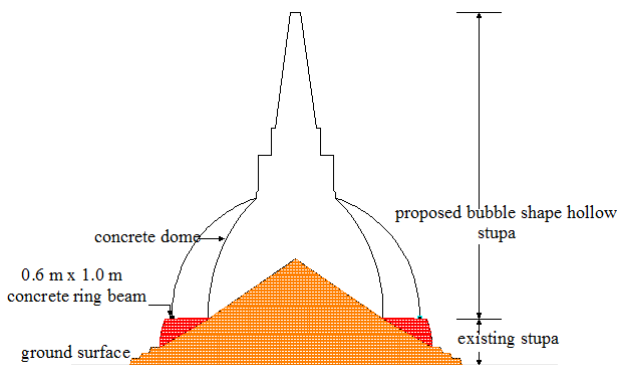
Figure 8: Alternative 3(2)  
Bubble shape hollow stupa

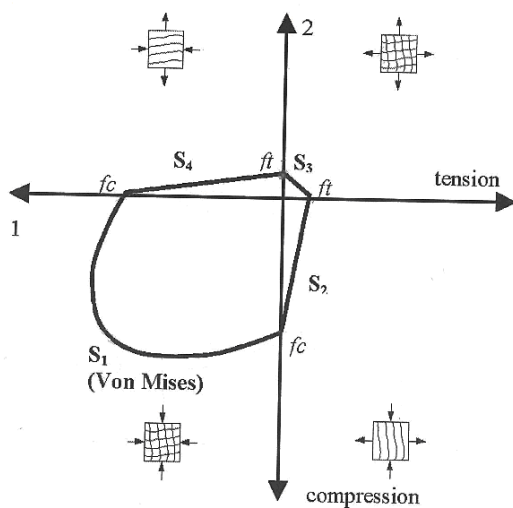
In our study, the behavior of the masonry in stupa was assumed as proposed by Symarkesis (Symarkesis, Antonopoulos and Mavruli 2005) based on modified Von-Mises theory. A failure area developed based on modified Von-Mises theory was used to check the possibility of cracking in the brickwork of the stupa. This area is defined by the union of four surfaces  $S_1$ ,  $S_2$ ,  $S_3$  and  $S_4$  as shown in the following figure.

$$S1: \sigma_1^2 + \sigma_2^2 + \sigma_1\sigma_2 + 3\tau^2 - f_{wc}^2 = 0$$

$$S2: \sigma_2 + \left(1 - \frac{\sigma_1}{f_{wt}}\right) \sqrt{f_{wc}^2 - 3\tau^2} = 0$$

$$S3: \sigma_1 + \sigma_2 - a = 0$$

$S_4$  – symmetrical to  $S_2$

Figure 9: Modified Von-Mises failure criteria for masonry

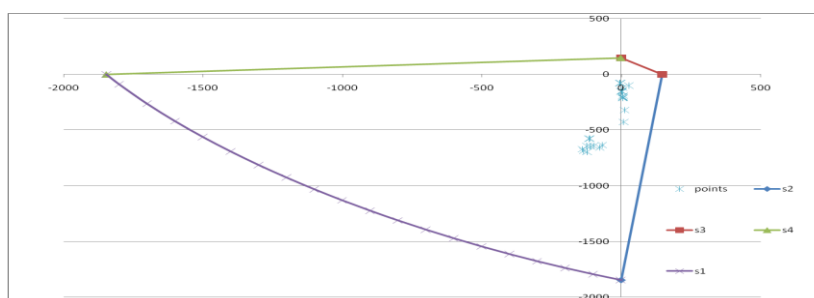
Figure 10: Principal stresses in the failure surface – New brickwork (Alternative 1)

The maximum and minimum principal stresses  $\sigma_1$  and  $\sigma_2$  at each node in the finite element model were obtained from the SAP 2000 analysis. The principal stress values at each node were averaged in order to obtain one principal value. The averaged maximum and minimum principal stresses are then checked with the above failure criteria. The results obtained for each alternative are presented in following figures.

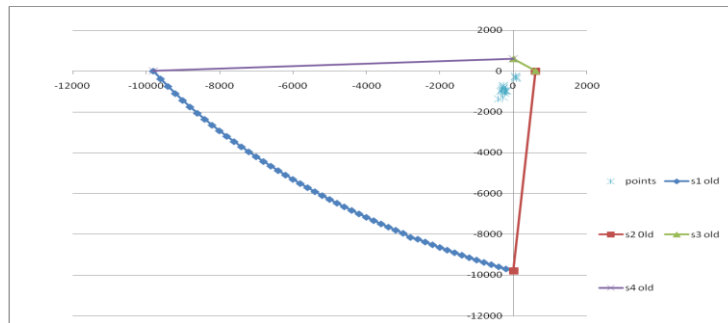
Figure 11: Principal stresses in the failure surface – Old brickwork (Alternative 1)

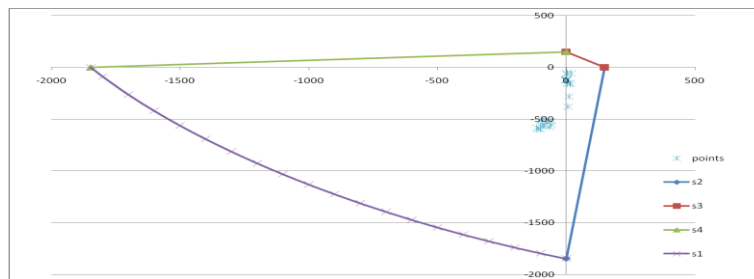
Figure 12: Principal stresses in the failure surface – New brickwork (Alternative 2)

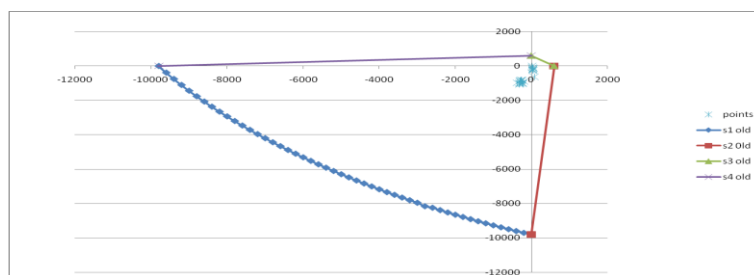
Figure 13: Principal stresses in the failure surface – Old brickwork (Alternative 2)

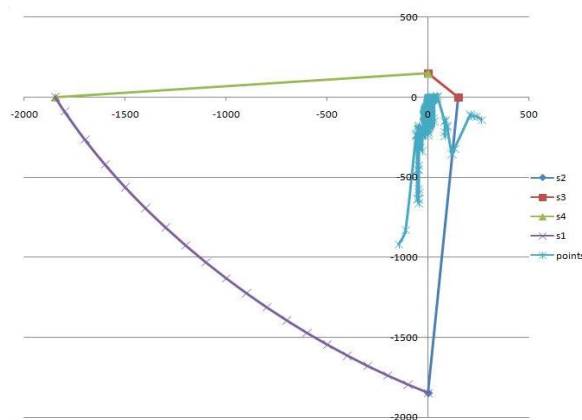
Figure 14: Principal stresses in the failure surface – New brickwork (Alternative 3-1)

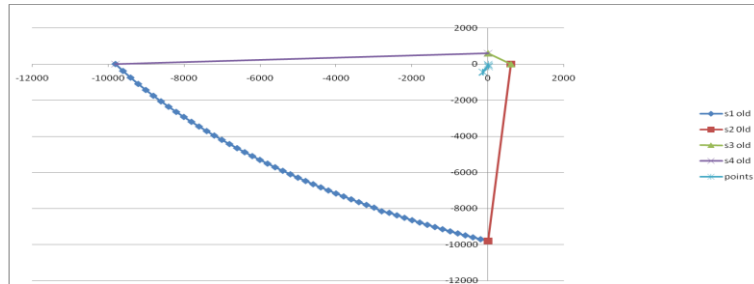
Figure 15: Principal stresses in the failure surface – Old brickwork (Alternative 3-1)

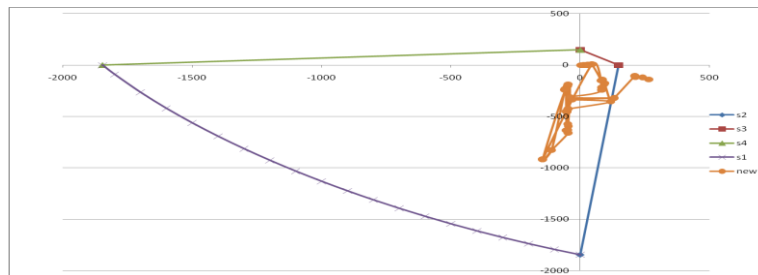
Figure 16: Principal stresses in the failure surface – New brickwork (Alternative 3-3)

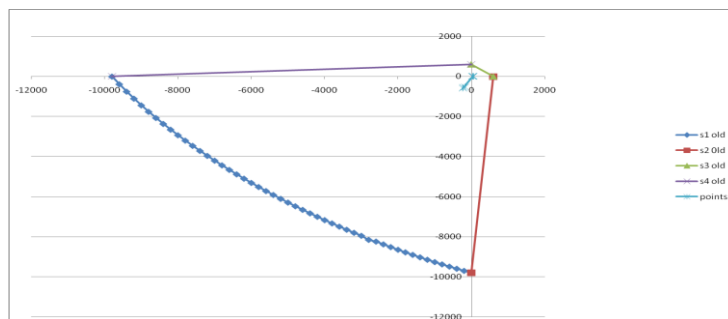
Figure 17: Principal stresses in the failure surface – Old brickwork (Alternative 3-3)
