TSUNAMI DAMAGED BUILDINGS ASSESSMENT USING HIGH-RESOLUTION SATELLITE IMAGERY, GIS & GPS DATA

Keywords: Differential Morphological Profile, IKONOS, Building Extraction, Tsunami

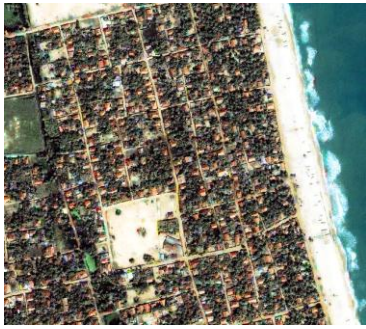
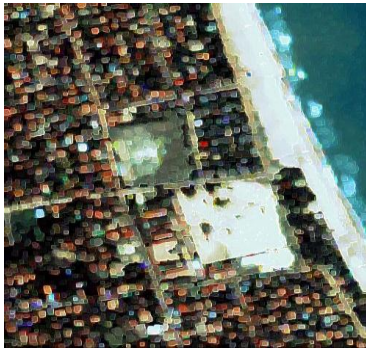
Figure2. The Research flow images

Original Image

GIS ground truth Data

Subset Image

Convert to Vector

Extract Buildings Edges

The building shadows are easy to extract using their low reflection value. Mask for shadows is built up using the reflection value between 0 and 60. The structures with similar scale to the SE diameter give high responses when SE in DMP value with bright structures in opening portion and dark structures in closing portion of the profile. For each pixel in the image, the position of the maximum responses within the DMP vector, indicate both the SE size that best characterize the structure that the pixel resides within and whether the pixel is part a structure that brighter or darker than the surrounding region. The maximum DMP response indicates with well a matched SE value that the pixel resides within. There are 8 differential morphological profiles were created using disc shaped morphological elements with radius increasing 7 to 15m (step size is equal to 4m). The SE that are less than 7m are not reliable for use because of the consists of small shadows, trees and wrecks of buildings. Those figures give noise for the classification results, we used SE more than 7m to detect for remain Buildings. Most of the bright building roof is gives the maximum response with opening differential profile and dark color roof, shadows are with closing differential profile. Unsupervised ISODATA Classification way is used for the classification and identification the structures, which most sophisticated algorithm which allows the number of clusters to be automatically adjusted during the iteration by merging similar clusters and splitting clusters with large standard deviations. Combining morphological operations is carried out for remove pixel errors that occurred due to delineation of image objects with DMP before classification.

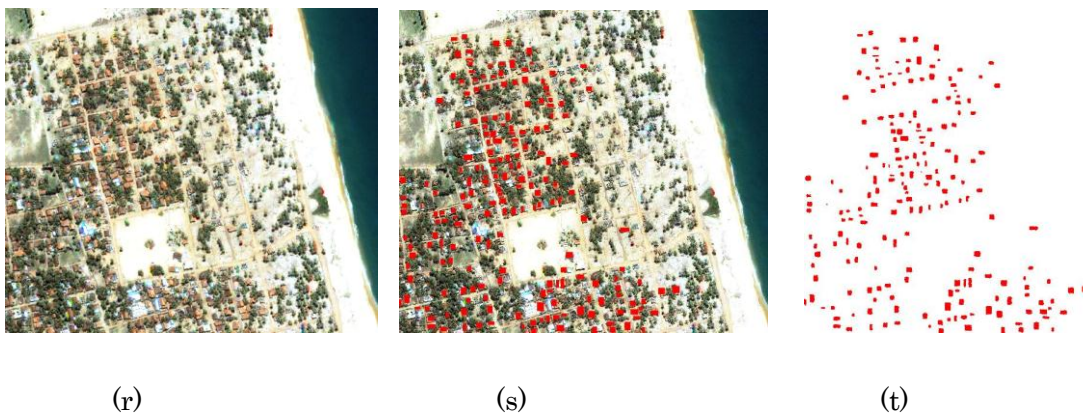
Figure 6. Building extraction results. (r) IKONOS image of the post-tsunami area. (s) Manually labeled buildings as ground truth. (t) Result of the building extraction according to approached method.

Table 2: Extraction of houses after the tsunami

<i>Object base</i>	<i>Pixel base</i>
<i>Correctly extracted building roof</i>	163	10948
<i>Total Area of the segment</i>	208	356562
%	78.36	3.07

Table 3: Completely destroyed structures in the image

<i>Object base</i>	<i>Pixel base</i>
<i>Correctly extracted building roof</i>	297	1691
<i>Total Area of the segment</i>	498	356562
%	59.60	86.48
