# **Improvement of Urban Environment Through Sewer Network Monitoring Using CCTV Technology**

Research submitted in partial fulfilment of the requirements for the degree Master of  
Science in Environmental Engineering and Management

Department of Civil Engineering

University of Moratuwa

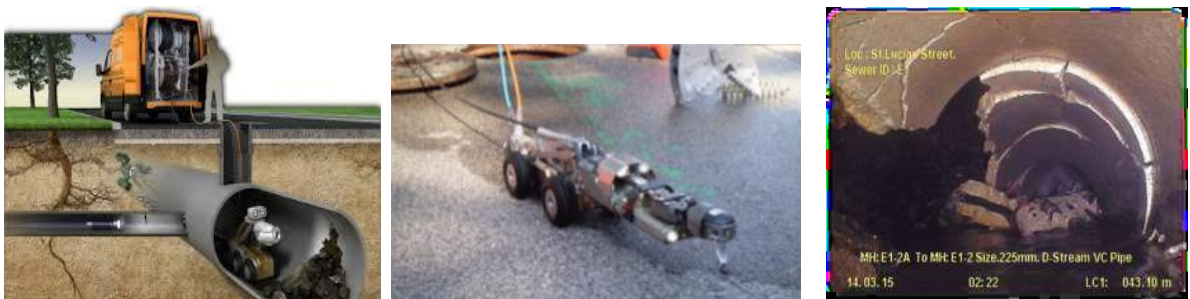
Figure 2.2: CCTV Camera and Output Images

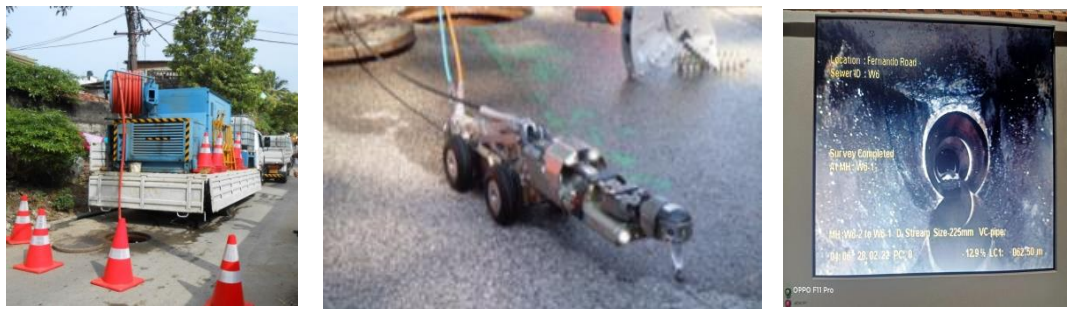
The high-definition CCTV (Closed circuits television) camera was inserted into the pipeline through the manhole and it traveled through the pipeline, captured pictures, and recorded video while rotating its camera 360 at angles. After the inspection was completed, the CCTV camera was removed from the line. The data was downloaded and analyzed. The result from the CCTV analysis provided the location, failure mode, and condition grade. The occurrence of defects (e.g., collapses, Breaks, blockages) identified in the investigation is then evaluated through the classification system. The analysis identified the areas of failure and locate them both circumferentially and longitudinally on the pipe.

Figure 3.5: CCTV Investigation at Site

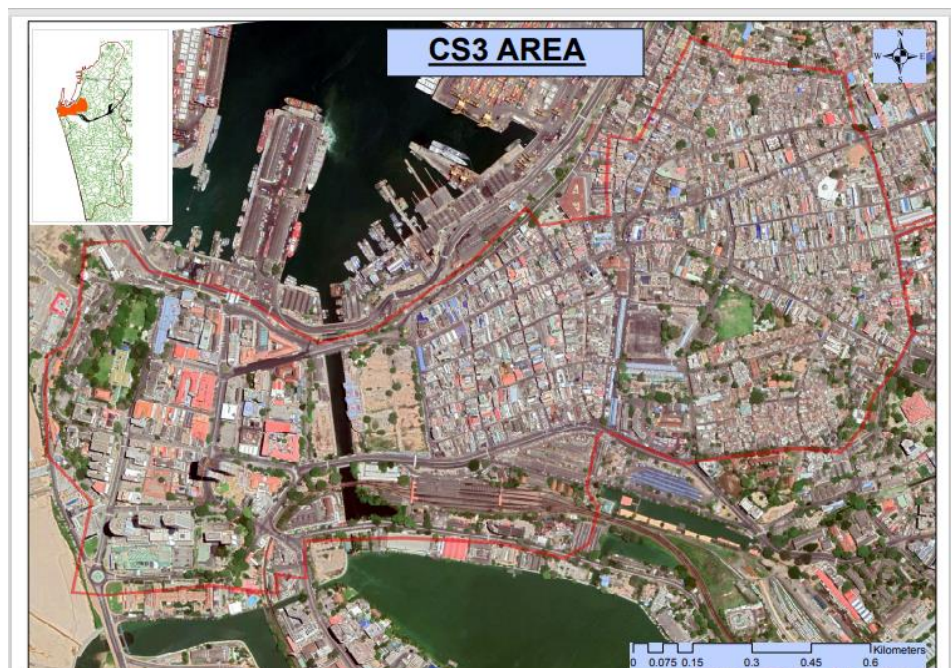
Figure.4.1: Pilot Project Area - CS3 Catchment-Colombo North

Significant Aggregate and Silt work was recorded at the CS3 pumping Station located in the Colombo Peta Area. It shows the significant no of failures of the sewer pipes and the future collapse of the network in the CS3 catchment.

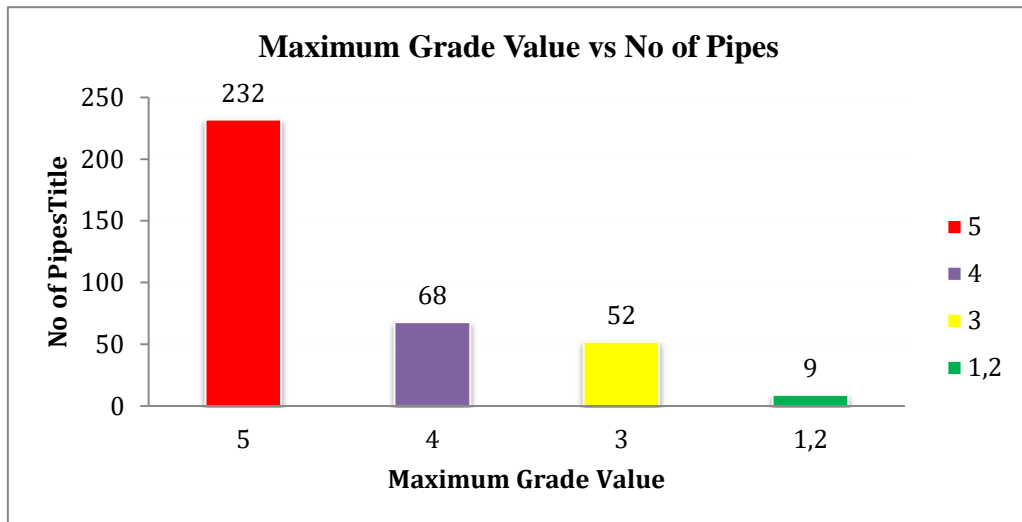
Investigation reveals utilities in understanding the system-wide risk along with the network. The results obtained from the aforementioned procedure considered 360 pipe segments and 33 km length of about 330000 independent observations of events related to CCTV inspection. These data sets were analyzed and the most critical pipe segments were identified. All identified failure-related problem was rated with a score and graded from 1-5 in increasing order of severity. The sewers having maximum grades 3,4,5, were classified as critical and they should be replaced or repaired within a given period. The pipes having max grade 1,2 were considered non-critical. Figure 5.5 shows the distribution of max grade value throughout the catchment.

Figure 5.5: Maximum Grade Value Distribution @ the Catchment

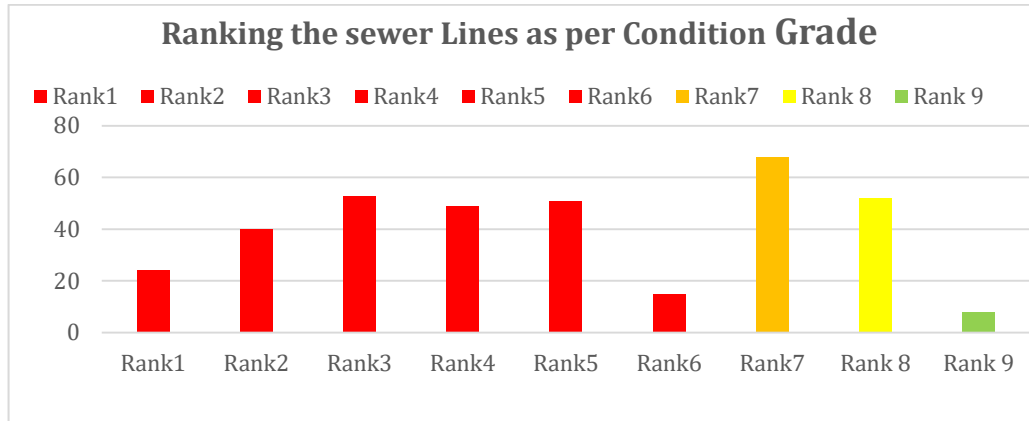
Figure 5.7: Ranking of Pipes

The above results will provide an overall figure on the Colombo sewer network, and it will be useful in the preparation of the sewer rehabilitation plan. In addition, Top-level Managers can decide on budget allocation and improvement of pipeline projects.

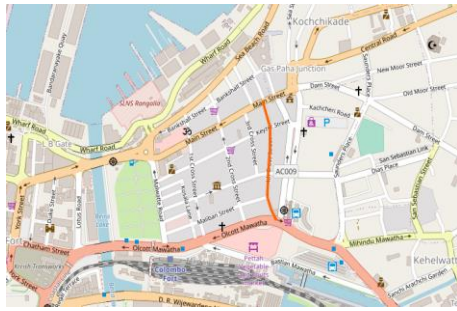
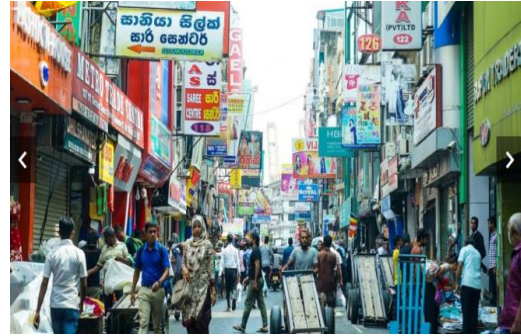
Figure 5.8: Olcott Mw - 4<sup>th</sup> Cross Street

This unable utility service provider quickly captures the problematic places to be attained without detailed engineering analysis. For example, immediate attention is to be paid to replacing or rehabilitating sections between MH A49-4 to A49-3- where a greater no of failures were observed.

for example, immediate attention is to be paid to replacing or rehabilitating sections between MH A49--4 to A49-3 where a greater no of failures are observed.
