**INVESTIGATION OF SUITABLE  
METHODS TO PROTECT MAIN ROADS  
ADJACENT TO WATER BODIES**

Master of Science by Research

Department of Civil Engineering  
University of Moratuwa  
Sri Lanka

October 2024

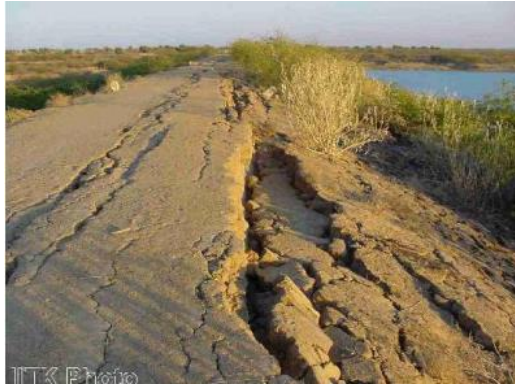
- i. Holes and the initiation of piping action can significantly affect the embankment crest and may lead to collapses. This process, in combination with other factors, is illustrated in Figure 2.1 (Drave, 2012) below.

Figure 2.1 Failure of road Embankment

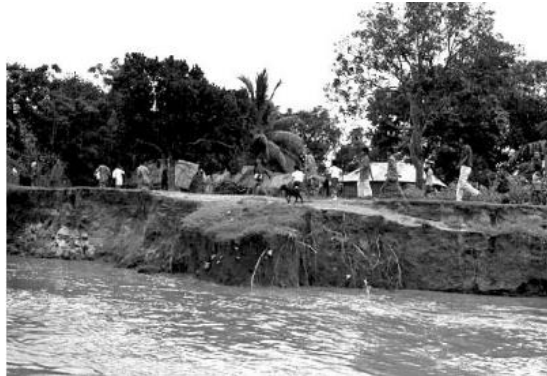
- ii. Surface runoff due to rainfall leads to sheet erosion and the creation of gullies and rills on poorly protected embankment shoulders, slopes, and toes, as shown in Figure 2.2 below (Drave, 2012).

Figure 2.2 Failure of River Bank

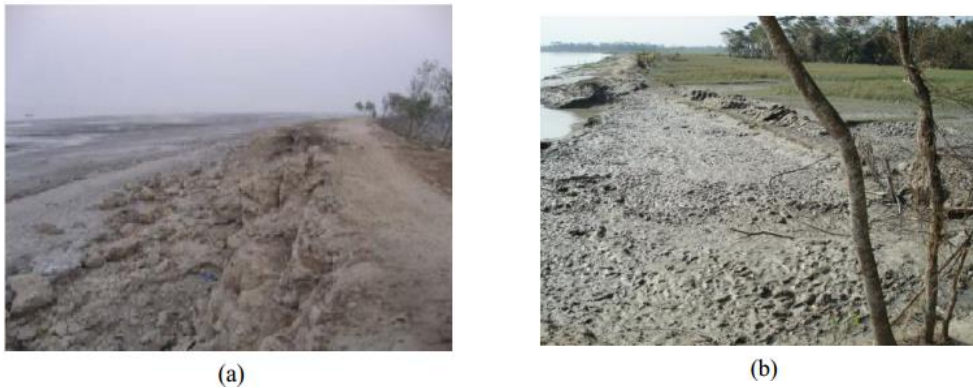
Figure 2.3 Photographs ‘a’ and ‘b’ depict embankment damage brought on by wave action

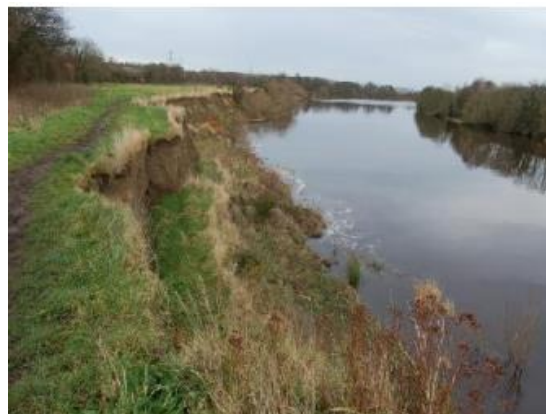
Combined with vortex motion in rivers and estuaries, turbulent water currents generally undercut banks through erosion, which can ultimately lead to the collapse of the embankment if adequate protection is not taken. At the mouth of a branch river or canal, and particularly around sluice gates, turbulent water currents erode the banks and, consequently, the embankments. Figure 2.4 shows the failure of an embankment slope due to turbulent water currents (Wikimedia Commons, 2010). The formation of continuous borrow-pits in a river or by the seaside tends to undercut the embankment toes and slopes due to full inundation during the monsoon. These borrow-pits, together with the associated low-lying areas, if flooded, may cause a flow of water that runs very close to the embankment toes and slopes, rapidly eroding the surfaces in some places.

Figure 2.4 Photograph illustrating how turbulent water currents can cause embankments to break.

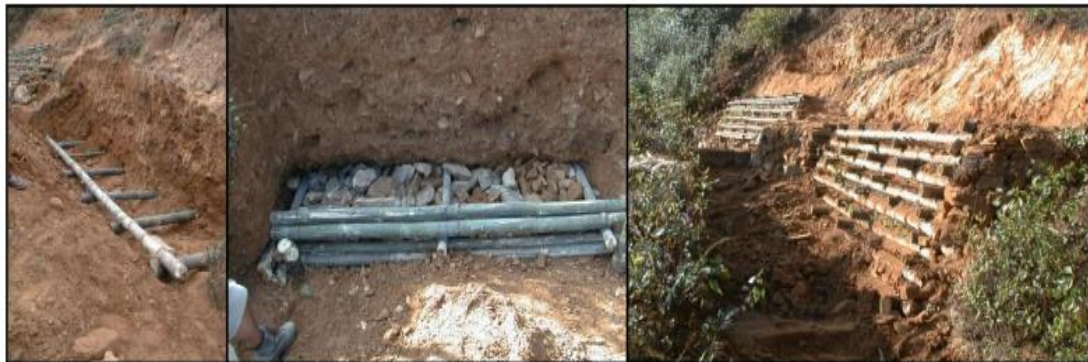
In Figure 2.9, a bamboo crib wall covered in vegetation is being built. The construction turns into a retaining wall when it is filled. The previously described local species of chopped branches, when collected from a nearby region, offer immediate mechanical support before taking root in the soil and stabilizing the slope. In addition, the branches' exposed portions will sprout leaves, resulting in an aesthetically beautiful and low-maintenance vegetative cover on the slope. Although the bamboo gives the building instant rigidity and shelter, as it decomposes and the live cuttings develop and proliferate, its significance progressively decreases. The root mass that is created will eventually stabilize the slope by uniting the parent soils and fill.

Figure 2.9 Stages of bamboo crib wall construction

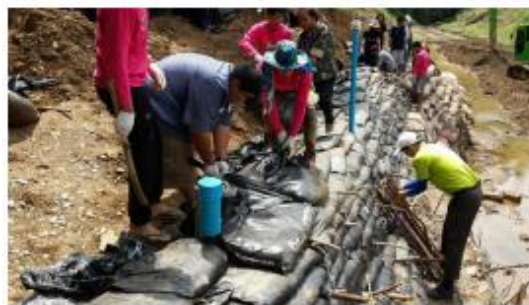
Figure 2.12 Placement of flapped soil bag with live stake

The flapped soil bag dimensions are shown in Figure 2.11. Friction forces between bags are enhanced by the weight of overlying and adjacent bags. Live stakes (0.8 to 1 meter long and 18-25 cm in diameter) of various species were placed horizontally between each flapped soil bag at 0.5-meter intervals (Figure 2.12). Species used included Bougainvillea, Erythrina subumbrans, Salix tetrasperma, and Spondias pinnata. The lower end of the live stake was cut sharply and positioned to touch the soil behind the bags, allowing roots to grow out and act as living soil nails.

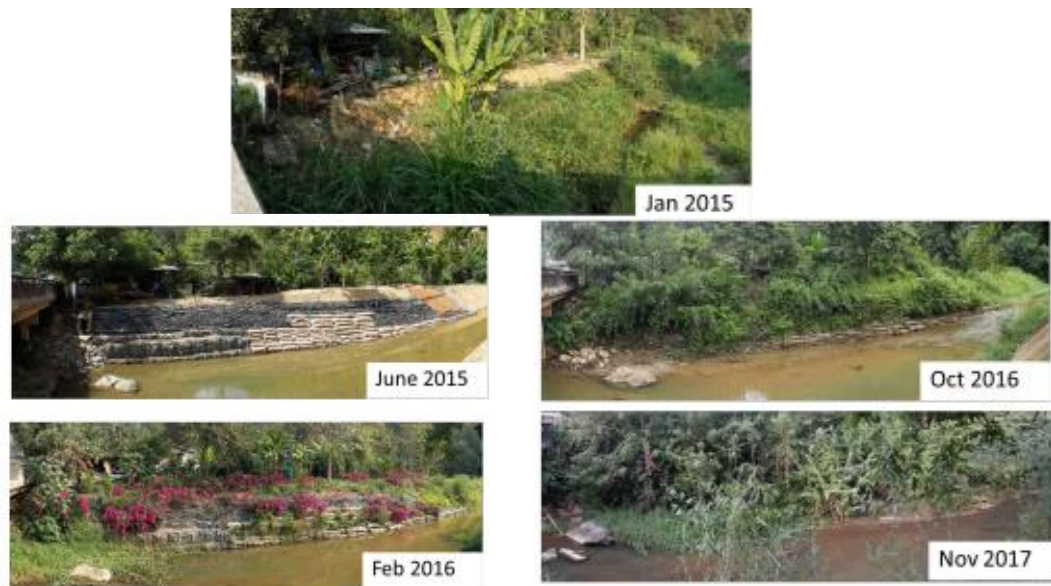
Figure 2.13 shows the stabilization at different stages: before construction (Jan 2015), immediately after construction (June 2016), 8 months later (Feb 2016), 1 year and 4 months later (Oct 2016), and 2 years and 5 months later (Nov 2017). Eight months after construction, the aesthetic value of the bio-engineered wall had clearly improved, with vegetation almost fully covering the flapped bags, protecting them from UV rays. After one year, local species began to dominate the vegetation on the bags, and biodiversity was evident after two years (Nov 2017). Overall, the ecological restoration of the stream bank showed significant long-term improvement.

Figure 2.13 Appearance of the vegetation cover of the failed sections over time

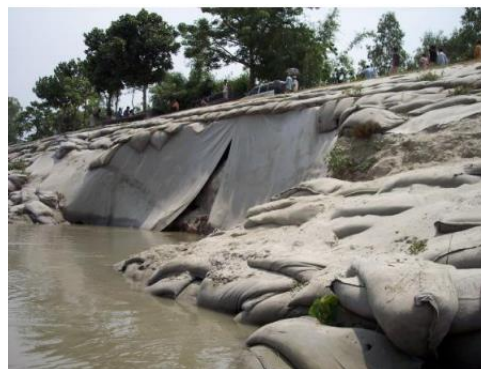
This method is comparatively low-cost and temporary for protection. Gunny or polyethylene bags, each with a capacity of about 1.25 cubic feet and filled with low FM sand, are arranged in a rip-rap pattern across the terrain. Polyethylene bags are preferable to gunny bags due to their greater durability. This approach is ideal for emergency repairs and situations requiring minimal time and expense. Sandbags' inadequate performance against a cyclonic storm surge is depicted in Figure 2.14 (Islam and Arifuzzaman, 2010). The failure may be due to the absence of proper connections between the individual polythene sand bags. Often, the bags were simply placed adjacently without any mechanical linkage, leading to shifting and displacement under external forces like heavy rainfall and water flow. Sand-filled polythene bags, especially those not mixed with cement, might lack sufficient weight and compaction, making them more susceptible to movement by water forces. Effective drainage is crucial in slope protection; inadequate drainage can lead to water accumulation behind the rip-rap, increasing hydrostatic pressure and causing the bags to shift or collapse.

Figure 2.14 Cyclonic Storm Surge Protection: The Poor Performance of Sand Bags

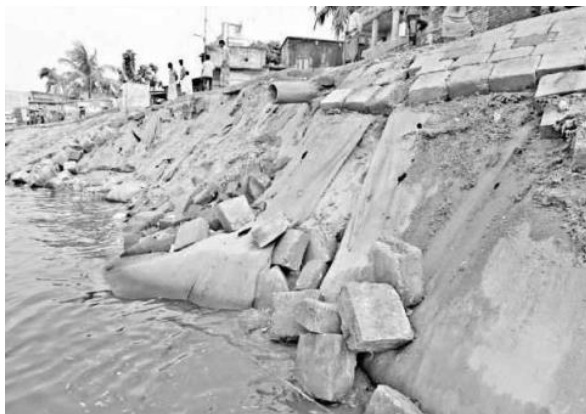
Cement-concrete blocks combined with geotextile have recently been used for slope protection. However, this approach is expensive and not ecologically friendly. Cement-concrete (CC) block-based protected embankment slope failure at Keraniganj is depicted in Figure 2.15 (Source: Prothom Alo, dated 04.04.2011). This failure's causes could include the absence of any interlocking arrangements between individual units to keep them as one unit or washing away due to high tidal surge in the absence of poor drainage arrangements and the geotextile used in the construction was not anchored adequately. Lessons learned from this failure include ensuring that individual blocks are interconnected for overall stability, achievable through interlocking designs or additional fastening materials. The geotextile must be securely anchored to perform its reinforcing role effectively, requiring proper tensioning and fixing at regular intervals. Additionally, incorporating a well-designed drainage system is essential to mitigate water-induced failures, involving both surface and subsurface mechanisms to manage water flow and reduce pressure behind the wall. By addressing these issues, future slope protection projects using cement-concrete blocks and geotextile can achieve greater durability, effectiveness, and longevity.

Figure 2.15 The Keraniganj Beribadh site's CC blocks are performing poorly

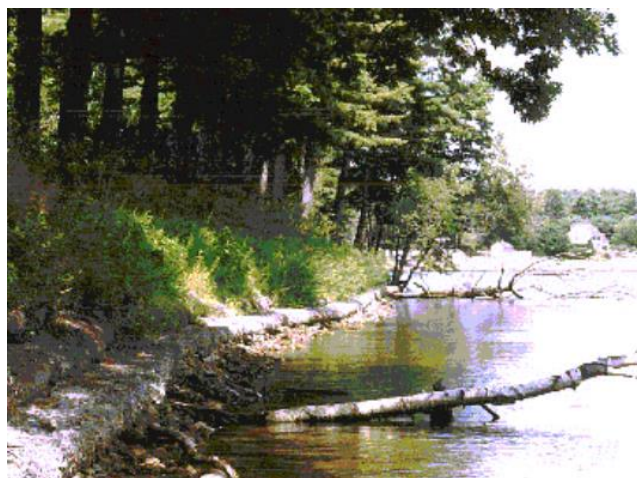
The project work was generally done according to specifications, but budget limitations precluded a full-time inspector. Some issues, such as the size of stones in the Reno mattresses for toe protection, could have been prevented with better oversight. After a year, some stones have emerged from the mattresses, necessitating refilling with properly sized stones. Vegetation was generally well-established after one growing season, though some areas faced establishment problems due to small or improperly placed plants. The vegetation progression during the first growing season, from spring to mid-summer, is depicted in Figure 2.17. When paired with a thick layer of coconut, the modified gabions can withstand erosion for three to five years before the coconut starts to deteriorate. To address missing areas, it is recommended to further enhance vegetation through live staking.

Figure 2.17 showing the post-construction performance

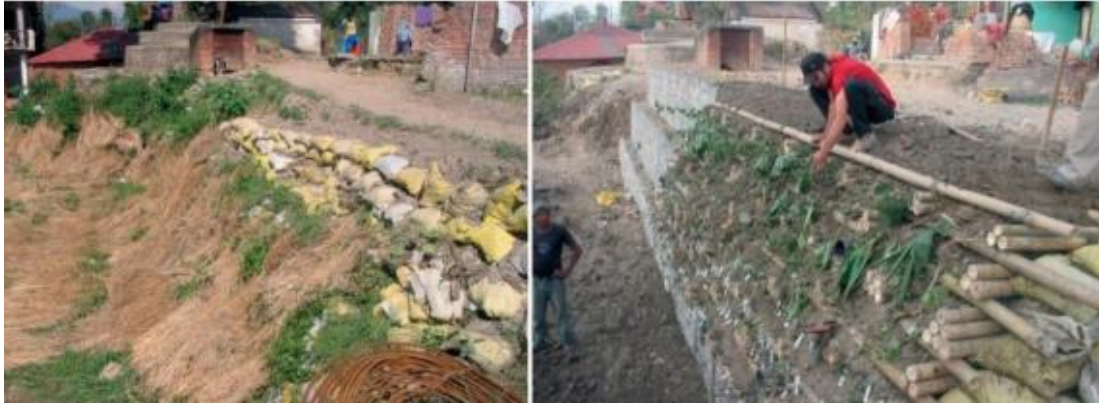
- While offering the same level of technical stability, vegetative crib walls are less expensive than gabion or stone masonry walls, costing only 25% of the former and 15% of the latter.
- Although vegetative crib walls have more vertical settlement compared to a gabion/masonry wall, they are better attached to the slope.
- Low soil moisture levels are guaranteed by vegetative crib walls, which also prevent cracking and improve rainfall interceptions.
- Because of the improved cohesiveness and soil reinforcement, they offer better stability.

Figure 2.18: Kusunti, Lalitpur, before and after construction photos

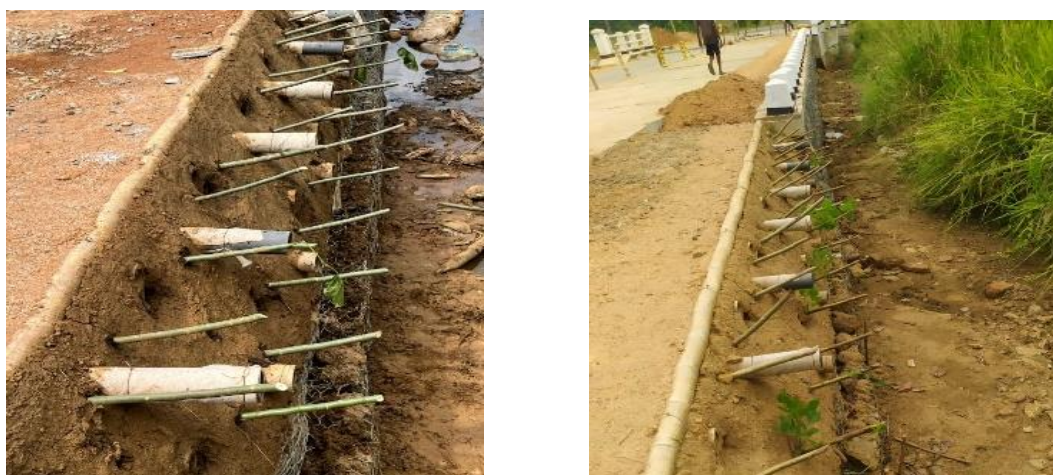
Figure 3.22 Photographs taken at Location 2 on 21.03.2024 after the stabilization technique

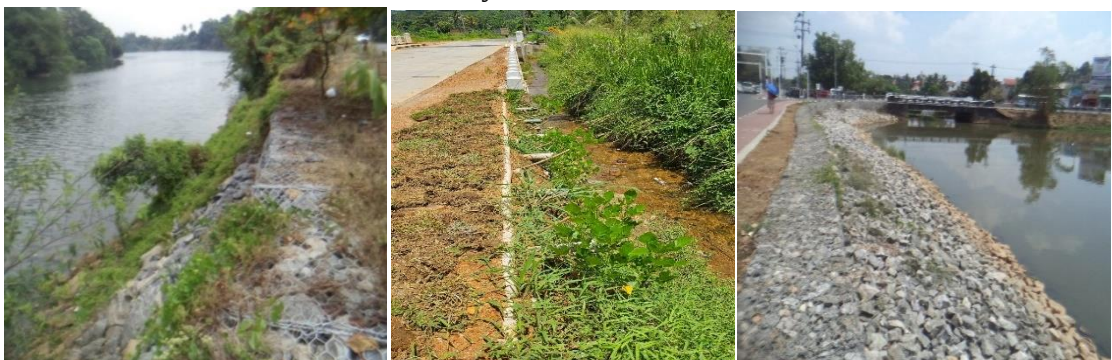
(a) Location 1 (after 10 yrs) (b) Location 2 (after 3 mth) (c) Location 4 (after 5 yrs)
