# **RECOMMENDATION OF MAINTENANCE SCHEDULE BY ANALYSING CONDITION MONITORING TEST DATA OF GENERATORS**

Department of Electrical Engineering

University of Moratuwa  
Sri Lanka

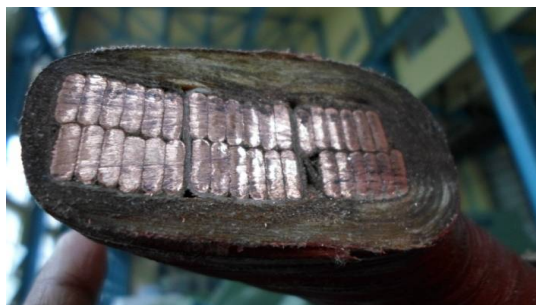
Figure 1:3 Physical cross section of winding

The above figure 1.3 shows the cross section of a winding. There are many different stresses that can affect the rate of insulation degradation in stator and rotor windings. Thermal, Electrical, Ambient, and Mechanical stresses, the so-called TEAM stresses are identified for continuous deterioration of the windings. [6]

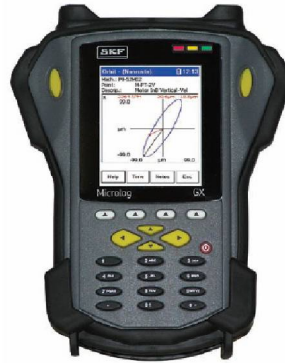
Figure 4:3 SKF GX Series Microlog Data Analyzer

The critical frequencies ( $f_{v,k}$ ) ;  $k=1, 2, 3 \dots$  are defined as those frequencies which lie significantly above the noise floor. The following figure 4.3 is shown below which was developed by SKF.

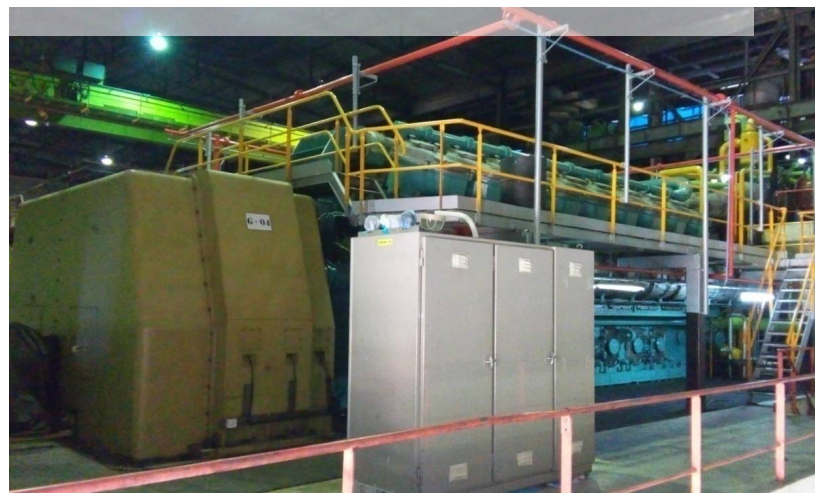
Figure 5:6 Pielstick plant generator with Diesel engine

All four engines are reciprocating engines which are fixed on a concrete base with dampening springs. Therefore those PC4-2 18V type engines are reciprocating horizontally to connect the generator as shown in following Figure 5.6

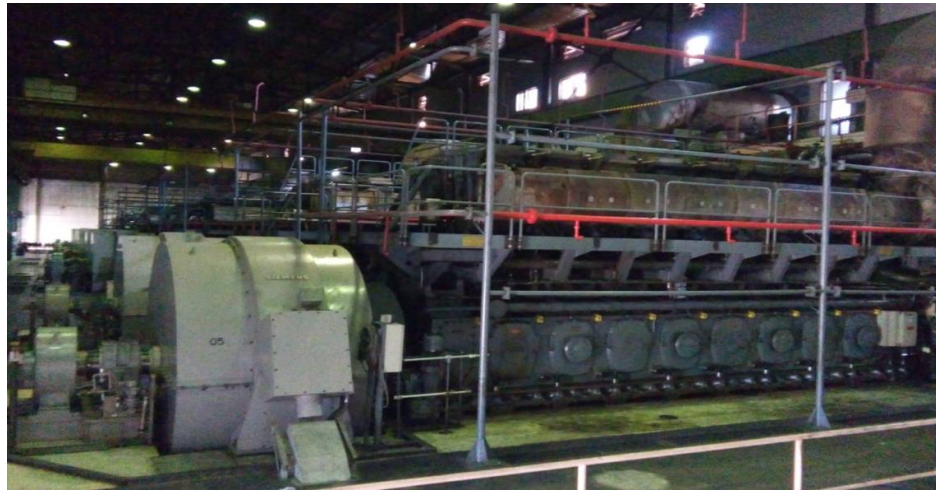
Figure 5:12 Layout of MAN plant Genset

8L 64/58 eight numbers of engines are fixed on a concrete base with dampening springs in the MAN plant. Since those engines are reciprocating type, horizontally connect to the generator as shown in the following figure 5.12.

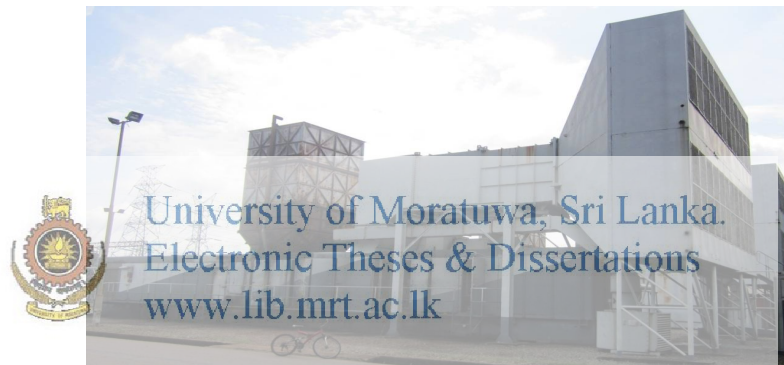
Figure 5:17 Layout of KPSGT02, Kelanitissa plant

Presently available four gas turbines are operating at 5100 rpm. Those gas turbines are running with lesser vibration in normal condition comparatively to diesel engines. Both turbine and the generator are fixed on soft foundation. Following figure 5.17 shows horizontal layout of small gas turbine.

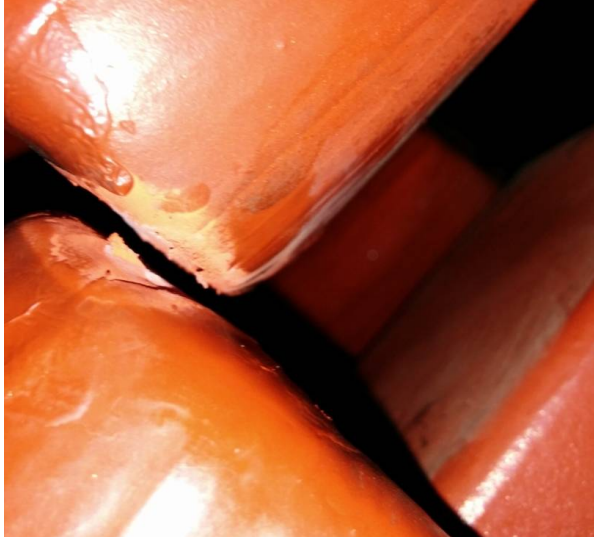
Figure 5:19 PD Symptoms observed from GT 07 on 2014.08.13

the power system of Sri Lanka. Recently the generator had been tripped few times and it was observed PD symptoms of the stator winding as shown in figure 5.19.

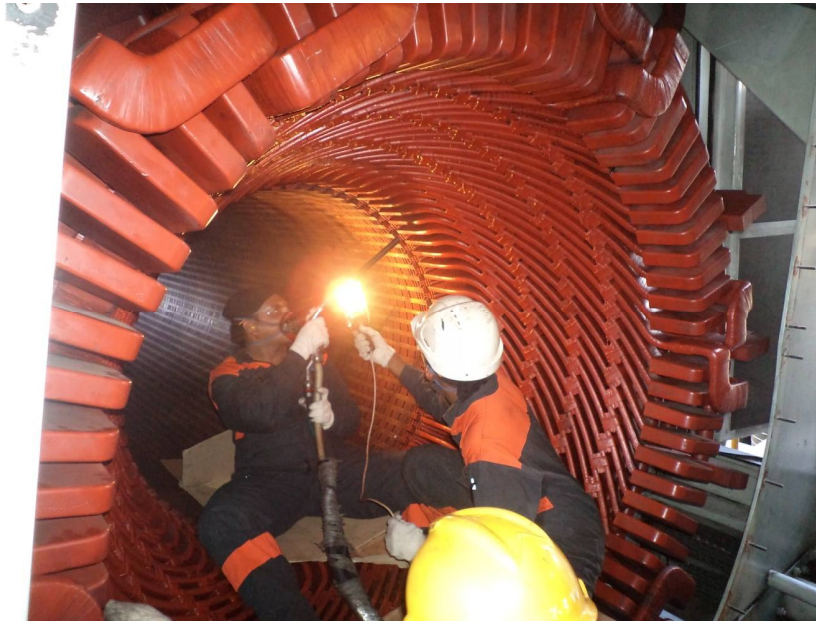
During this 96,000Rhr maintenance, winding cleaning special test was carried out in order to achieve performance of windings. Following figure 5:21 shows the dry ice cleaning process carried out on 2012.08.08.

Figure 5:21 Dry ice cleaning work of KPSGT7 during 96,000 Rhr maintenance

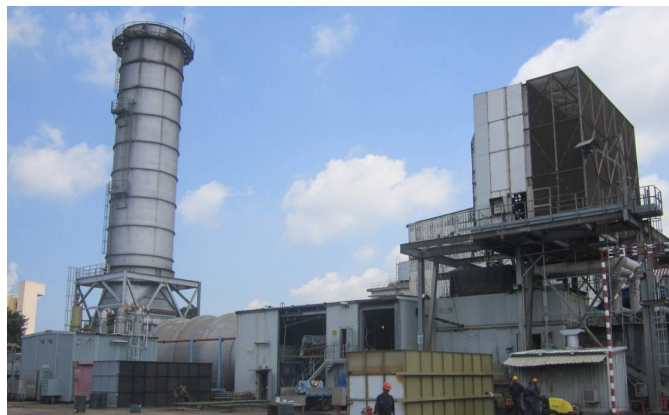
Both Fiat gas turbine and generator (KPSGT7) are operating at 3000 rpm speed. This kind of gas turbine is running with lesser vibration in normal condition comparatively diesel engines. Both turbine and the generator are fixed on a concrete base with dampening springs. Following figure 5.23 shows horizontal layout of gas turbine No 7. (also called Fiat turbine)

Figure 5:23 Kelanitissa Gas turbine No 07

Since this gas turbine operating at 3,000 rpm speed, vibration is more harmful to the rotating parts and then effect to generator stator also. Comparatively capacity of the generator, adverse effect to the power system is also considerably high. Therefore it is necessary to have special tools for measuring vibration before propagation and damage to other parts.
