# Enhancement of River Bank Stability by *Hibiscus tiliaceus* Root Reinforcement: A Nature-based Solution

L.G.C. Madhushan, U.P. Nawagamuwa and M.D.J.P. Wickramasooriya

**Keywords:** Bioengineering, Mechanical reinforcement, Riverbank protection, Root cohesion, Slope stability

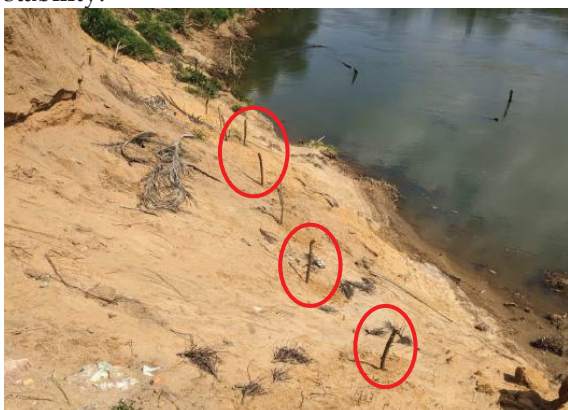
Figure 2 – Live poles of *Hibiscus tiliaceus* planted on a failed riverbank section

Although Sri Lanka is rich in native vegetation and diverse tree species, there remains a significant lack of technical data and quantitative research on the mechanical stabilization contributions of these species through their root systems. *Hibiscus tiliaceus* (“Wal Beli” or “Belipatta” in Sinhalese) was identified as one of the common tree species in the riverine environment of the lower Kelani River basin, from Hanwella to the river mouth, and has proven effective in mitigating riverbank failures and enhancing bank stability. Furthermore, field inspections revealed that riverine dwellers have actively used *Hibiscus tiliaceus* in failed riverbank sections (Figure 2) along the Kelani River to improve riverbank stability.

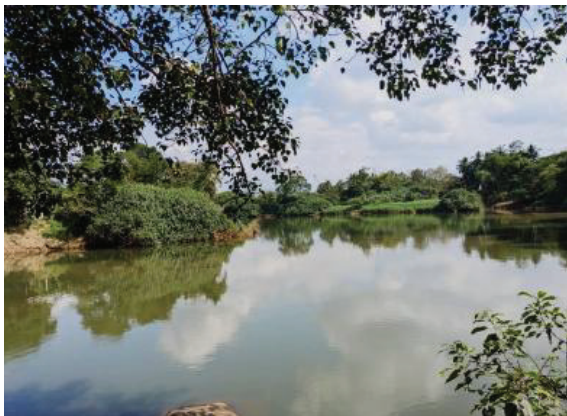
Figure 6 – Vegetation barrier of *Hibiscus tiliaceus* near the Kaduwela bridge

Based on field inspections along the Hanwella to Kaduwela riverbank, *Hibiscus tiliaceus* was identified as one of the common tree species utilized by riverine dwellers for riverbank protection. Consequently, *Hibiscus tiliaceus*, locally known in Sri Lanka as “Belipatta” or “Walbeli,” was selected due to its proven mechanical reinforcement properties, adaptability to riparian environments (Figure 6), and suitability for bioengineering applications. This species possesses a vertical-horizontal (VH-type) root system [13], combining deep-penetrating taproots with widely spreading lateral roots.

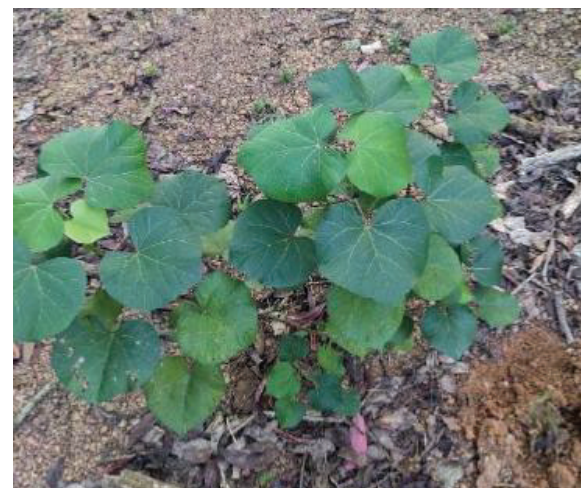
Figure 8 – *Hibiscus tiliaceus* plant

These cuttings have exhibited survival rates ranging from 45% to 79% [11], depending on site conditions such as soil type, moisture availability, and management practices. Once established, the plants demonstrate a moderate to fast growth rate, often attaining heights of 0.75 to 1.5 m per year under favourable tropical conditions (Figures 8 and 9) [11].

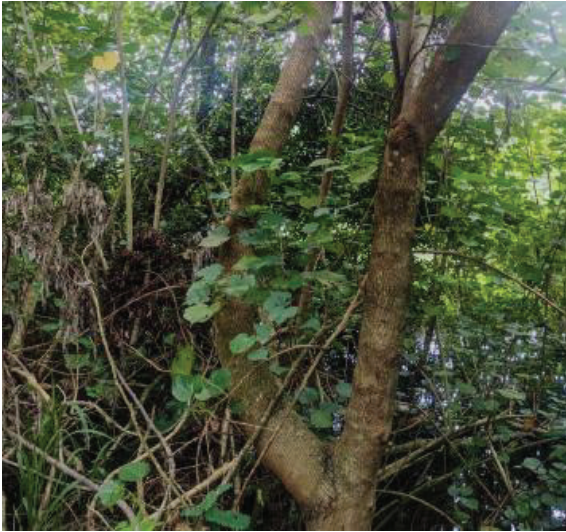
Figure 9 – Well-grown *Hibiscus tiliaceus* tree
