# **Performance of Timber, Masonry and Earth Houses in the Christchurch Earthquakes New Zealand September 2010 and February 2011**

Hugh W Morris,  
Department of Civil & Environmental Engineering  
The University of Auckland  
(hw.morris@auckland.ac.nz)  
Andrew H Buchanan,  
David Carradine  
The University of Canterbury  
Richard Walker  
Consulting Engineer

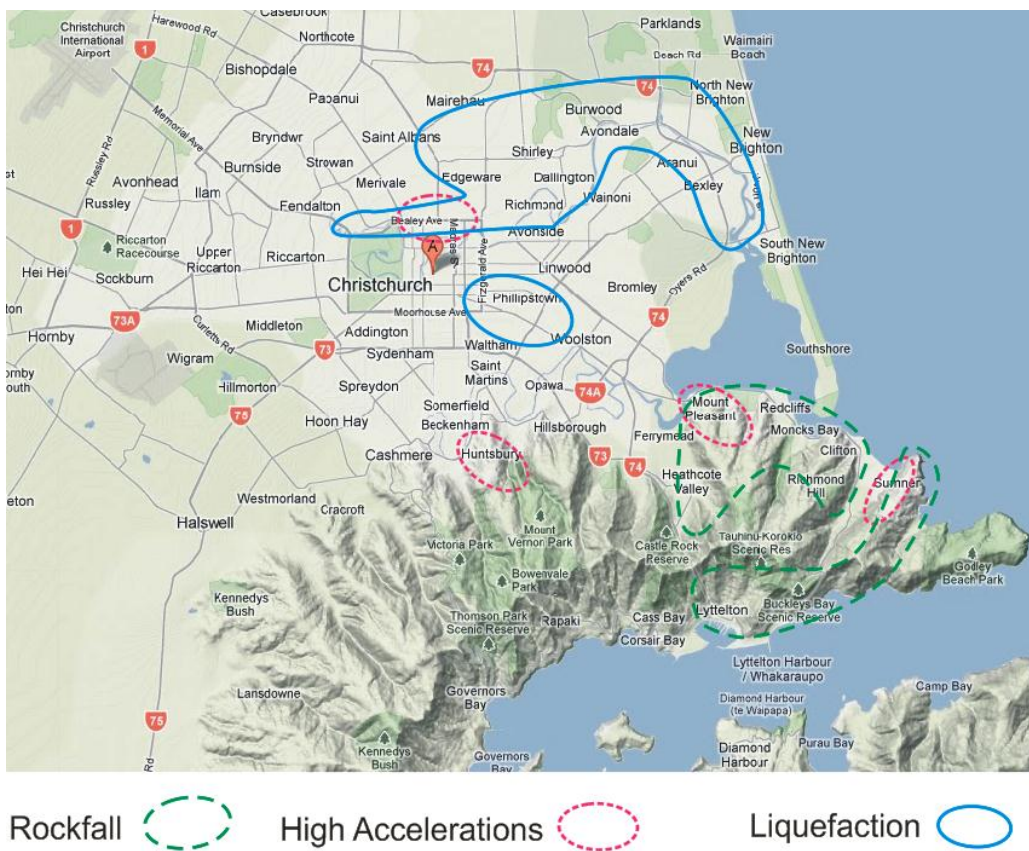
Figure 3 Approximate location of worst house damage types in February 22 Earthquake (Google map)

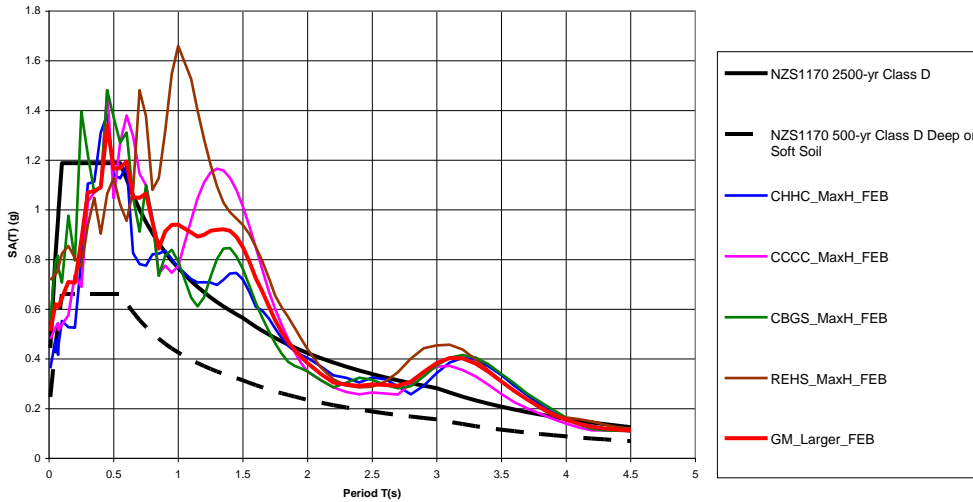
Most common damage expected from earthquakes is due to lateral ground movement which is usually characterised by ground accelerations. As was seen earlier in figure 3 the ground accelerations were very high in many parts of the city and substantially exceeded design levels. Figure 10 shows the central city spectral accelerations with the design spectra for the 500 year design level and additionally the 2500 year maximum considered values from the most recent loadings standard. While accelerations were very large the duration of shaking in the central city was short with high accelerations occurring over about 7s. Christchurch was very well instrumented but there were no records in the hill suburbs. The nearest instruments gave the highest peak ground accelerations (PGA) of 1.4g horizontal and 2.2g vertical, it is likely that residential hill suburb accelerations were even higher.

Figure 10 Horizontal spectral ground accelerations in central Christchurch and NZS1170 design levels (Bradley)

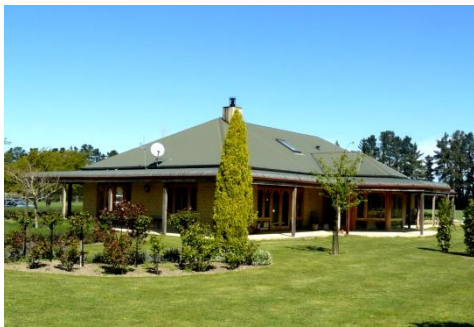
continuous to the top plate which is additionally anchored to both the wall and the ceiling diaphragm. The most significant damage was a cracked floor slab evident from a 2-3mm crack in the floor tiles. This crack continued as a 1mm crack through the concrete foundation beam reinforced with a D16 top and bottom (two top and bottom are recommended in NZS4299). There were also hairline cracks at foundation level as shown in Figure 22. It appears that there was some differential movement at the west corner where settlement and movement of the verandah posts embedded in the concrete path caused cracking in the upper south wall (Figure 1). Lateral movement had caused movement or minor pounding of the lintels leaving gaps of 4-6mm at ends of the lintels (Figure ).

This house suffered minimal damage which was primarily due to differential ground movement and while there were indicators that the building had suffered significant shaking the limited amount of damage in this significant event provides evidence for the effectiveness of the building system.

**Figure 23** Charing Cross adobe house, 4km South East of the epicentre
