**IMPORTANCE OF DETAILED CONSIDERATION OF  
CONSTRUCTION SEQUENCE IN INSTALLATION OF  
RETAINING WALLS WITH EXCAVATION:**

**A CASE STUDY**

M.Eng. in Foundation Engineering and Earth Retaining Systems

Department of Civil Engineering

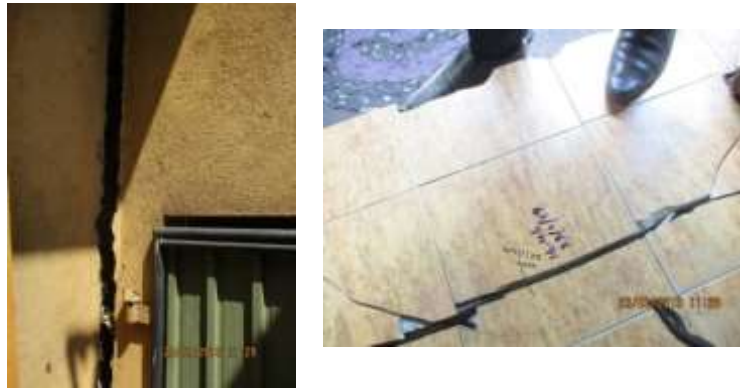
*Figure 1.1: The nature of wall and floor crack of a building.*

The site observations hinted that these damages occurred due to the ground settlements during the construction stage and may have been occurred due to unfavorable loading condition during the construction stage. Therefore, this study is carried out as a forensic analysis of the above case study.

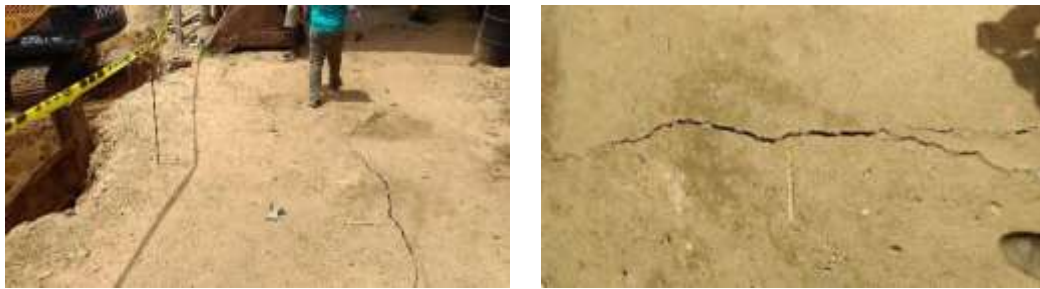
The shoring arrangement had been set up as per mentioned above and the gabion walls had been constructed. The backfill of the land side of the gabion had only completed upto +2m MSL. As per the construction methodology, the next activity is removing the interlocked sheet pile shoring ( Sheet Pile Line 01) and prepare the canal embankment to the design slope to lay the gabion reno-matress. However, once the sheet piles of the interlocked segment were ejected severe ground cracks were appeared since outer sheet pile line (Sheet Pile Line 02) was deformed towards the canal side (Figure 2.6).

Figure 2.6: Initiation of Ground Cracks.

In a short while after the initiation of ground cracks, severe cracks started to appear in the residential building (i.e. the building named as “House” ). The nature of these cracks was so severe that the safety of the people inside the house were at risk. The construction works had been stopped immediately and monitored whether the cracks were propagating.

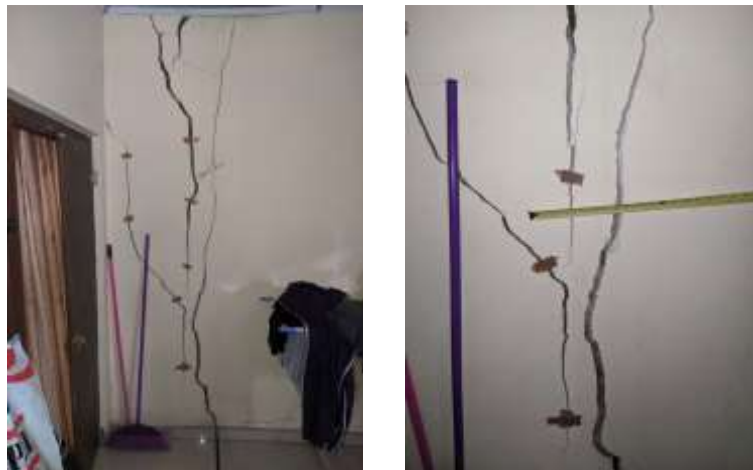
Figure 2.10: C3 wall crack.

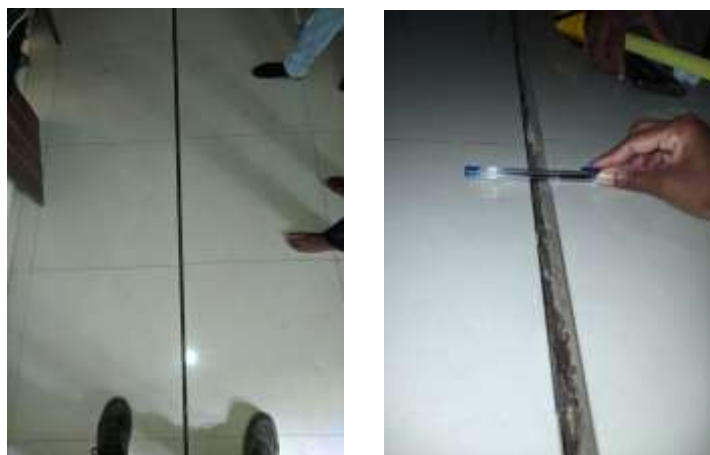
Figure 2.11: C5 floor crack.

Many minor and major cracks were visible in all over the house and contractor immediately started to identify all the cracks inside the building and started to monitor them. Once the crack propagation was observed to be stable, forensic analysis was conducted in collaboration with NBRO and it was decided that these settlements was occurred due to removal of interlocked sheet piles, backfilling is done only for +2 mMSL and the only resistive force provided by intermediate sheet piles with plates were not enough to hold the lateral earth pressure.

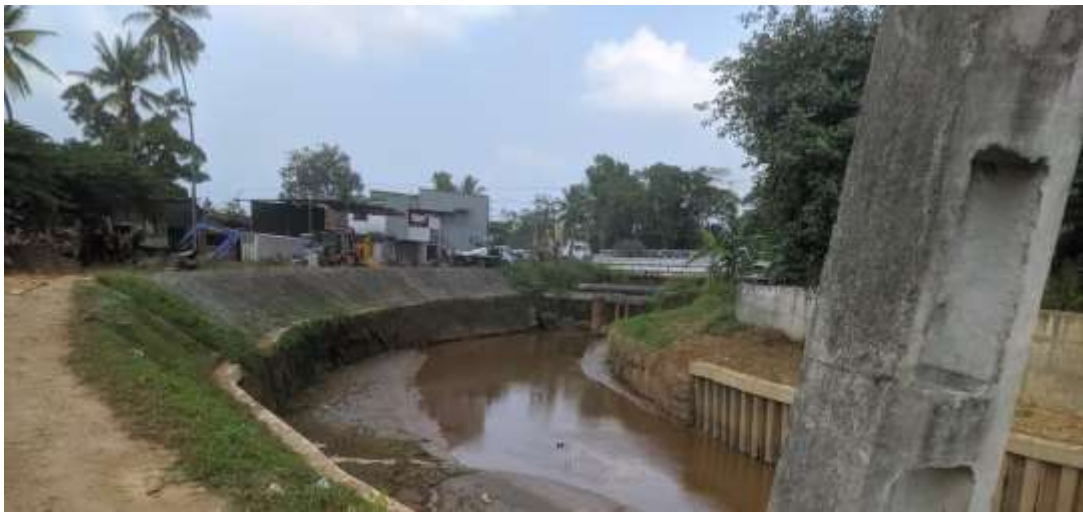
*Figure 2.12: Completed canal bank protection as seen now.*

As per the initial design, the top of gabion finished level was at +3 mMSL and existing ground was at +6 mMSL and hence there was a 3m vertical difference which was originally proposed to be stabilized by a gabion mattress. Due to this unexpected collapse, the design and methodology were modified and it was decided to modify the gabion section such that the top level of gabion was at +4 mMSL (with reduced lateral pressure as the level difference was now 2m) and construct the sloped gabion mattress starting from +4 mMSL and that is the completed canal bank protection as seen now (Figure 2.12).

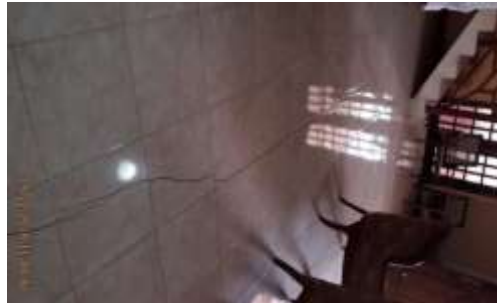
Figure 2.21: C1 crack on 19.12.2018.

This floor crack denoted as C1 was appeared along the living of the house and crack width was 4mm.

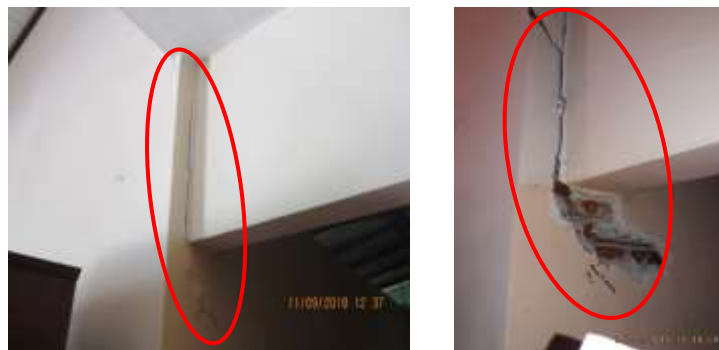
Figure 2.22: C2 crack on 11.09.2018 and 19.12.2018.

The width of the crack C2 was recorded as 7.36mm initially and it was further widened to 19.29mm during the subsequent 03 months.

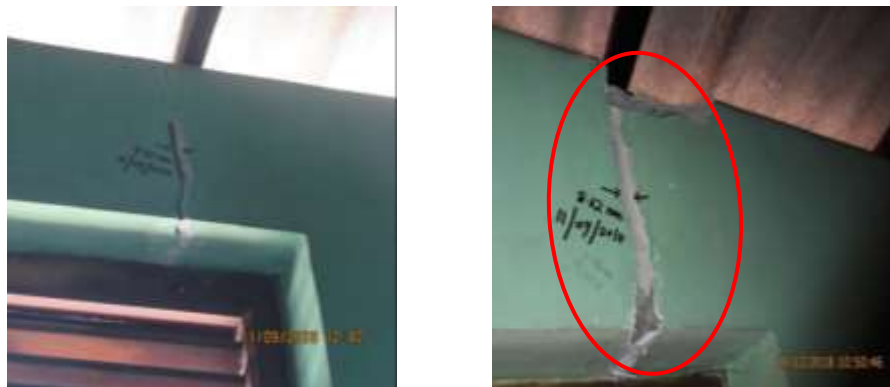
Figure 2.23: C3 crack on 11.09.2018 and 19.12.2018.

The vertical crack C3 was initially measured as 8.62mm during the initial assessment and it was further widened to 11.46mm within the course of next 03 months.

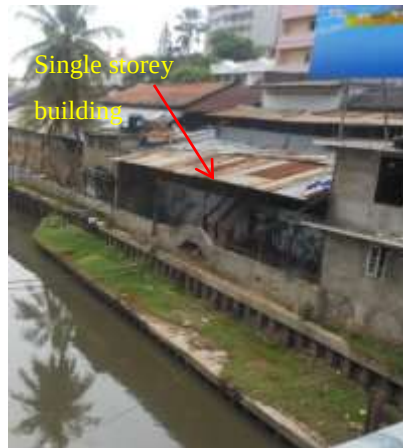
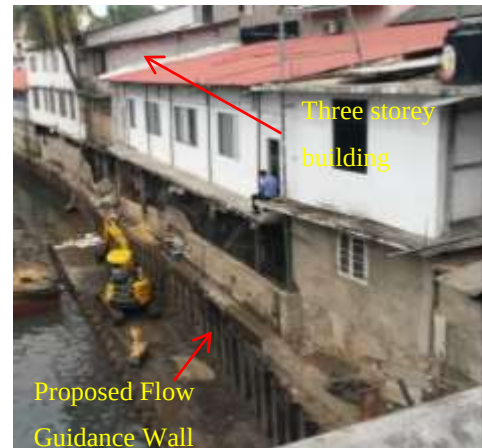
It was recorded that a significant modification to this building had been carried out from the design stage to the construction stage. Part of the building close to the canal had not been included during the design stage and it has been modified significantly during the construction stage.

Figure 2.30: Damaged building condition during design stage and construction stage

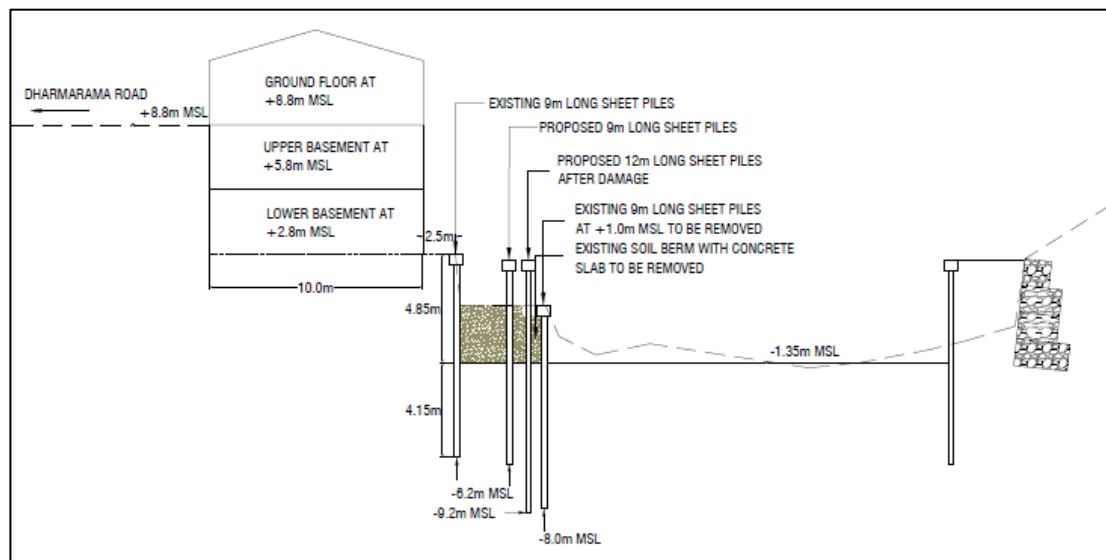
The major cause of the damage was found as the loss of lateral pressure from the berm and lost the stability. All construction works were temporality suspended after the collapse and widening or propagation of the cracks were monitored. The central engineering consultancy bureau were requested to assess the damage and submit a remediation plan .

*Figure 2.34: Cross sectional view of the canal bank protection design used at the site after damage.*

Accordingly, another row of sheet piles with 12m in length were driven in between new sheet pile line and the berm to recapture the lost passive pressure of the berm (Figure 2.34). Also, this 12m length sheet piles extended sufficient length beyond the berm such that the area protected by the berm are protected by this new sheet pile line.

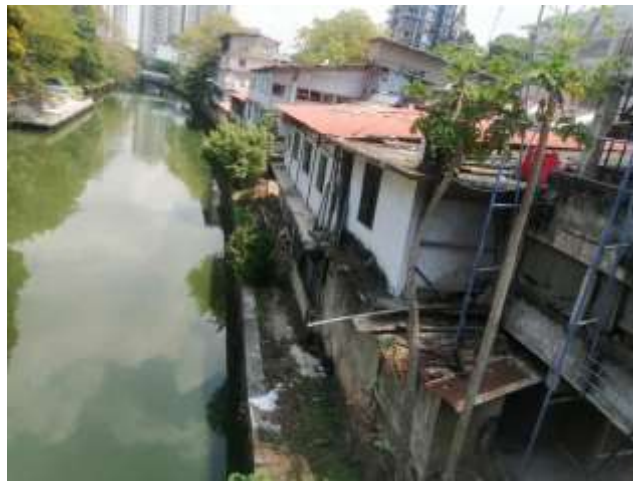
*Figure 2.35: Project site as seen today after the remediation sheet piles*

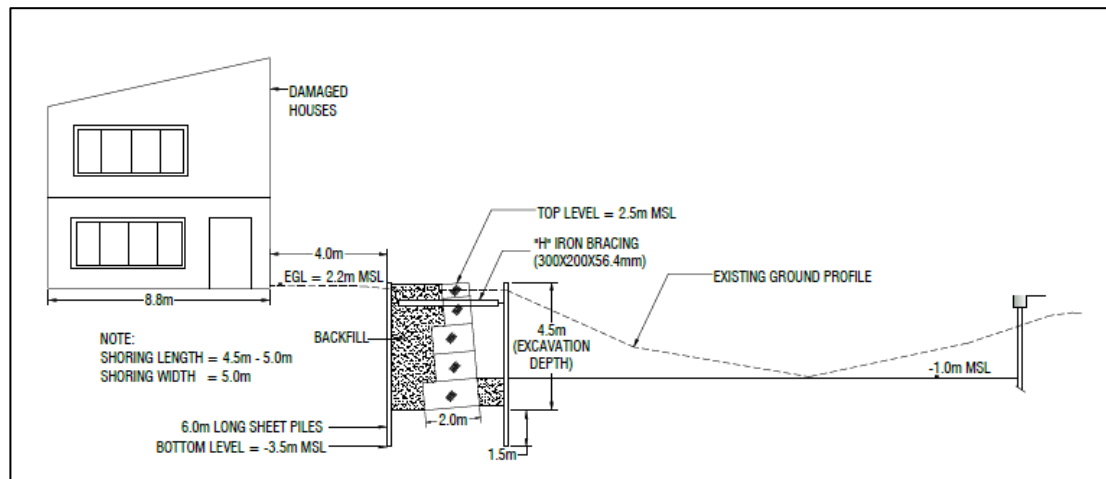
Figure 3.3: Section showing the Temporary Shoring Arrangement Used at the site.

For the application of design section to the actual site, it was decided to have a temporary shoring arrangement using 6m length sheet piles with H iron bracings at top level to retain the bank during gabion wall construction works. Sheet piles were driven upto -3.5m MSL and depth of excavation was 4.5m. The system adopted in the site is presented in Figure 3.3 and Figure 3.4.

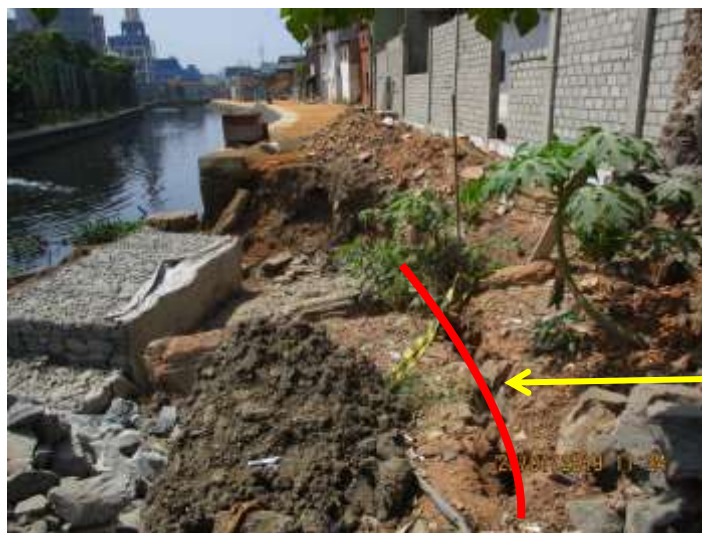
Figure 3.5: Ground movement at the back side of the House Ref No. P61.

As per the construction methodology, the temporary sheet piles have to be pulled off once the gabion walls are constructed up to +2.5 m MSL. But the temporary sheet piles have been pulled off at +1m MSL level of gabion wall construction resulting heavy movement of embankment causing structural damages to nearby buildings. It was observed that the rear wall of the House Ref. No. P62 has tilted towards the area of bank of the canal (Figure 3.5).

Line of Soil  
Movement towards  
the Canal.

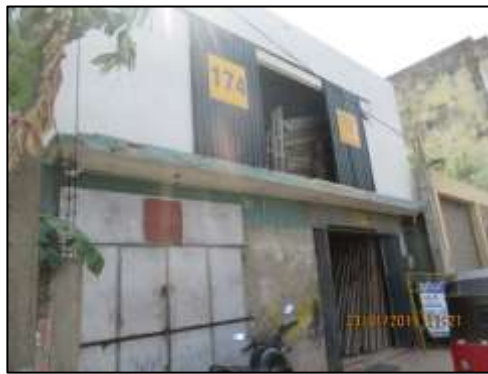
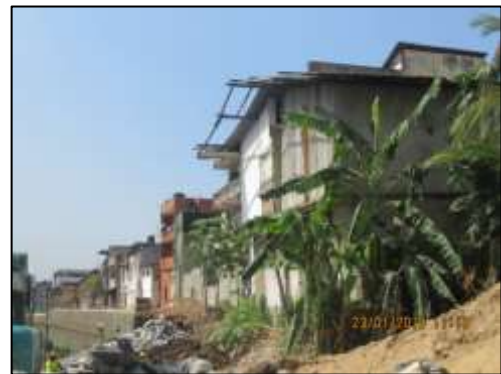
Figure 3.6: Front view and back view of P62 house.

The front part of the P62 house which face to Nagalagam Street has been demarcated as P62A in Figure 3.6 and that part was used as a steel formwork storage yard. The back part of the P62 house which face to St. Sebastian North Canal has been demarcated as P62B in Figure 3.6 and that part was used as the house structure of the owner.

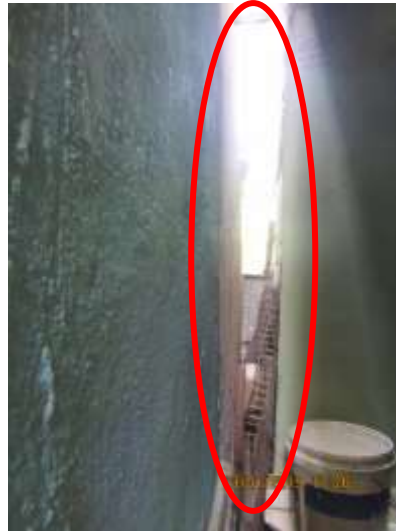
Figure 3.9: Detachment – 2 observed in the wall.

As shown in figure 3.9, Detachment -2 was observed in the internal wall which is closer to the staircase. The extent of detachment was 223 mm which was occurred during the construction of gabion walls were in progress.

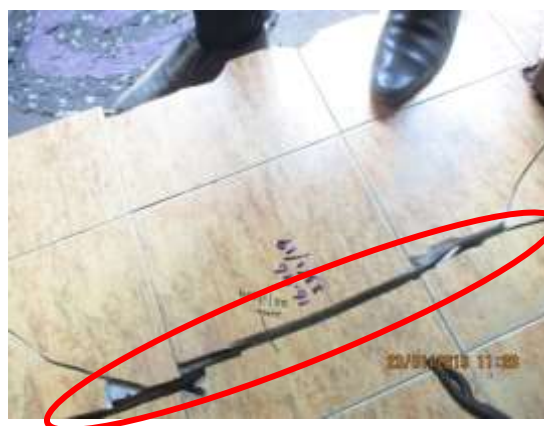
*Figure 3.12: C1 floor crack.*

No records were available regarding this crack in Pre-Condition Survey Report.

Measured Crack Width on 23.01.2019 was 16.46mm. This crack has been appeared at the rear side of the House Ref. No. P61. The crack which is depicted in above photograph has widened horizontally and displaced vertically. Through the observations, it can be determined that this part of the House Ref. No. P61 which is cracked along the line as depicted in the photograph is moving towards the canal gradually.

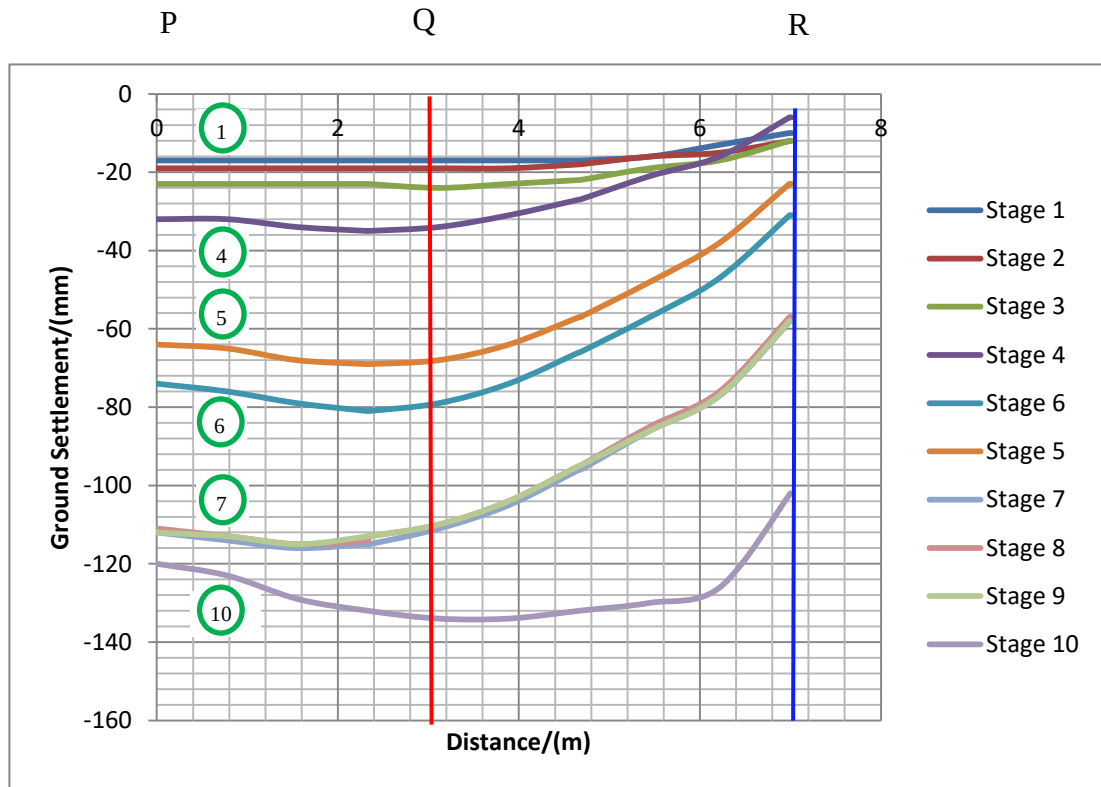
Figure 4.9: Ground settlement profile of System 01.

Accordingly, at the first stage, consolidation settlement due to the surcharge, 20mm ground settlement can be observed closure to the damaged structures (at Q) as shown in Figure 4.9

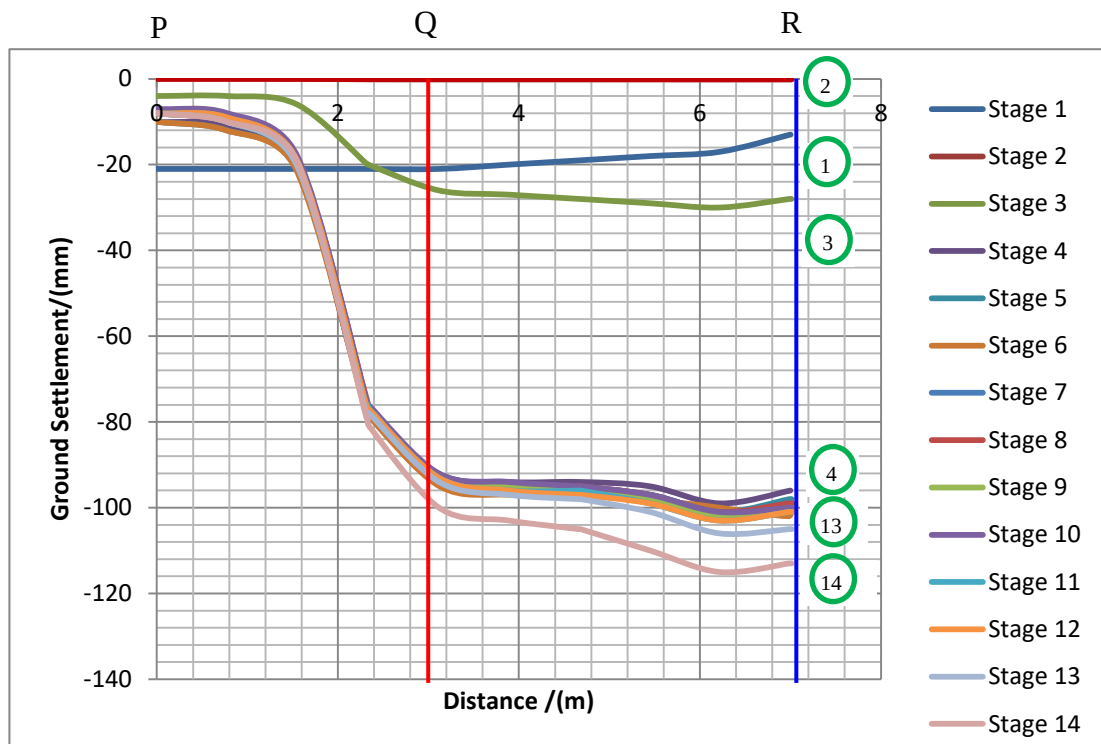
Figure 4.15: Maximum ground settlements along the Distance for System 02

Accordingly, when the sheet piles were installed at stage 01, the maximum ground settlement of 20mm was observed at 4m distance from the edge of shoring which represents the consolidation settlement due to the surcharge activated.

Installation of “H” iron prop at stage 02, any ground settlements were not observed. But, commencement of excavation of 1.5m depth and installation of second prop at stage 03, ground settlement has been increased to 25mm. Another 1.5m excavation at stage 04 resulted to increase the ground settlement to 90mm.

It is observed that there is a rapid rate of increasing in vertical settlement during stages 03 and 04. This trend of rapid increasing of the settlements has been ceased after stage 04. Apparently, the installation props have resulted in mitigating the settlement increase an even though the subsequent stage associated with excavation of further 1.5m (i.e. excavation to 4.5m depth level), there is no further increasing trend of the settlements and thus the effect of propping is highlighted.

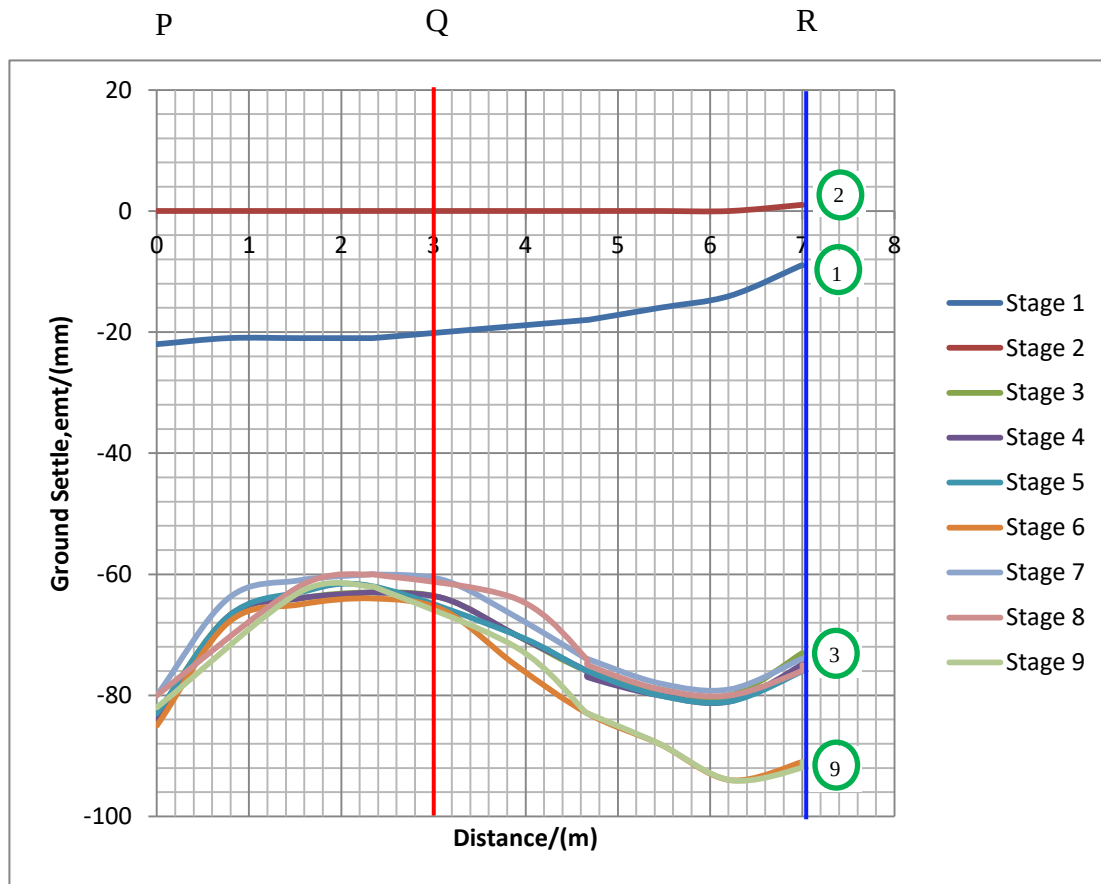
Figure 4.21: Maximum ground settlements along the Distance for System 03

The system 03 involved with the setting up of the props at ground level in stage 02. Therefore, even though there is a considerable rate of settlement during stage 04 (i.e. stage relevant to excavation), there is a reduction of total settlement by approximately 40mm than system 02. The rate of settlement is ceased once the excavation is completed and construction of gabion is initiated.

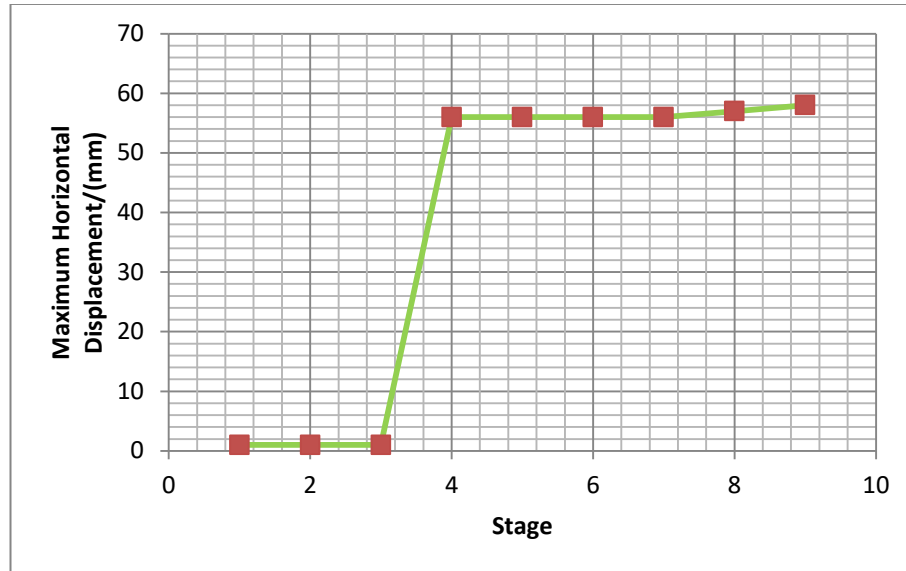
*Figure 4.23: Maximum Horizontal displacement at damaged structure location for each stage of System 03.*

The horizontal settlement shown in Figure 4.23 indicates a similar pattern as per previous stages where the horizontal displacement is abruptly increased during the excavation followed by a subdued increase in displacement afterwards. The displacement increases rapidly during the excavation, up to 58mm and the increased resistance of 9m sheet pile was able to hold the displacement graph near constant after the excavation. The amount of displacement is reduced even more than System 02 and yet it exceeds the allowable limit similar to the status of vertical settlements.

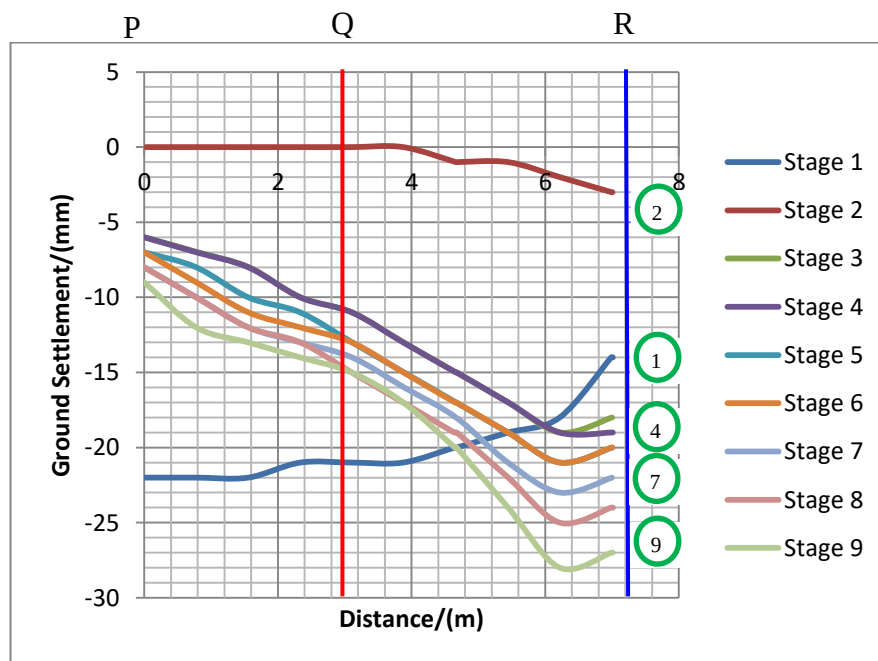
*Figure 4.27: Maximum ground settlements along the Distance for System 04.*

The system 04 involves propping at 03 levels. Stages 01, 02 and 03 represent the installation of props at 1.5m intervals. The stage 04 is associated excavation upto 41.5m depth and there is a slight increase in settlements in this stage which is understandable. A slight increase in settlements are observed during the next stages. When the overall settlement is considered, the total settlement is within the allowable limits of (i.e. 40mm) along the entire construction sequence.

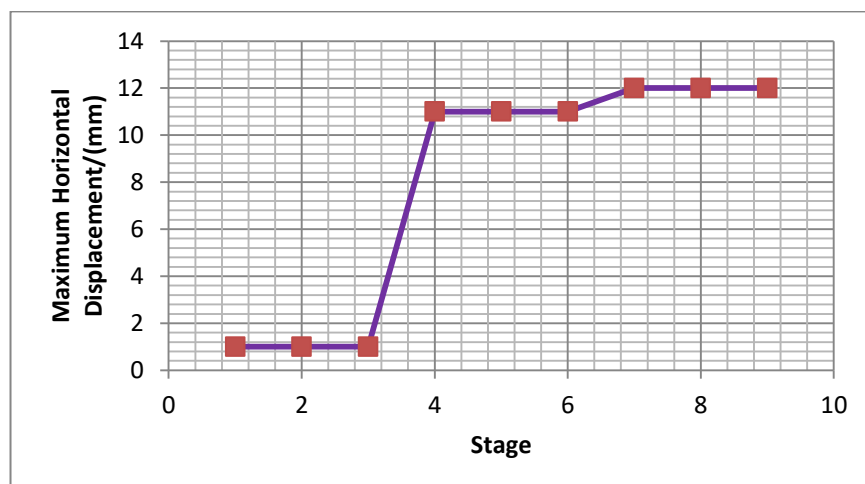
*Figure 4.29: Maximum Horizontal displacement at damaged structure location for each stage of System 04.*

The variation in horizontal displacement is shown in Figure 4.29. Similar to all previous systems, the horizontal displacement increases with a higher increment during the excavation stages and yet the amount of displacement after excavation is only 11mm due to the 9m sheet piles with increased bracings in system 04. The displacement after total construction is 12mm and has significantly reduced than all the previous systems. Similar to ground settlements, it can be observed that horizontal displacements also below the allowable limits throughout the entire construction sequence and hence the structural safety is further reassured considering the horizontal displacements with the arrangement of system 04.

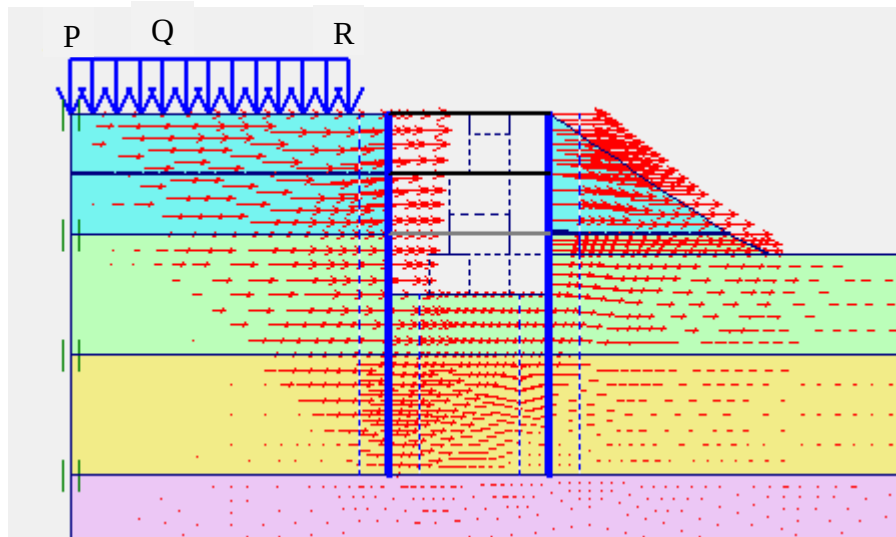
*Figure 4.30: Horizontal Displacement Profile of stage 04 of System 04.*

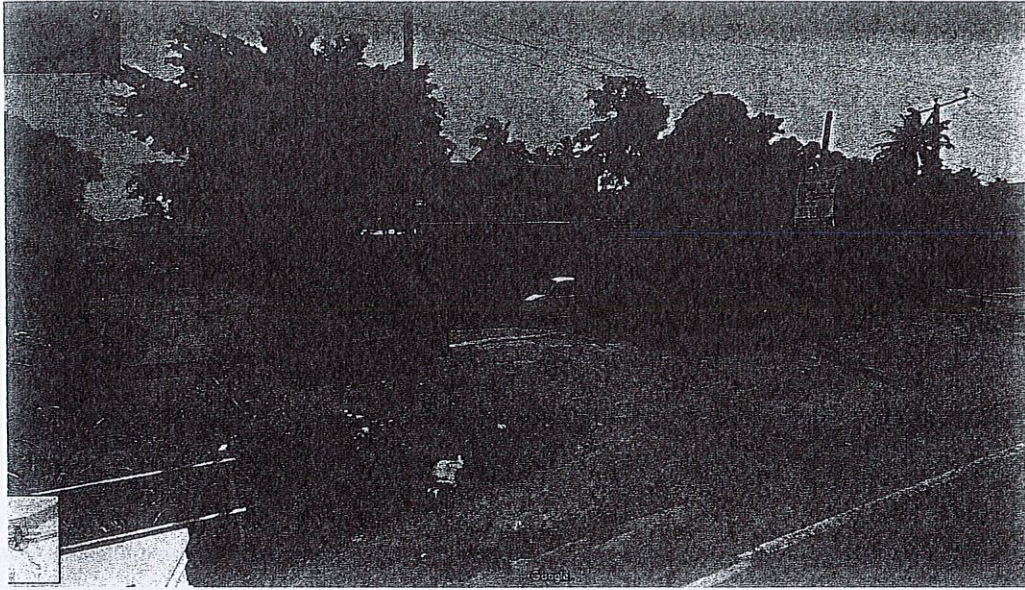
The damaged house was situated closer to the Madiwela Canal. It was a single storied building with load bearing walls and a Calicut tile covered roof. Recently a two storied building was constructed adjacent to the affected house towards the canal side. As per the details given by the client the depth of the canal was 6m from the existing ground level.

Figure 03 – Front view of the Building and the canal (Source: Google Street View)

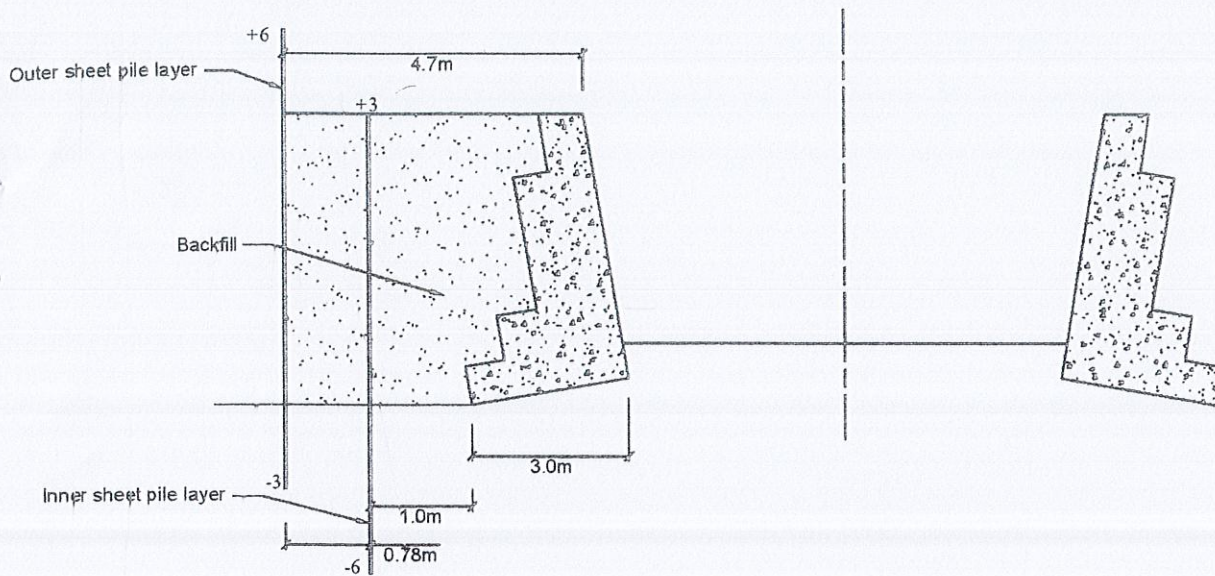
A Gabion wall was constructed using interlock sheet piles and the construction of it was finished in November 2018. After the construction, interlock sheet piles were left driven in to the ground to avoid further damage to the properties. As informed by the client and the house owner, the canal area is regularly prone to flooding.

Figure 05 – Cross section of the Gabion Wall

- (b) It is recommended in the soil investigation report to adopt steel sheet piles which are driven to the layer of 'completely weathered rock': i.e. to a depth of around 17m below borehole elevation. But sheet piles were only driven to a depth of 12m where a very weak residual soil layer is present. Therefore they are not supported at the ends to withstand pressure applied by the soil mass.

- (c) As sheet piles are not driven up to the recommended depths and a controlled fill was not used to fill the gap between the sheet pile wall and the gabion wall, it can be concluded that the sheet pile layer is tilted.

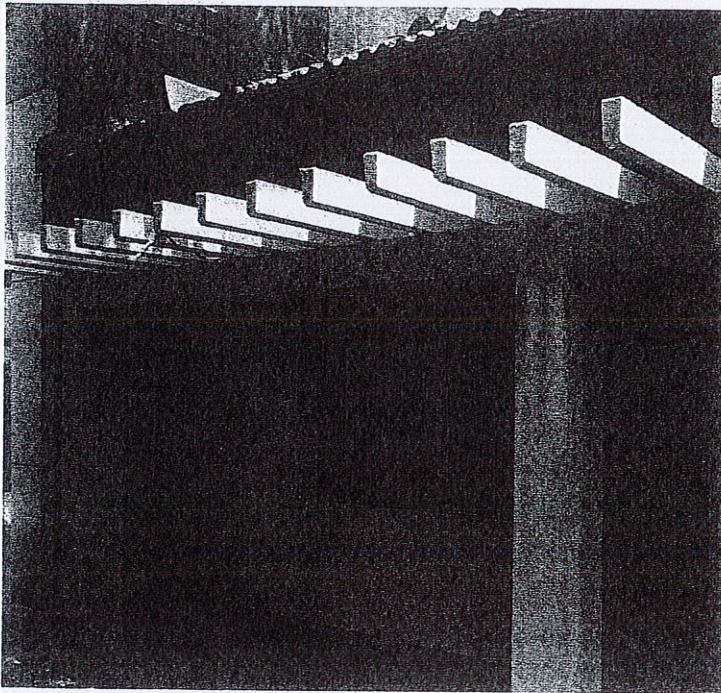
- e) It was observed that the single storied building was connected to the two storied building structurally.

Figure 12 – Two buildings were connected with each other.

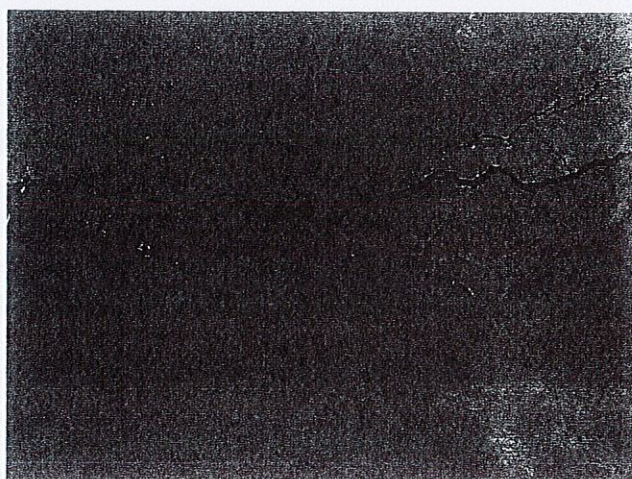
- (c) A new tension crack had appeared in the ground between the two storied building and the retaining wall.

Figure 14 – New tension crack near the two storied building

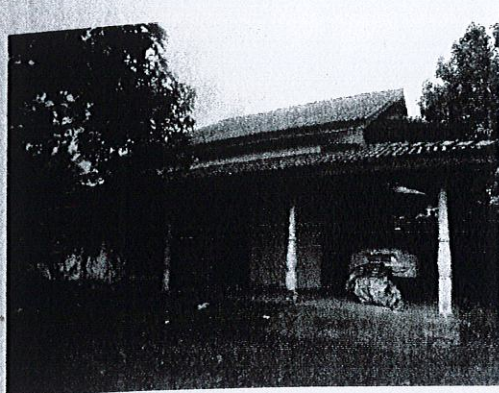
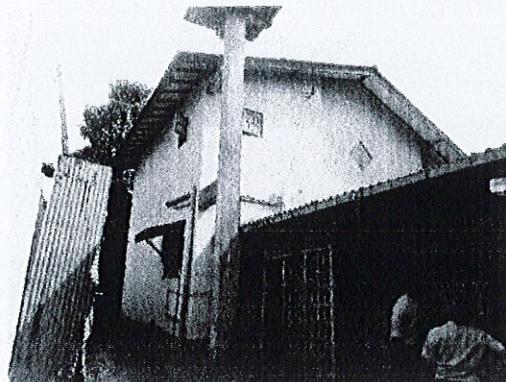
Fig. B.1 Front and rear views of No. 14/19 dwelling house

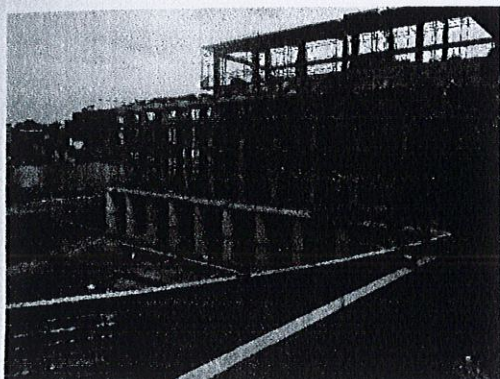
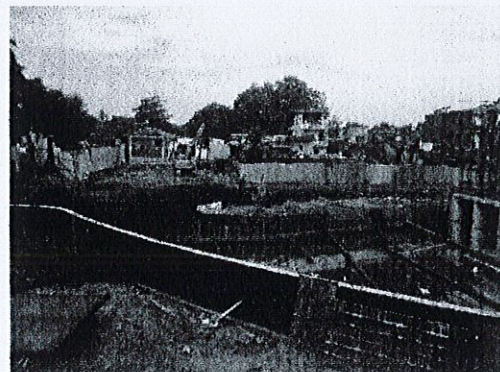
Fig. B.2 Adjacent construction of Pumping Station

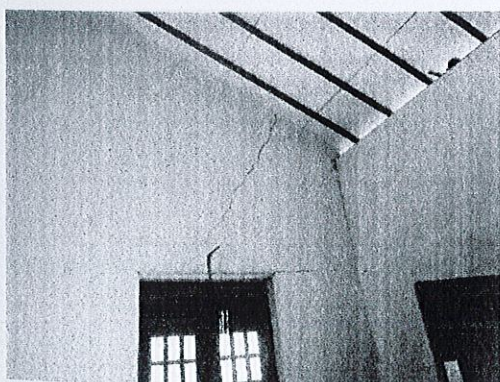
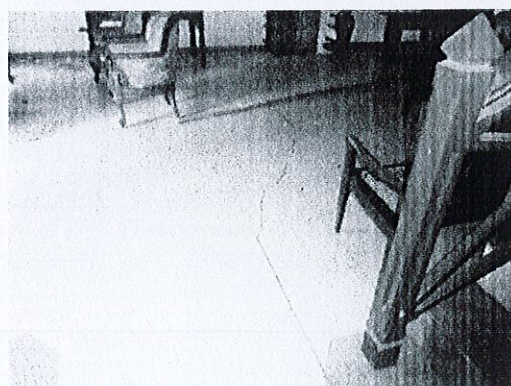
Fig. B.3 Wall and floor cracks in single storied front (living) area

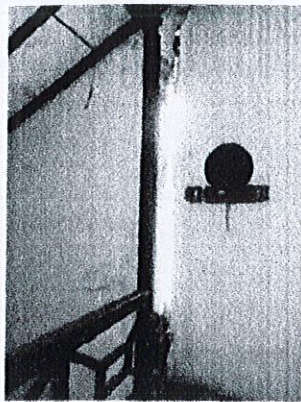
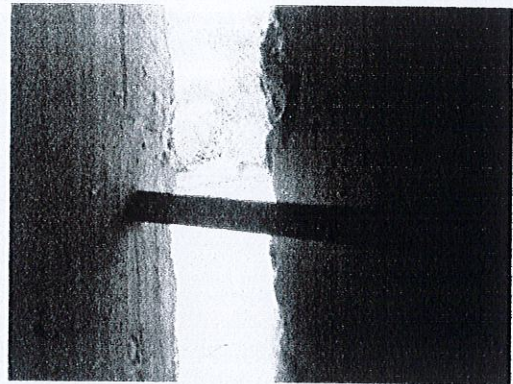
Fig. B.4 Wide open crack at upper floor wall

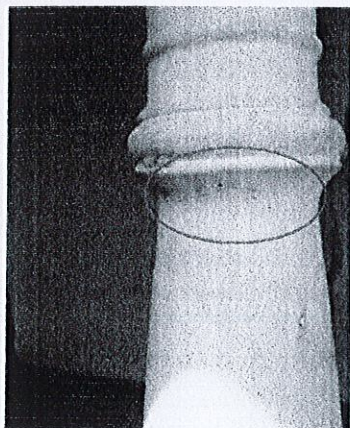
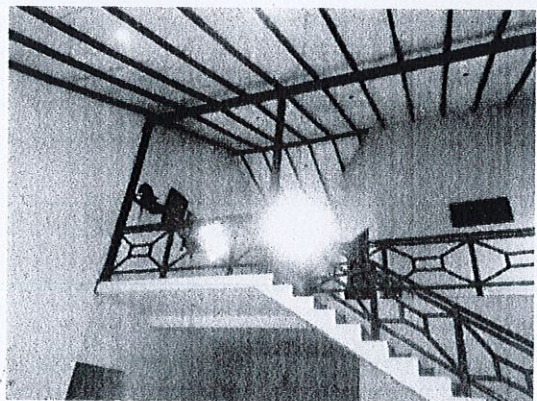
Fig. B.5 Cracks in front varandha columns and arrangement of roof rafters, some of which are about to dislodge from their connections

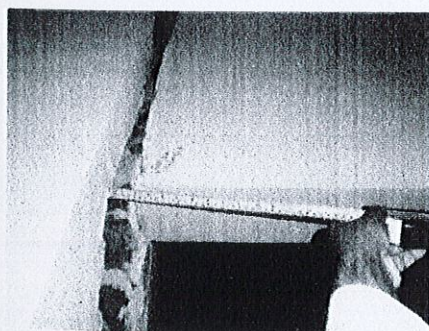
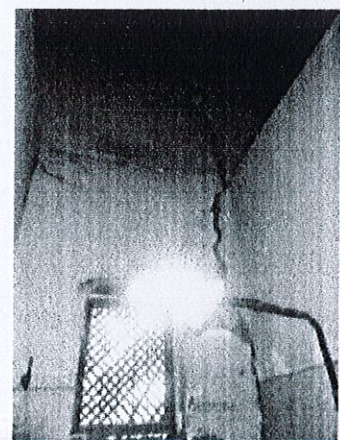
Fig. B.6 Cracks in walls at single story area (at rear and by the side of two story portion).

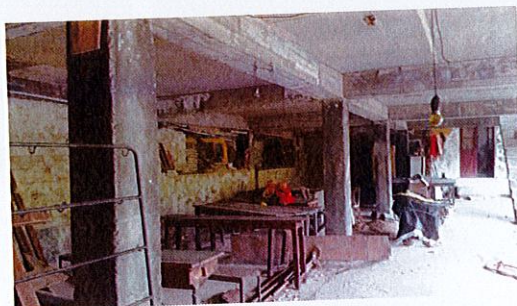
Slight spalling of concrete columns was also noted in the lower basement level, again due to the poor construction quality.

**Figure 9 - Slight spalling of concrete in columns**
