# DISTRIBUTION SYSTEM RELIABILITY ASSESMENT AND TECHNIQUES FOR IMPROVEMENT.

A dissertation submitted to the  
Department of Electrical Engineering, University of Moratuwa  
in partial fulfillment of the requirements for the  
Degree of Master of Science

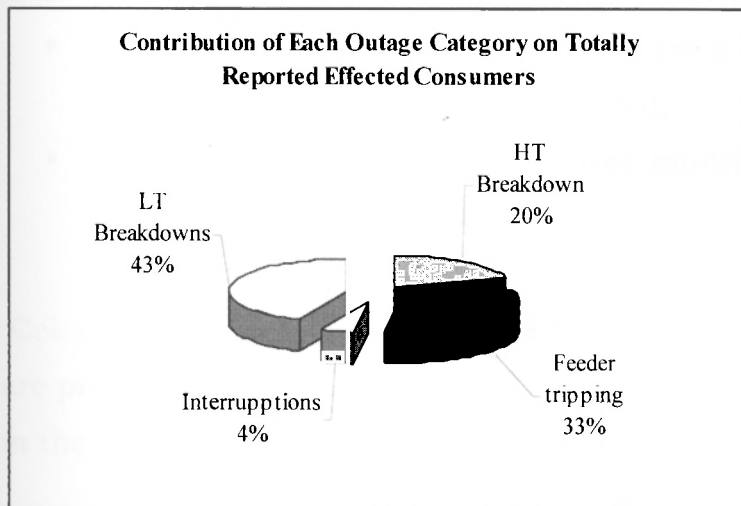
**Fig.2.2: Percentage of effected consumers due to different outage categories**

Above analysis clearly indicates that feeder trippings reported for year 2005 & 2006 are only 4% of the total outages but it affected as many as 33% of the consumers resulting in losses as much as 50% of the consumer hours. Therefore the main contribution to SAIDI values was from HT breakdown failures as the 33kV and 11kV outages affected thousands of customers. LV outages have limited impact and only a few hundred customers were affected by them.

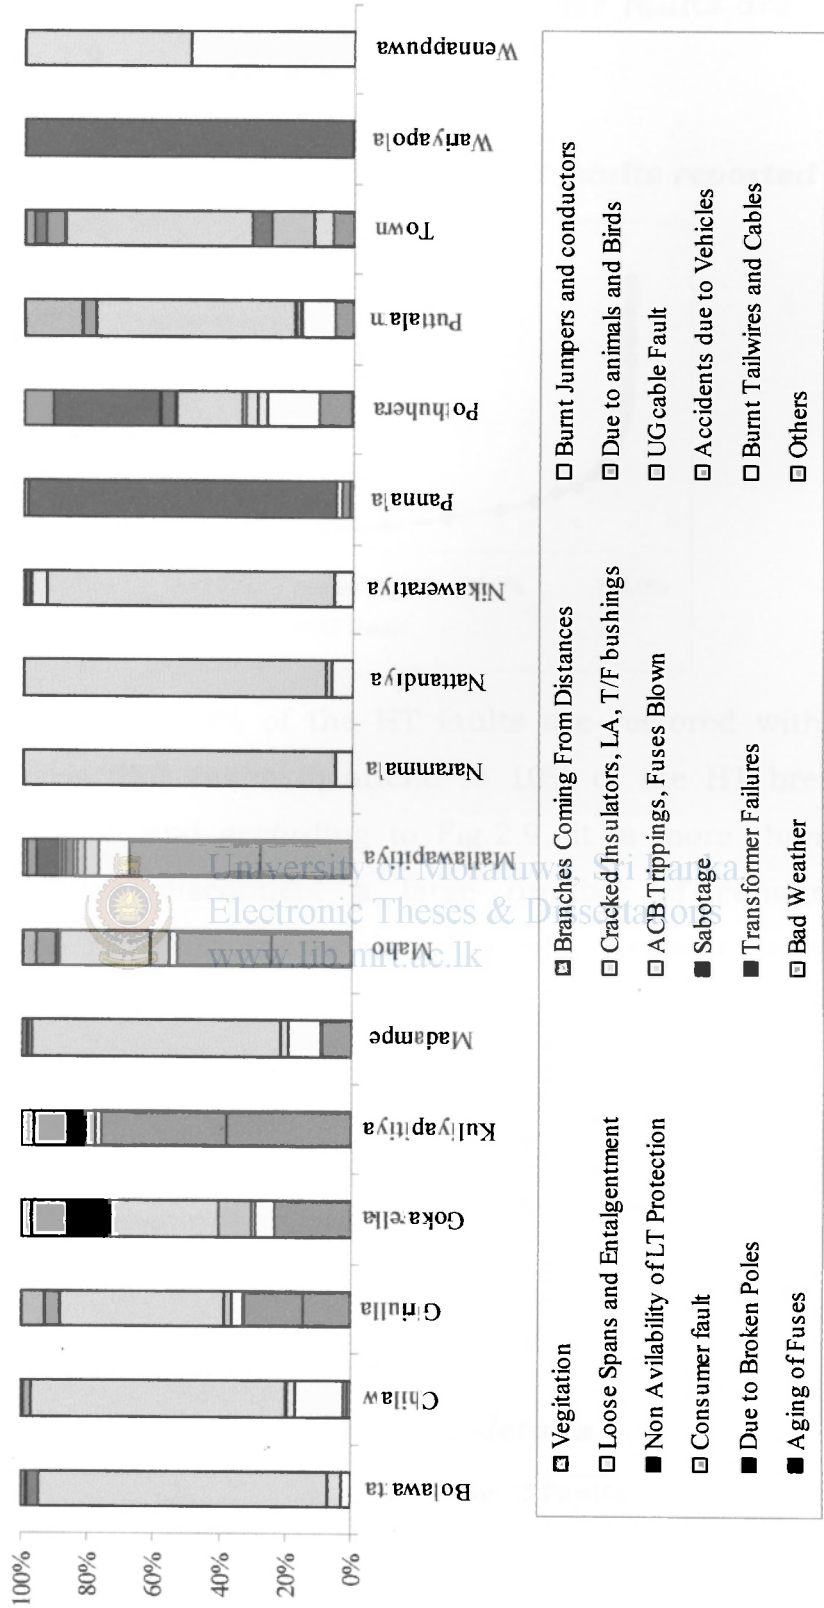
Reasons identified for HT failurers are given in illustrated in Fig.2.8. In puttalam, wariyapola, Gokarella and Giriulla areas, a large number of blown HT fuses events are reported in average about 7 HT fuses are blown everyday in 2005 & 2006.

**Fig 2.8 Identified Reasons For HT failures Reported to Each CSC**

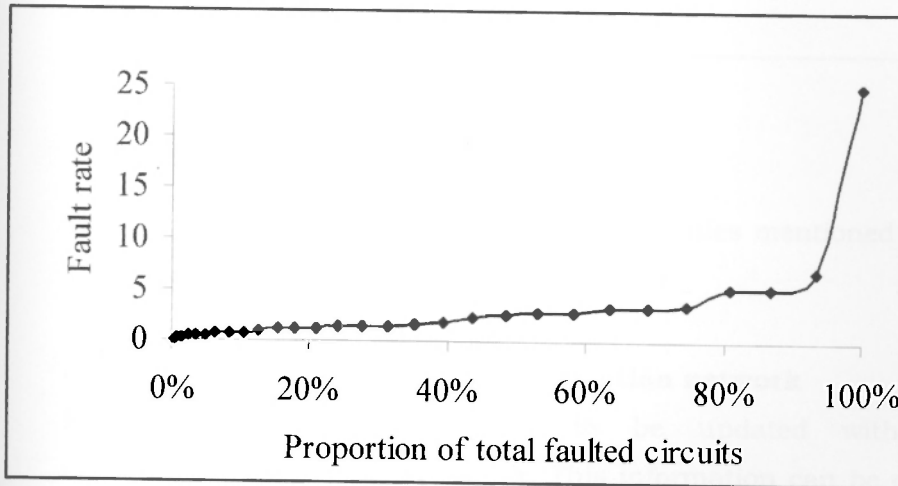
**Fig.2.10: Fault rate vs percentage of total circuits**

Proportion of total faulted circuits vs fault rate is plotted for all 33kV distribution feeders and presented in Fig.2.10. It indicates that proportion of total faulted circuits of 75% is having more than 0.5 fault rate. Where breaker operations and supply reliability are concerned, the present situation is not satisfactory and it has to be improved without delay. A large number of manual trippings requested by operation staff for load transfer has been indicated in Table 2.8. Even though the duration of manual trippings are very short they adversely affect all industries and a means should be found to eliminate them.

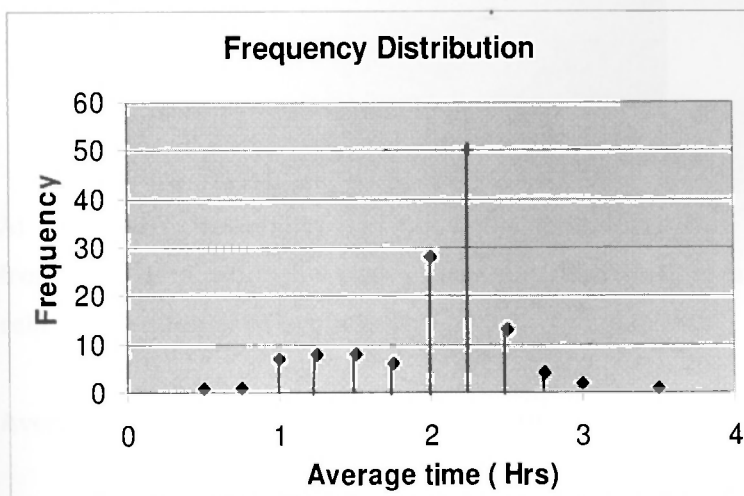
Summarized results given in table 41, are plotted as a frequency distribution as shown in figure 4.1 which pictorially represents the frequency of occurrence of MV power failures having the power restoration time between 0.5 hours to 3.5 hours .

**Figure 4.1 : Frequency Distribution of MV power failure of the selected area.**

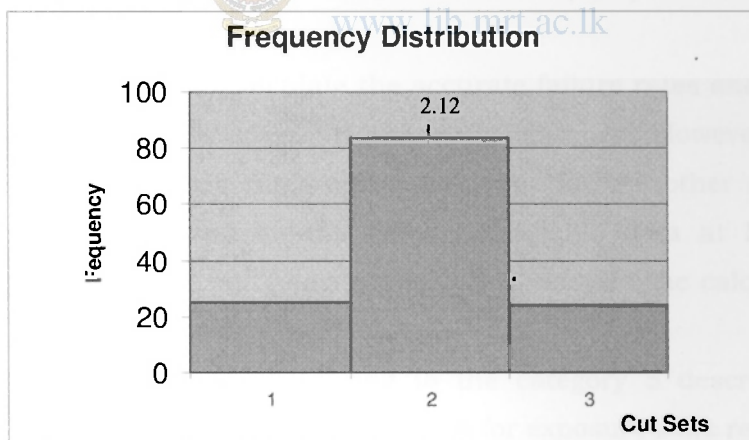
Frequency distribution of MV power failures against the cut sets are given in figure 4.2 in form of a histogram.

**Figure 4.2 : Frequency Distribution of MV power failure of the selected area- Bar Chart**

As per the figure 4.2

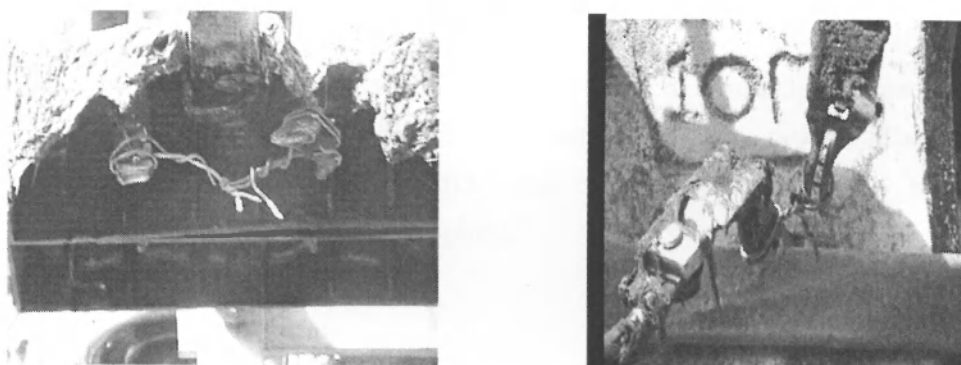
Improper electrical connection of HT jumpers is the main reason for frequent HT breakdowns. Instead of connecting two conductors with a binding wire it is recommended to crimp HT connections.

**Fig.5.3: Improper electrical connections**

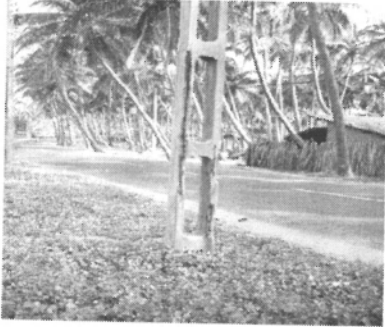
Concrete poles are not suitable at coastal areas due to corrosion problem. Instead of poles constructed with normal cement, special cement having corrosion resistant characteristics can be used to make concrete poles to be used in coastal areas. Similar cements are widely used today in construction activities in areas close to the sea.

**Fig.5.5: Corroded concrete poles at coastal areas**
