**STUDY OF ARCHITECTURAL ASPECTS ON
RESETTLING TSUNAMI VICTIMS IN
SRI LANKA**

A dissertation Presented to The Faculty of Architecture for M.Sc. (Architecture) Examination

Faculty of Architecture
University of Moratuwa
Sri Lanka

2006

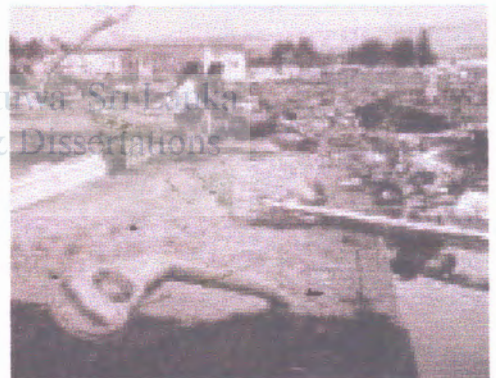
Fig.1-City in to pile of rubble after earthquake

It damage buildings, dams, collapse underground structures such as caves and tunnels, offsets streams, road and bridges. Earthquake losses are largely preventable. Approximately 90% of the loss of life in all earthquakes is the result of buildings collapse. Until recently, this was unavoidable; but more is known about the nature of earthquakes and their effects now.

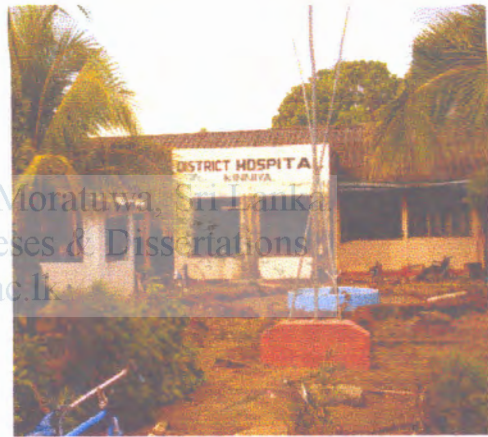
Fig. 10- Destruction of buildings.

During that time, between 31,000 and 37,000 people were killed by drowning or debris impact, and nearly 80,000 houses were destroyed along with tens of thousands of vehicles and much infrastructure.

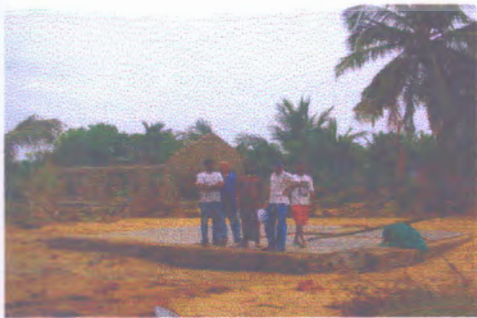
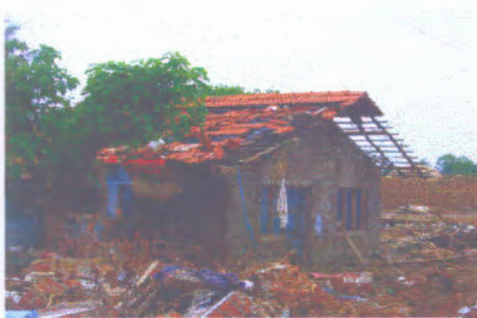
Fig. 32-Distroyed houses

Damage to the residential areas and the civic centre is extensive. Some 77 houses were destroyed, an unknown number were partially damaged. While the built environment was demolished, the natural environment is existed towards the tidal waves.

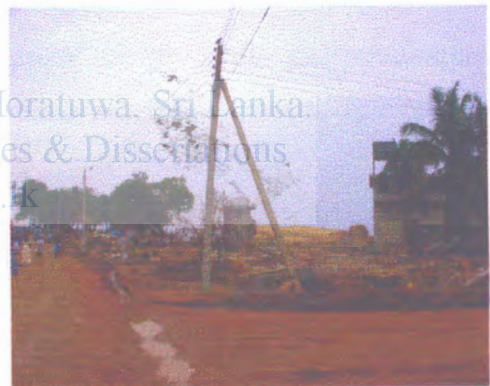
Fig. 34- Electricity system

They have gained water from main water supply and have used grid electricity.

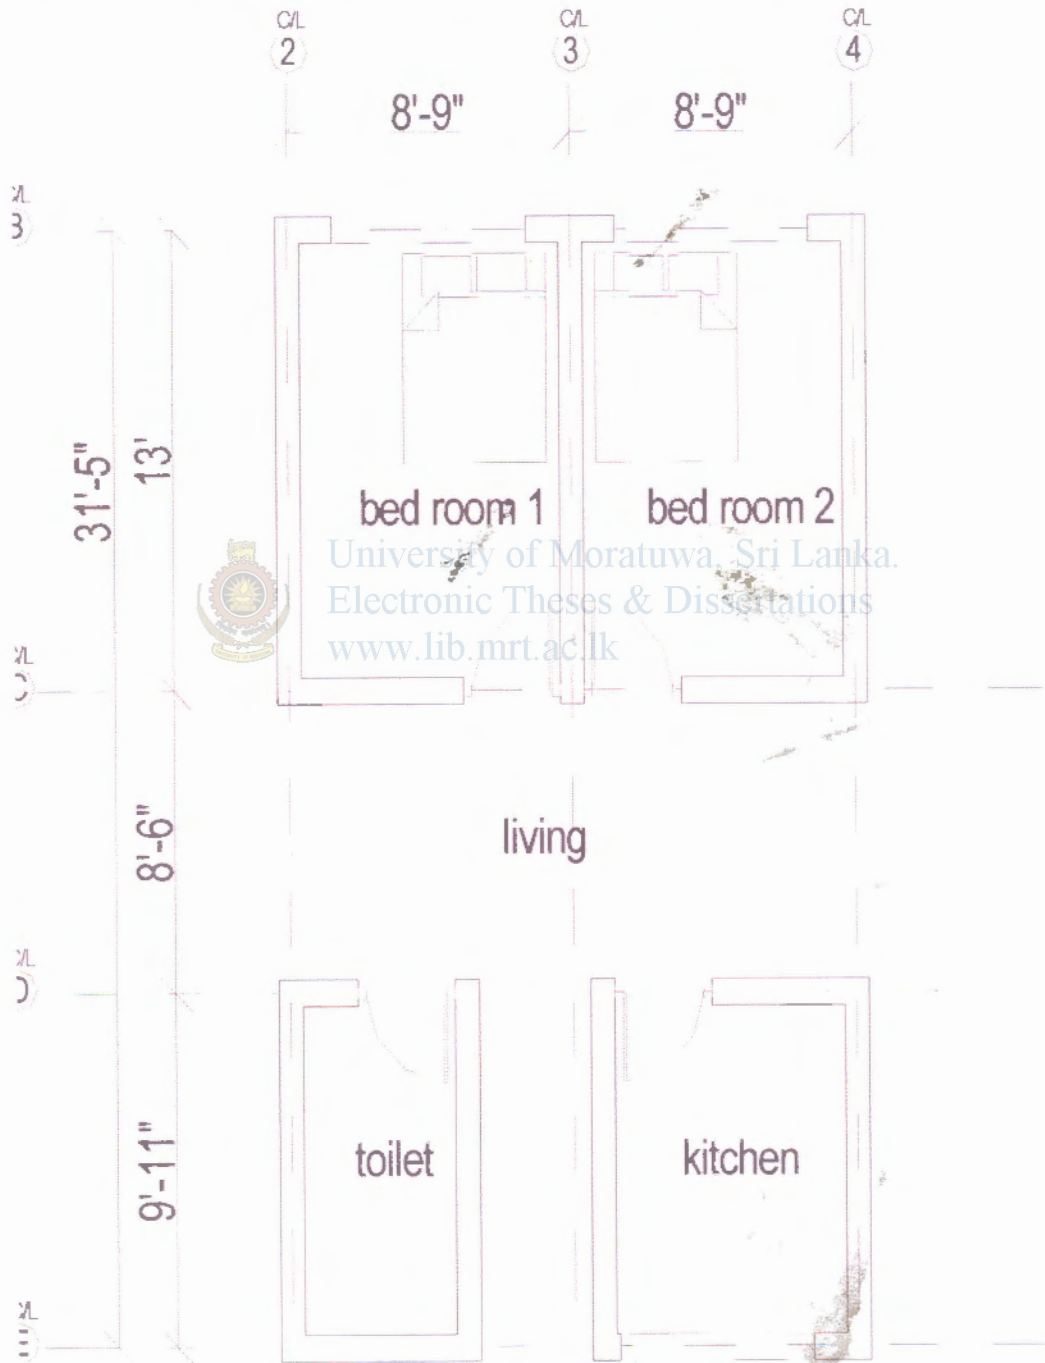
Fig. 37- Individual Unit

Considering the housing unit, one unit consists of two bed rooms, facing the main road, kitchen and toilet is in other side. Open Living space links two parts of the house. It acts as a multi functional space, in between the bed rooms and the kitchen. Living is faced to secondary road. There is a level change between bedrooms and living space.

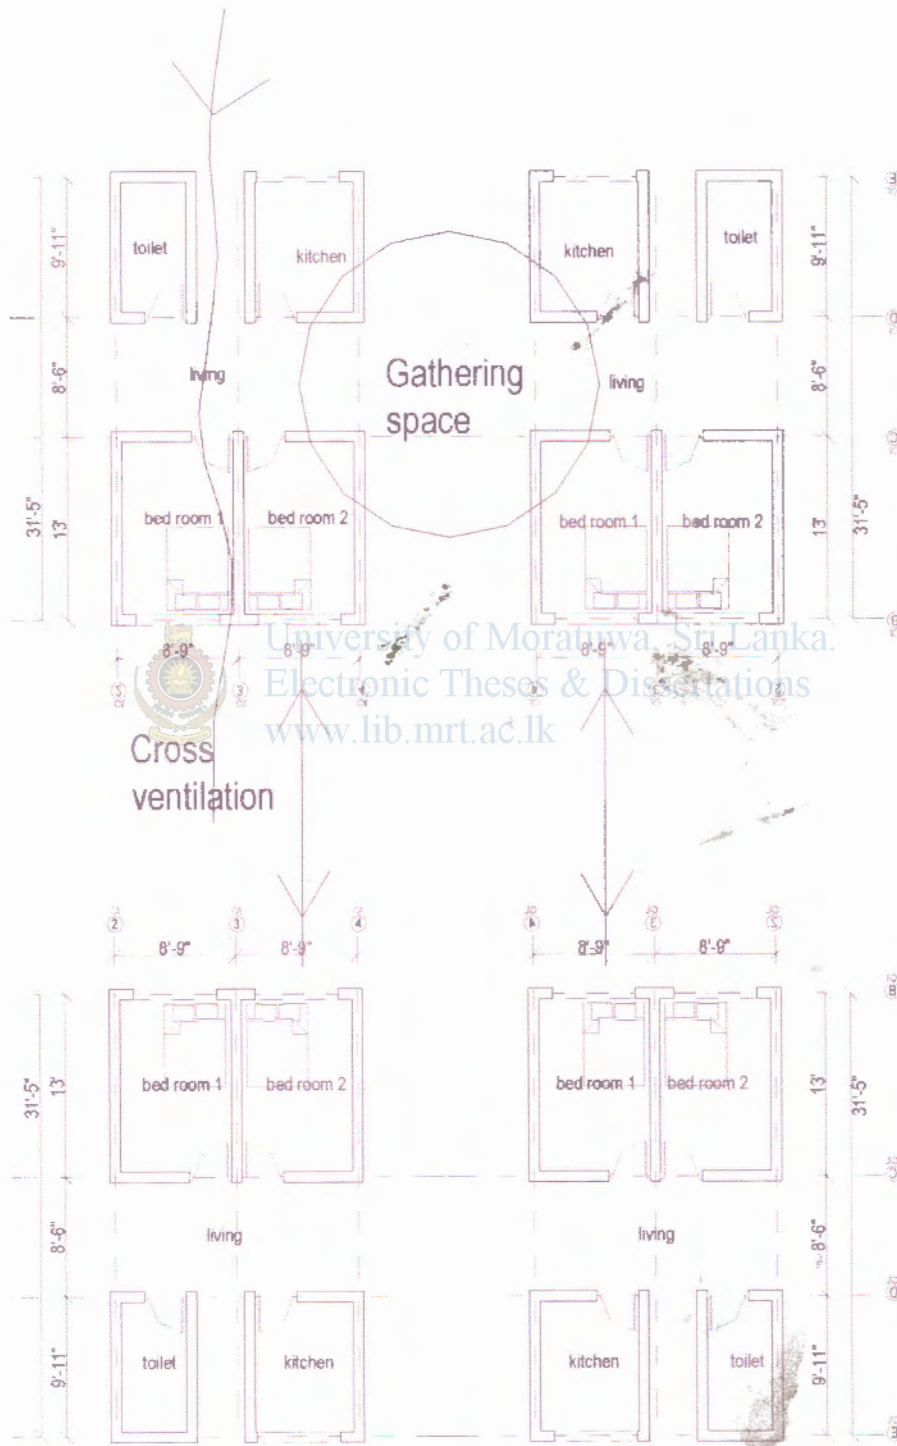
Fig. 38- Housing arrangement

Considering housing lay out, bedrooms are facing each other. Entrances are made gathering spaces, which is link with the living room.

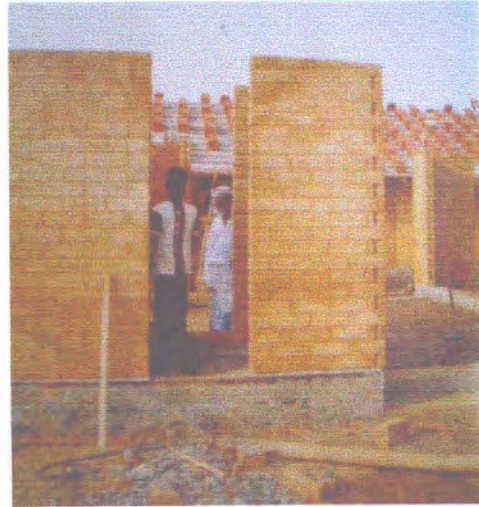
Fig. 39-clay and cement blocks

The walls are made out of clay and cement mixed blocks. It is a new building material with less cost because Clay is a available material in that area. Heat gain is less, therefore it reduces the heat in side of the house. It has been finished with Cement rendered floor.

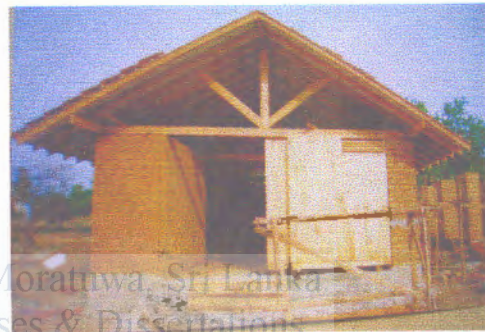
Fig. 40- Roof structure

Roof consisted of first class imported timber with calicut tile cover. Wide span is provided by this roof structure. The cost is high. There is a gap between roof and the wall for the ventilation. Internal courtyard is also reducing the heat. It create comfortable living environment.

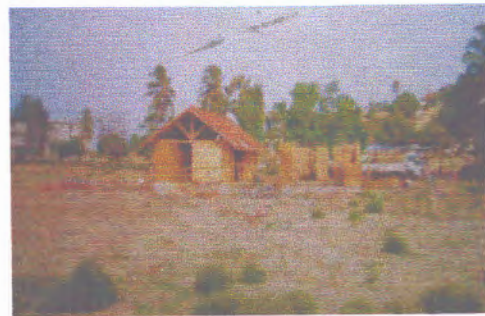
Fig.41- Scheme is in same construction stage

There is a community participation, in the construction stage. When the scheme is in same construction stage, they get advantage of Labour efficiency, cost effective, minimum material wastage and easy supervisions. There is a unity among the Muslim community. They contribute to build their own village.

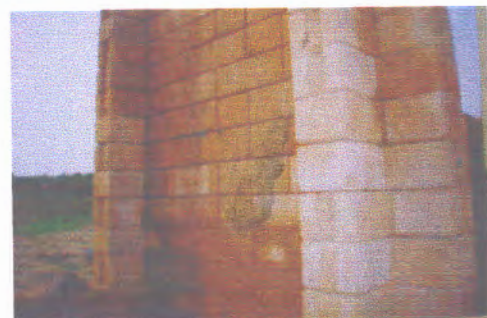
Fig. 42- Clay –cement brick wall

New construction techniques have been introduced.

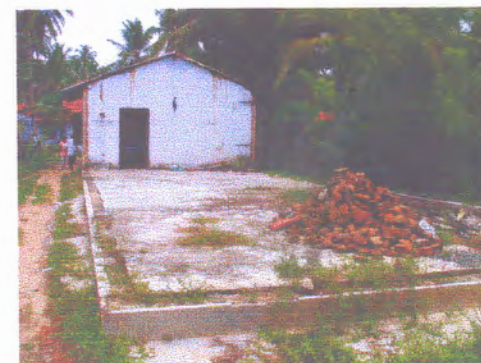
Fig. 52- Destroyed houses

Tidal waves washed out the village. Rest of the people suffer deaths of family members, relatives, friends, loss of belongings and their residences.

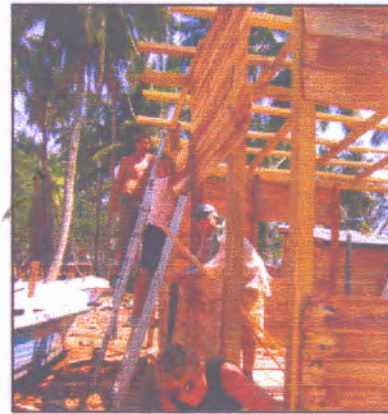
Fig. 58- Construction of wooden houses

In the Transitional phase, wooden raw houses, Pre School and school are provided. The people of the Peraliya, have live long time there, because permanent house have taken long time to construct.

The situation is same in the wooden transitional houses. They have faced several issues because of the climatic conditions.

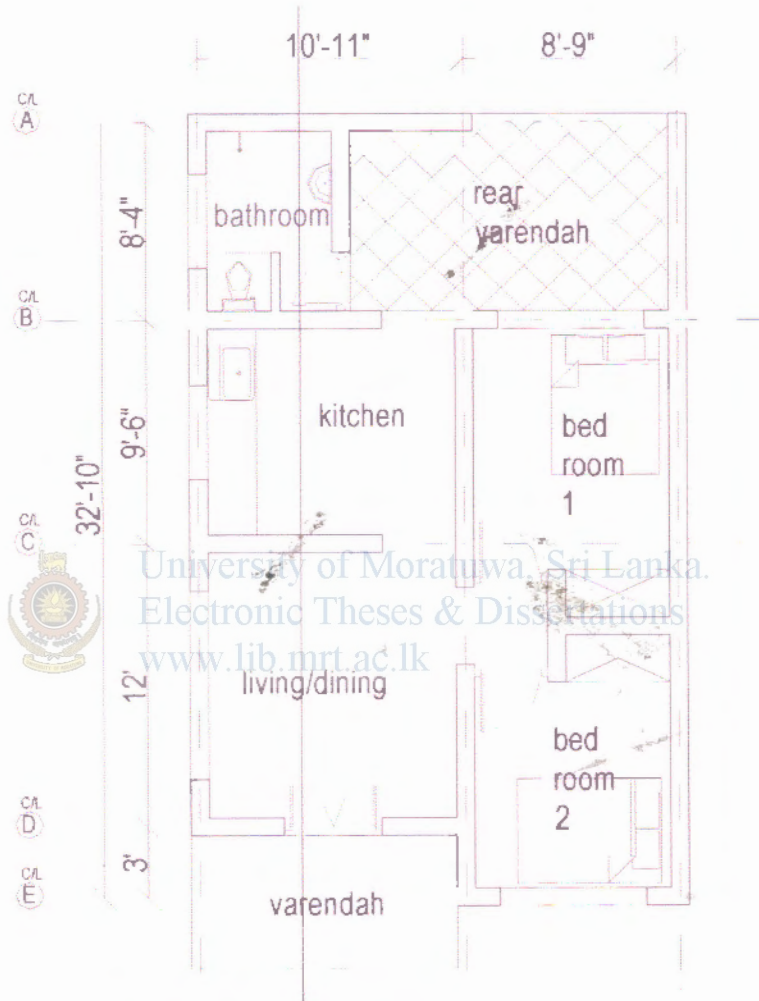
Fig. 63- Plan of one unit

Individual Unit consist of 9'6"X8'9" two bed rooms, Living/ dining, Kitchen and attached Bath room. Each bed room faces towards front and rear of the unit. Thus it Provides cross ventilation through the unit.

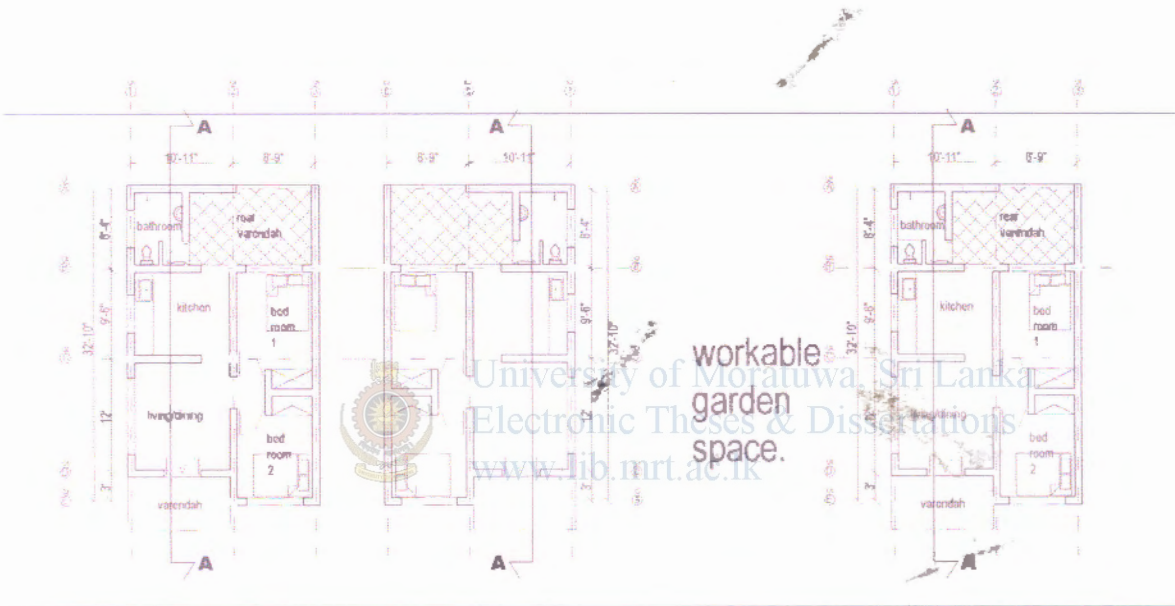
Fig. 65- Cluster Layout

Considering the Cluster settlement, each unit in 6 perch plot. Floor area is around 600 sq ft or 650 sq ft. So it reduces the garden space. To avoid that issue, the architect has located the unit closer to one boundary providing blind wall there. It creates large garden space with the neighbour. It acts as workable gathering space which creates sense of community.

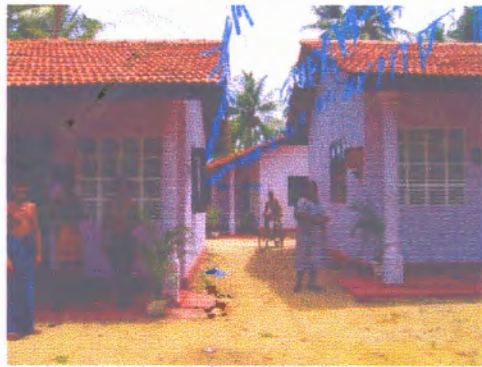
Fig. 67- The housing scheme

Permanent houses are arranged as clusters, while creating narrow pathways in between the houses.

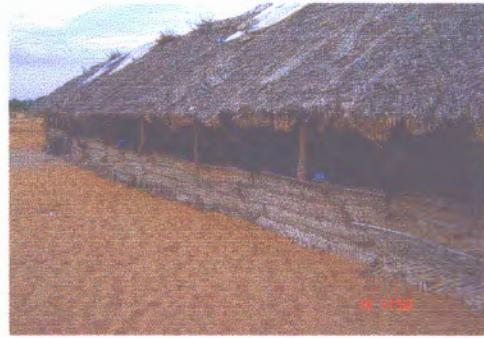
Fig. 72- Raw house in the beach covered with coconut and palm leaves

They have built temporary structures with palm leaves, more close to the sea, 5 or 10 meters near the beach. "Pila" is used for some of the activities like repairing nets and it is the gathering space for the people which act as living area.

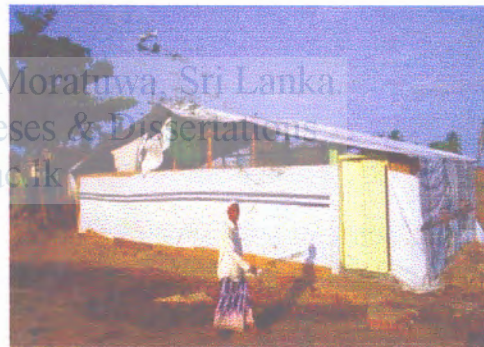
Fig. 83- Tent structures

Each family given individual tent structures. The camps for the immediate resettlement had common toilets and common kitchens.

Basically in North east province one long tent is for several families, because in Muslim communities several families live together.

In the emergency stage, foreign involvement is highlighted. Provided tent structures are not suit to the tropical climate condition. Inhabitants felt uncomfortable and move to another option or made changes of tents.

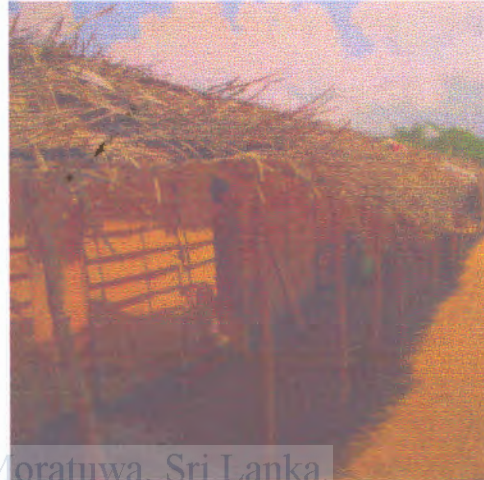
These temporary houses were made out of timber walls, palm leave roofs with eaves, closable door and windows. Basically they are raw houses. The common cooking spaces were provided in the rear side.

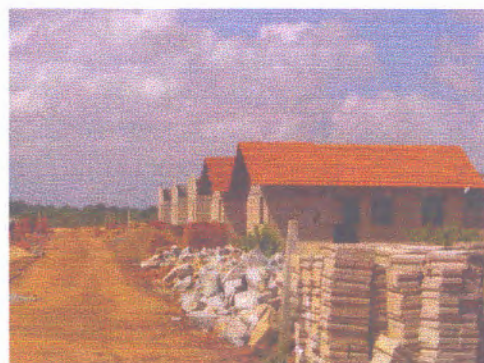
Fig. 86- Geometrical layout

The lay out of the housing schemes is generally geometrical. Designated areas have been provided for common activities such as community centres, play grounds, pre schools etc, which facilitate their lifestyle. Roads and pedestrian paths lead down to the sea.

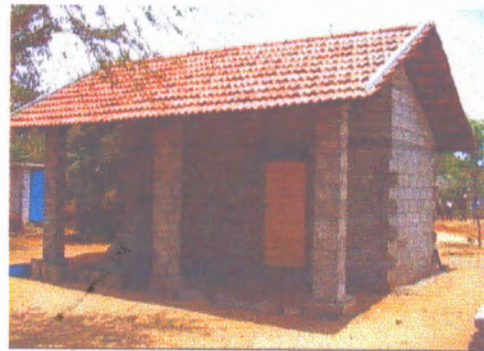
Fig. 88- Typical house with verandah

One is face to the main road with a verandah. Toilet is detached but close to the house. There is single bed room, and large space is function as living and dining room. Detached toilet has temporary roof cover.

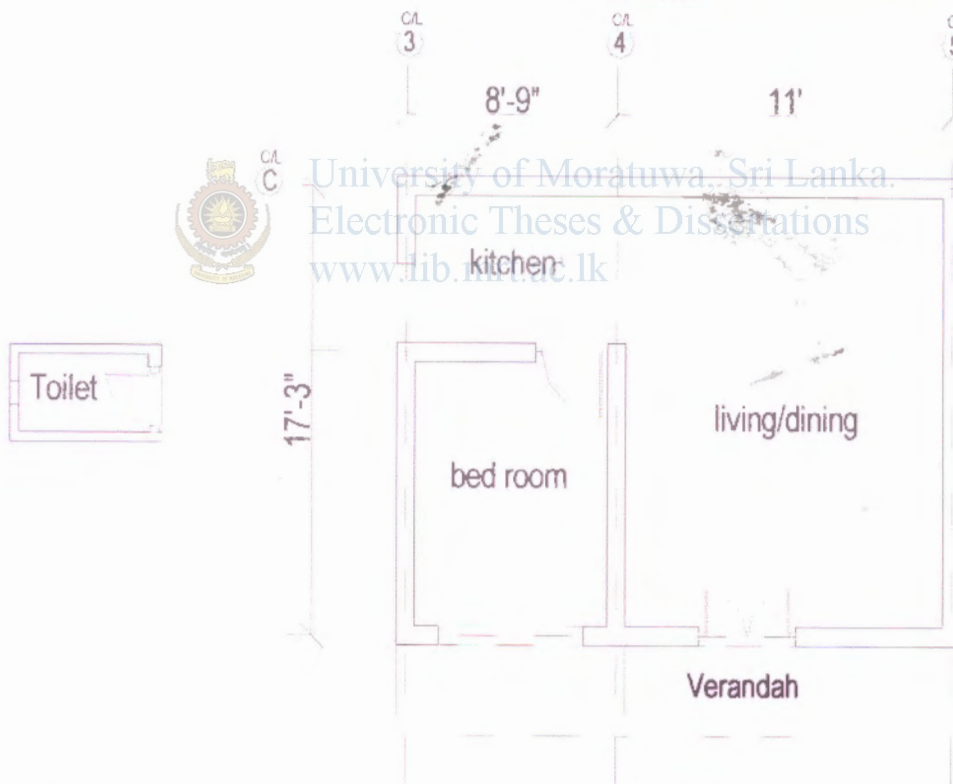
Fig. 89- Individual unit 1

After studying the general social and economical aspects of the victims, has identified two type plans for the housing unit, consist of two or one bed rooms, living, kitchen and toilet. Generally one unit has 500sq.ft. floor area.

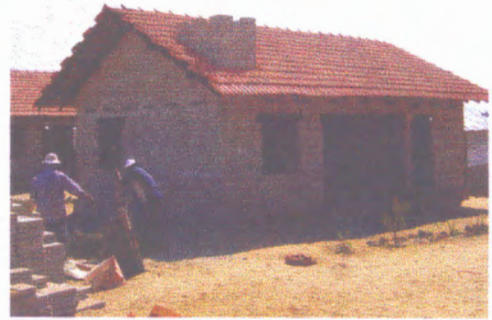
Fig. 91- House without verandah

The other type is faced to secondary roads, without a verandah. Toilet is attached to the house. Providing facilities for indoor living. There are two bed rooms. One is Open to the Kitchen, and the other one is open to the living room.

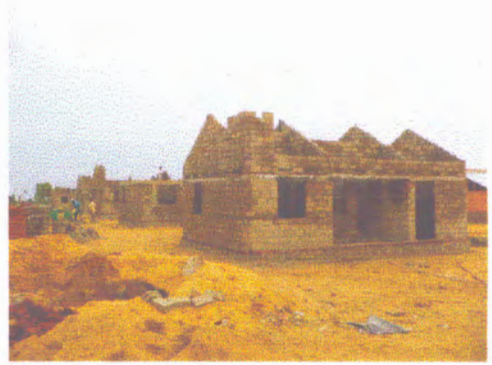
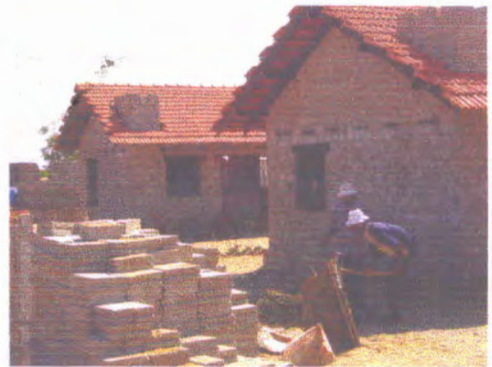
Roof is consisted of unplane coconut rafters and Calicut tile roof cover without a ceiling. Gaps between the tiles provide ventilation. Wooden doors and windows have been used.

Cement, calicut tiles and coconut timber are the most available materials in this area.

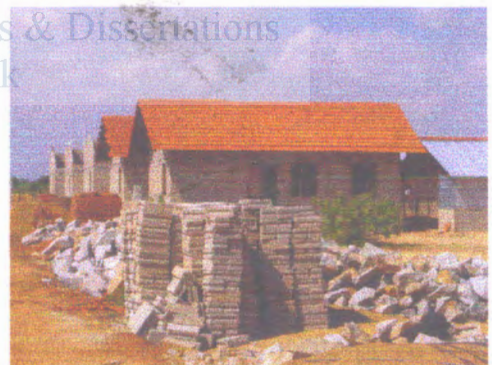
Fig. 95- construction period

The houses are in same construction period. Hence get benefit of labour efficiency, cost effectiveness, minimum material wastage and easy supervision.

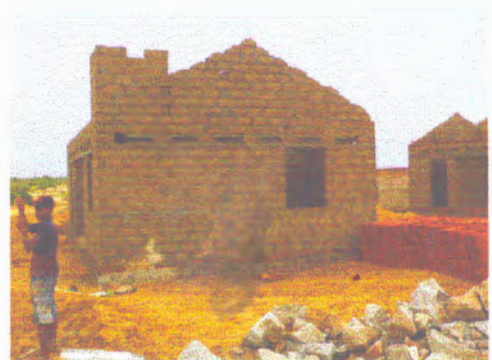
Fig. 96- construction materials

Rubble and clay bricks have been also used as construction materials

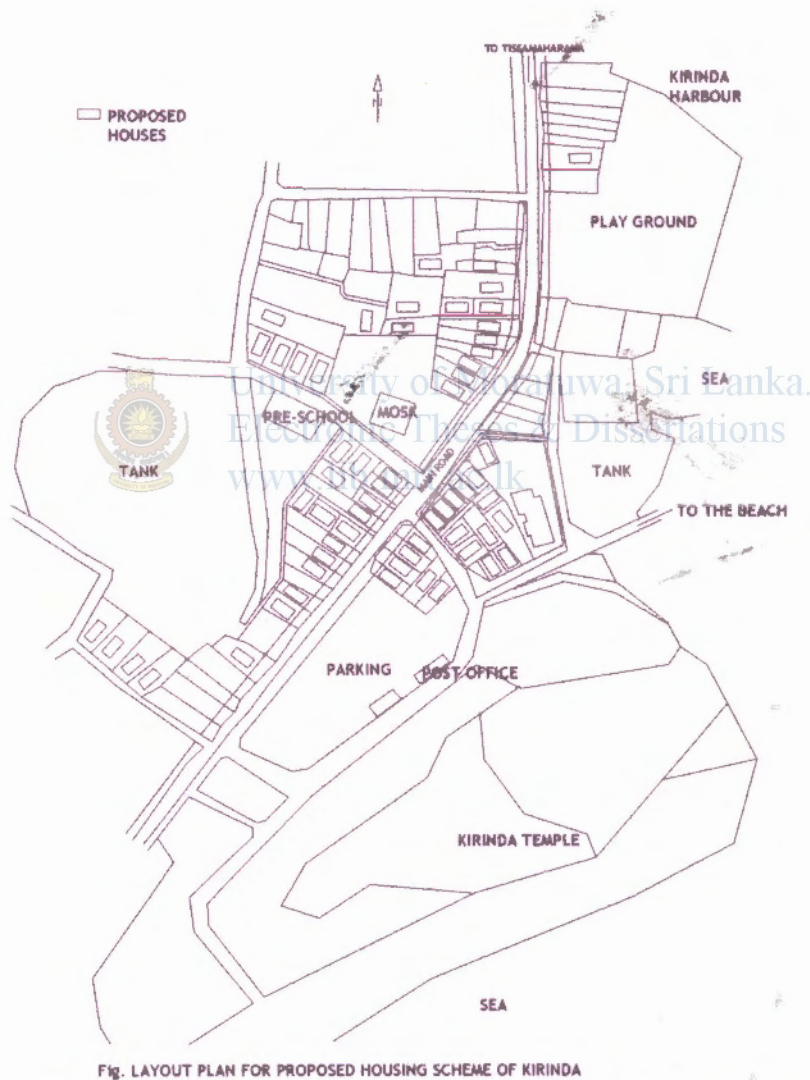
Fig. 98- Layout plan

Considering the resettlement of Muslim community, although Archt, Shegaruban is a Japanese person, the overall layout functions well, because of the analytical study of the area and the community participation. Critical issues have been solved, because the affected people have been locating in same area.

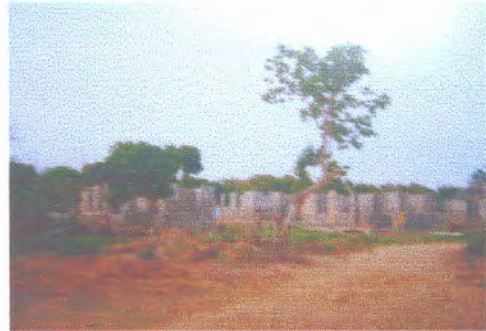
Fig. 100- houses are in same under construction stage

Cost efficiency, Labour efficiency, minimum material usage and easy supervision can be identified because all housing units were done in same period of construction.

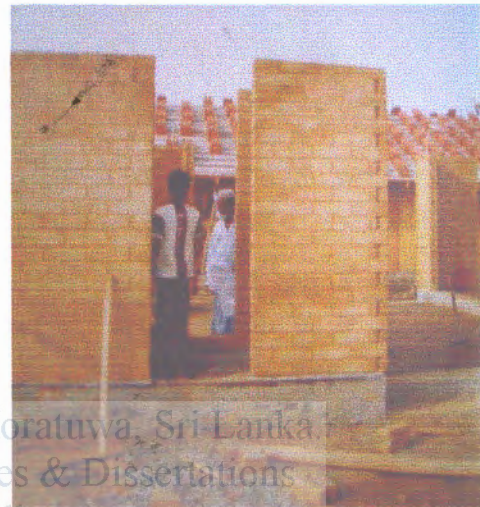
Fig. 101- Clay & cement blocks

Introduced new clay and cement mixed blocks, reduce the heat gain and provide comfortable living inside. As a construction material, clay which is available in village premises has been used to produce the introduced clay and cement mixed blocks.

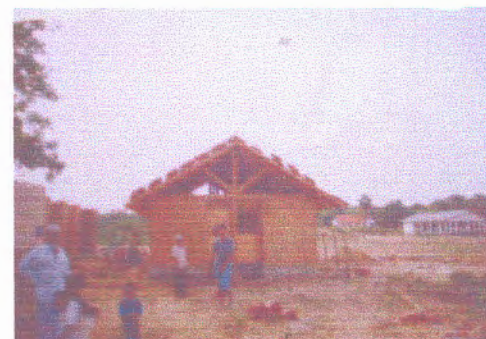
Fig. 102- Individual house

The gap between wall and the roof, creates stack effect.

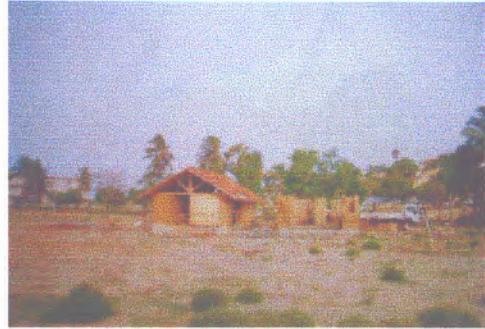
Fig, 103- Front Elevation

Bed rooms of the housing units are faced to main road. So inhabitants have lost the quality of privacy at the only private space of the unit. Also the used of imported timber for the roof structure is not cost effective.

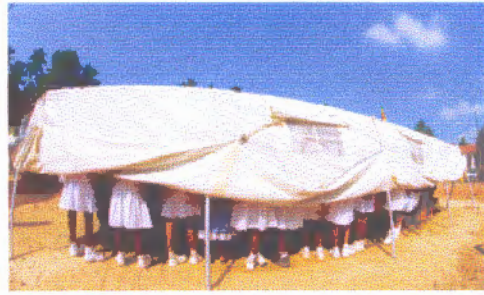
Fig. 107-Tent school

Fig shows a congested School under a tent. They have raised the tent to get ventilation.

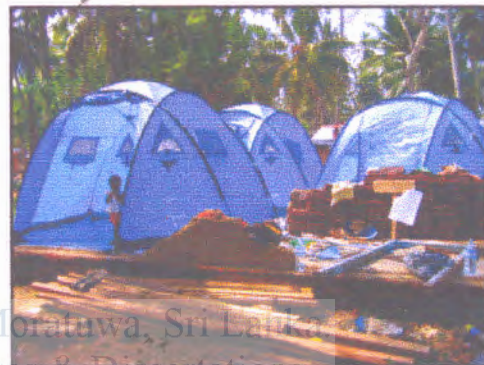
Fig.108- Raised tents

The expensive tents sent from the western countries did not suit the tropical climatic conditions. In the case of Peraliya, they had to move tents to higher ground to escape save from the flooding.

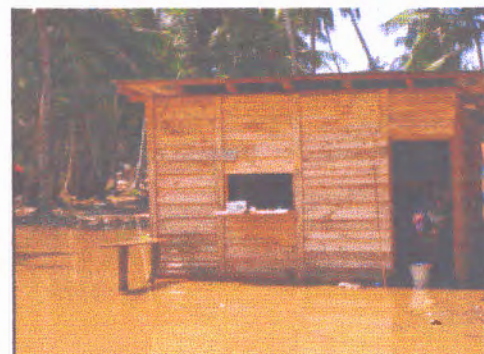
Fig. 109-Flooded wooden house

They are totally covered and no proper windows. It makes uncomfortable living without adequate ventilation. Some of the individual houses have been constructed in the beach and still they remain. Again it will create haphazard development in the future.

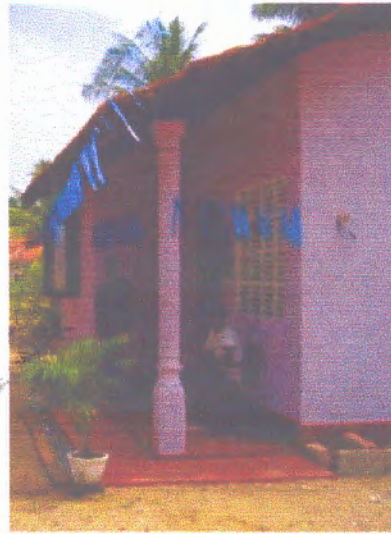
Fig. 110-Permanent house

There is no provision for future extensions.

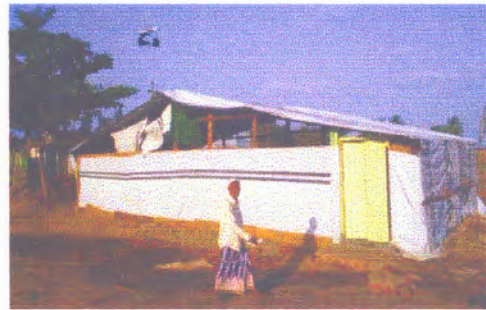
Fig.111-Long temporary structure

As immediate resettlement, the long tent structure, facilitated for several Muslim families, because in Muslim communities, several families used to live together. Though it is an immediate settlement, quality of their lifestyle has been considered.

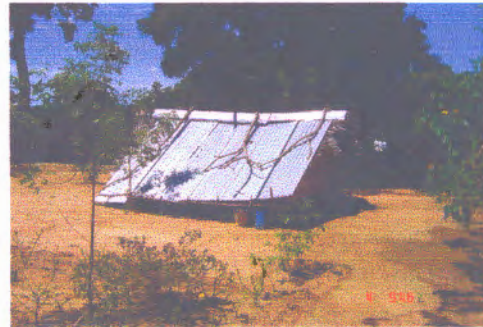
Fig.112- Temporary shelter

Although the affected people got permanent houses, some of them have moved to the beach again, and settled down in temporary structures which made out of available materials.

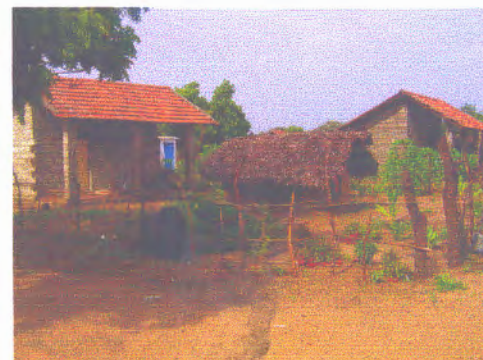
Fig. 113-Existing palm leave structure

They have built temporary shelter near the permanent house and it is used while the permanent house is remained. In other hand middle income people are not satisfied available facilities.

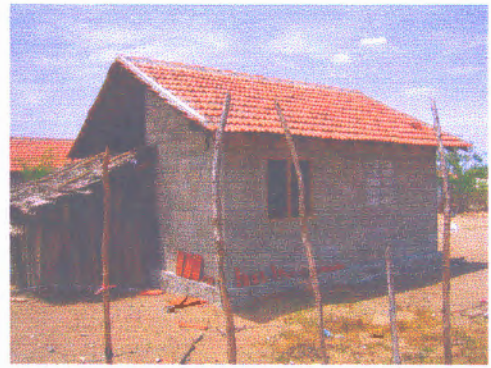
Fig.114 - Addition of outside kitchen

Already they have attached kitchen with the permanent house, in some places they have built outside kitchen, because they prefer out door cooking and preparing , while communicating with neighbours.
