ROAD SAFETY EVALUATION IN GALLE: TOWARDS STAR RATING FOR SRI LANKAN ROADS

Hirushi Tharaka¹, Niranga Amarasingha²

Faculty of Engineering, Sri Lanka Institute of Information Technology

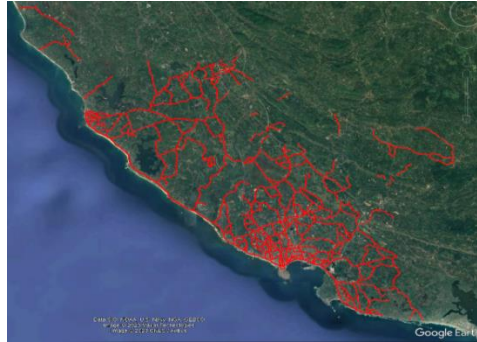
Figure 1. Selected road segments in Galle District

collection was conducted by considering 312 road sections around the Galle area. With the help of “Google Earth Pro”, the data collection process was carried out. Collecting data was done individually for respective road sections in accordance with the prevailing roadside elements. Figure 1 shows an extracted image from Google Earth, and the red color lines represent the road segments where the data has been collected. Data collection was done by considering fourteen variables. The accident data was collected from Galle Police Station for the past five years.
